16-BIT MICROCONTROLLER STARTERKIT
SK-16FX-144PMC-USB

FUNCTIONAL LIMITATION
USB FUNCTION INTERFACE

CUSTOMER INFORMATION

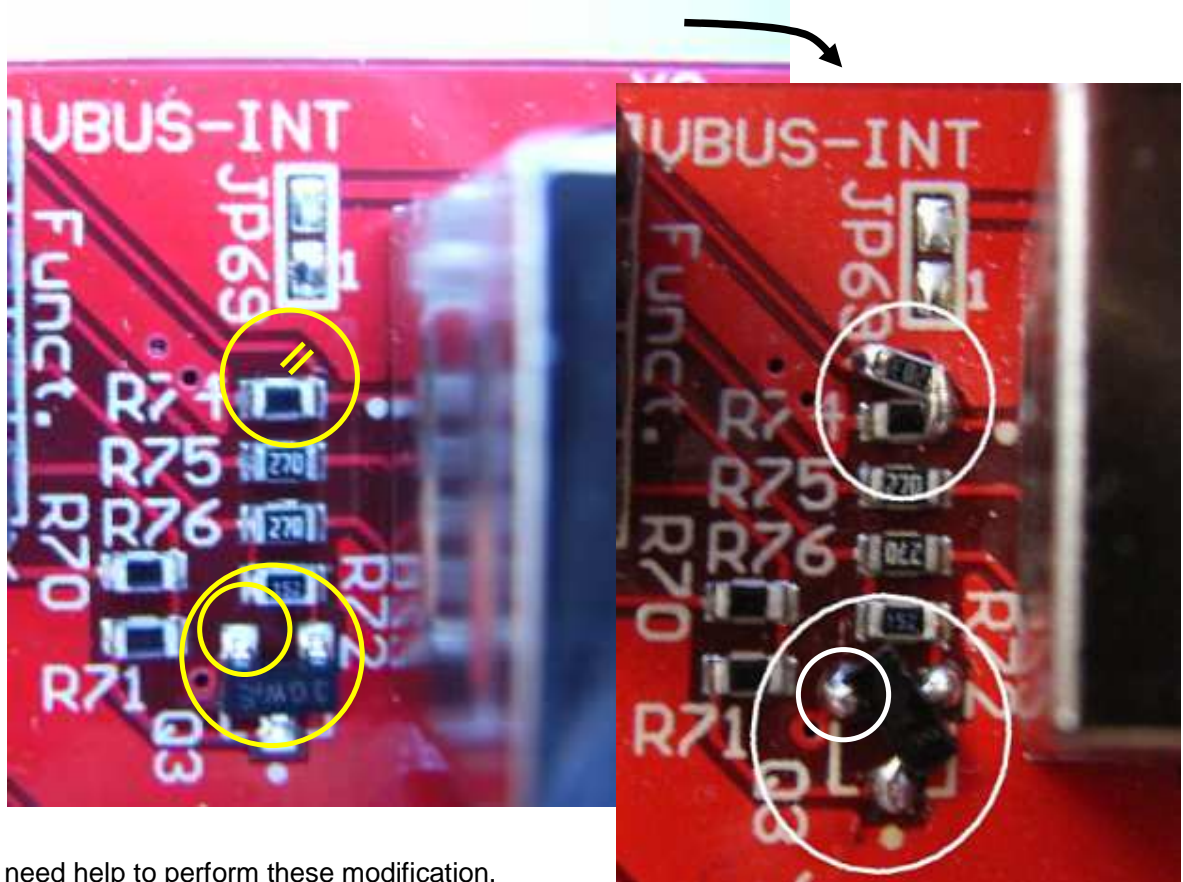
5.2 Design modification V1.1

- In case that the SK-16FX-144PMC-USB is not self powered but connected to an USB Host, an increased current may be driven via VBUS of the USB Function interface X3 connected to the microcontroller's interrupt input.
- Even when Vbus is not yet detected the D+ pull up resistor is enabled.
- Even when HCONX jumper JP67 is open, D+ pull up resistor is enabled

The problem is caused by PCB design error.

The problem can be fixed manually as follows:

1. Cut the trace from X3-1 to JP64-1 (VBUS) as shown close to R74
2. Solder an additional resistor R99=20kOhm between X3-1 and JP64-1 (VBUS)
3. Remove (desolder) Q3 carefully
4. Put Q3 backward on top and solder Q3 again as shown
Keep the position of the marked pin close to R71 (Emitter)

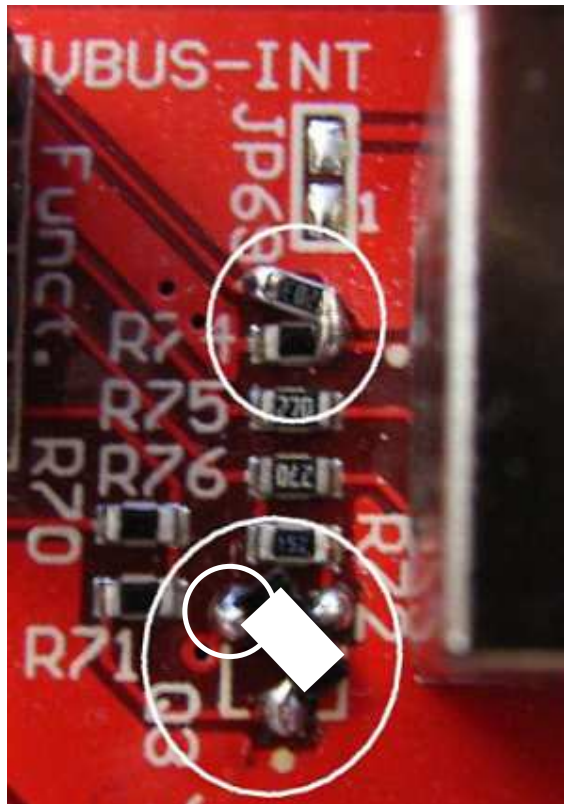
5.3 Use SK-16FX-144PMC-USB V1.1 or newer

After patching to V1.1 some boards were assembled with the wrong type of transistor (NPN instead of PNP) for Q3.

The SK-16FX-144PMC-USB revision V1.1 or newer have the bug fix already included. On some boards the wrong type of transistors were assembled. If the function mode has problems after resetting the MCU to be recognized by the host, this can be an indication for the wrong type of transistor. Repaired boards have a white mark on the transistor.

The problem can be fixed manually as follows:

1. Remove (desolder) Q3 carefully
2. Put a new BC857C **PNP** transistor backward on top and solder it as shown
Keep the position of the marked pin close to R71 (Emitter)
3. Mark the transistor Q3 to discover that the board was fixed.
