Sitara™ AM335x ARM® Cortex™-A8 Microprocessors (MPUs) Silicon Revisions 2.1, 2.0, 1.0

Silicon Errata

Literature Number: SPRZ360F
October 2011 – Revised November 2013

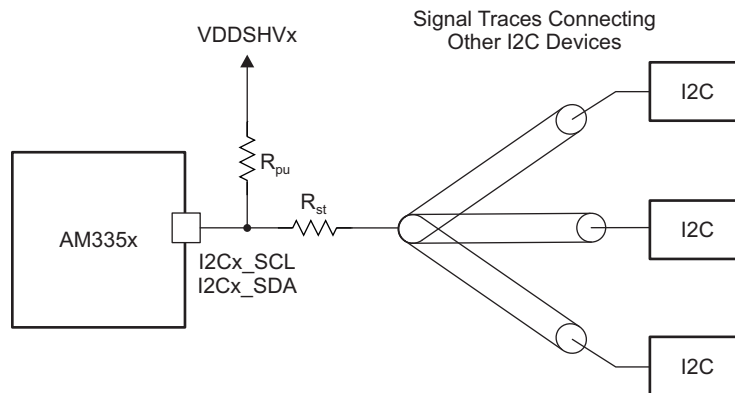
Figure 4. Placement of Series Termination Resistor and Pullup Resistor

The I2Cx_SDA and I2Cx_SCL outputs are implemented with push-pull 3-state output buffers rather than open-drain output buffers as required by I2C. While it is possible for the push-pull 3-state output buffers to behave as open-drain outputs, an internal timing skew issue causes the outputs to drive a logic-high for a duration of (0–5 ns) before the outputs are disabled. The unexpected high-level pulse will only occur when the SCL or SDA outputs transition from a driven low state to a high-impedance state and there is sufficient internal timing skew on the respective I2C output.

This short high-level pulse injects energy in the I2C signals traces, which causes the I2C signals to sustain a period of ringing as a result of multiple transmission line reflections. This ringing should not cause an issue on the SDA signal because it only occurs at times when SDA is expected to be changing logic levels and the ringing will have time to damp before data is latched by the receiving device. The ringing may have enough amplitude to cross the SCL input buffer switching threshold several times during the first few nanoseconds of this ringing period, which may cause clock glitches. This ringing should not cause a problem if the amplitude is damped within the first 50 ns because I2C devices are required to filter their SCL inputs to remove clock glitches. Therefore, it is important to design the PCB signal traces to limit the duration of the ringing to less than 50 ns. One possible solution is to insert series termination resistors near the AM335x SCL and SDA terminals to attenuate transmission line reflections.

This issue may also cause the SDA output to be in contention with the slave SDA output for the duration of the unexpected high-level pulse when the slave begins its ACK cycle. This occurs because the slave may already be driving SDA low before the unexpected high-level pulse occurs. The glitch that occurs on SDA as a result of this short period of contention does not cause any I2C protocol issue but the peak current applies unwanted stress to both I2C devices and potentially increases power supply noise. Therefore, a series termination resistor located near the respective AM335x SDA terminal is required to limit the current during the short period of contention.

A similar contention problem can occur on SCL when connected to I2C slave devices that support clock stretching. This occurs because the slave is driving SCL low before the unexpected high-level pulse occurs. The glitch that occurs on SCL as a result of this short period of contention does not cause any I2C protocol issue because I2C devices are required to apply a glitch filter to their SCL inputs. However, the peak current applies unwanted stress to both I2C devices and potentially increases power supply noise. Therefore, a series termination resistor located near the respective AM335x SCL terminal is required to limit the current during the short period of contention.

Insert series termination resistors on the SCL and SDA signals and locate them near the AM335x SCL and SDA terminals. The SCL and SDA pullup resistors should also be located near the AM335x SCL and SDA terminals. The placement of the series termination resistor and pullup resistor should be connected as shown in [Figure 4](#).

Table 6 provides series termination and pullup resistor value recommendations. The I2C signal level and respective VDDSHVx power supply voltage is shown in the first column. Two resistor value combination options are provided for each voltage. One option supports a maximum high-level input current of 200 uA to all attached I2C devices, while the other option supports a maximum high-level input current of 100 uA to all attached I2C devices.

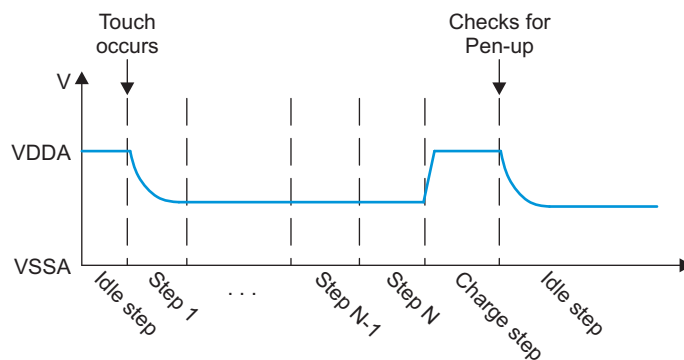
Figure 5. TSC Generates False Pen-up Interrupt

Details The touchscreen controller (TSC) determines the pen state (up or down) by checking the respective analog input (AIN0 for 4-wire or AIN4 for 5-wire) voltage level immediately after the Charge step. This does not provide enough time for the analog input voltage to return to the normal Pen-down voltage before testing the pen state. This will cause the TSC to generate a false Pen-up interrupt if the Charge step is enabled with the strong pull-up turned on when using hardware synchronized steps. [Figure 5](#) illustrates the effect on the analog voltage when constant pen pressure is applied to the touchscreen and held through the Charge step.
