LS1012A Reference Design Board Errata

This document lists and describes all known errata for the LS1012ARDB. It also describes the available workaround for each erratum and detailed erratum explanation, where needed.

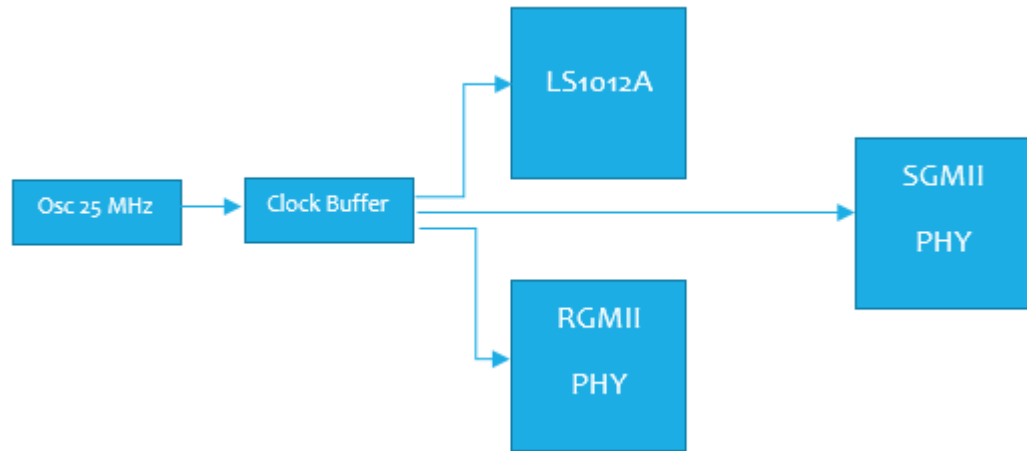
Figure 1. E-00001 workaround

E-00001: LS1012A and Ethernet PHY clock inputs from same 25 MHz clock source

Description: Due to the SGMII PCS bug identified in the LS1012A SoC, the Ethernet PHY 25 MHz input and LS1012A 25 MHz clock input need to be sourced from same source.

Impact: SGMII CRC errors observed on link and the link is not stable.

Workaround: It is not possible to make any workaround on the Rev C boards. Refer to Rev D schematics for implementation of updated clock architecture.

Fix plan: The permanent fix will be available on the Rev D and higher boards.

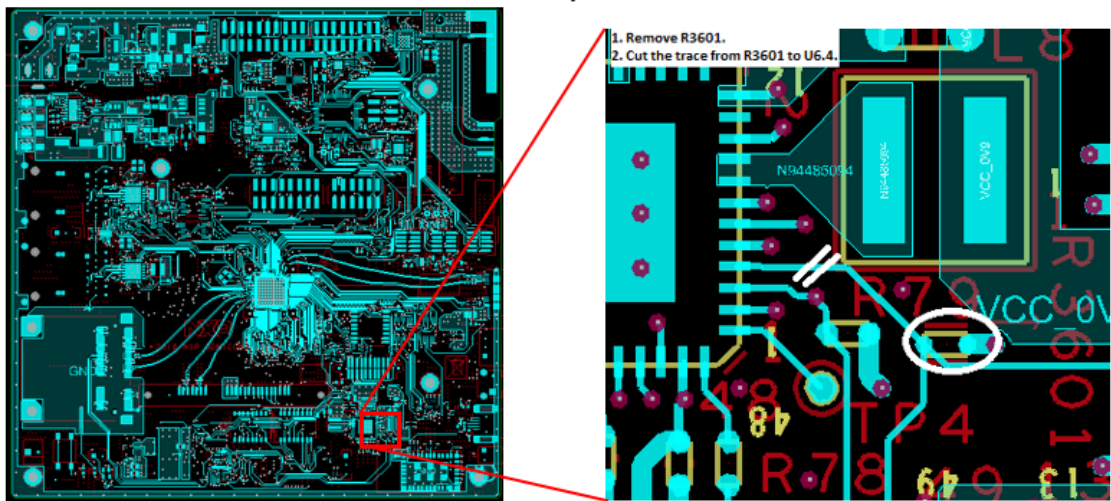
Figure 2. E-00002 workaround

E-00002: USB 3.0 HDD drive is showing intermittent failures during enumeration and data transfer

Description: USB 3.0 HDD fail during data transfer and enumeration. The USB power switch asserts power fault. The root cause is traced to battery charger and power mux circuitry. This circuitry loads the VBUS and the power switch disables VBUS along with the POWERFAULT assertion.

Impact: All USB 3.0 based use cases is impacted.

1. Remove the Li-Ion battery, if it is connected on connector J2.
2. Unmount R3601.
3. Cut the trace from R3601 to the U6.4 pin.

Fix plan: The permanent fix will be available on the Rev D and higher boards.

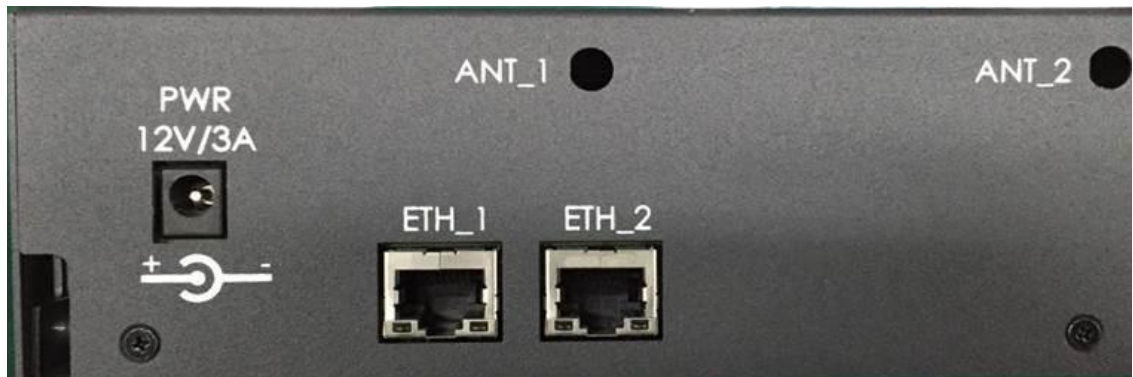
Figure 3. Incorrect ETH_1 and ETH_2 port markings on LS1012ARDB chassis

E-00005: Chassis silk markings for Ethernet ports

Description: ETH_1 and ETH_2 port names on the chassis silk are swapped.

Impact: The naming creates confusion with the port mappings in the U-Boot and Linux software releases.

Workaround: If the ETH_1 and ETH_2 port markings on the chassis silk of your LS1012ARDB are as shown in the figure below, then paste stickers on the chassis silk to correct the markings, as given in the table below.

Old marking	New sticker marking
ETH_1	ETH_2
ETH_2	ETH_1

Fix plan: A permanent fix will be available on the Rev. D and and higher boards.

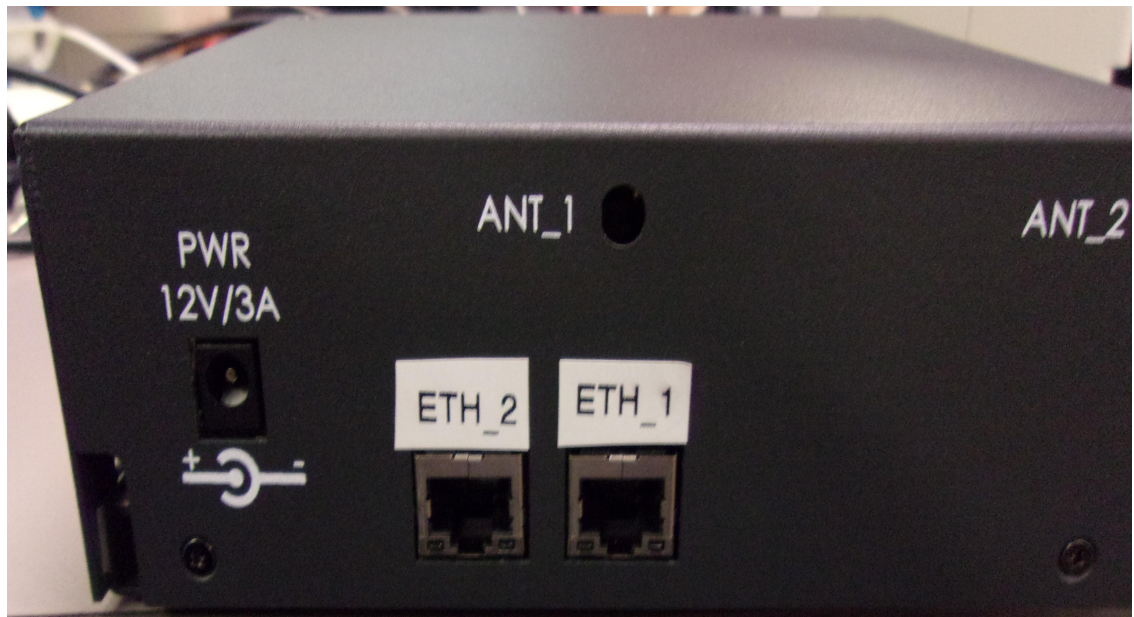
Figure 4. Correct ETH_1 and ETH_2 port markings on LS1012ARDB chassis

The figure below shows the correct Ethernet port markings on the LS1012ARDB chassis.
