## Product Change Notification - SYST-18KHMV915

ERRATA - dsPIC33EVXXXGM00X/10X Family Silicon Errata and Data Sheet Clarification

## dsPIC33EVXXXGM00X/10X Family Silicon Errata and Data Sheet Clarification

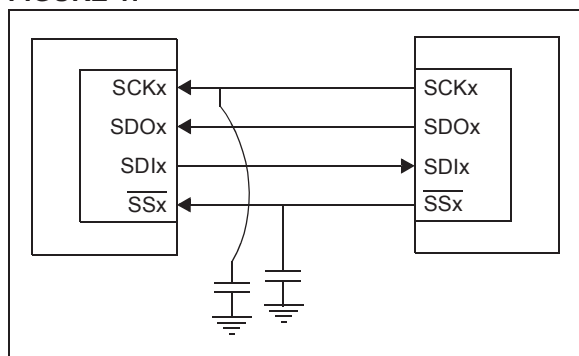
FIGURE 1:

When the SPIx module is configured in SPIx Slave mode (MSTEN bit (SPIxCON1<5>) = 0), the frame slave (FRMEN bit (SPIxCON2<15>) = 1) and the SPIFSD bit (SPIxCON2<14> = 1), in Standard Buffer mode with the Clock Polarity Select bit, CKP = 0, the data is not transmitted in both 8-bit and 16-bit mode, but the data is being received correctly.

Adding a capacitance on the signal, as shown in Figure 1, will help the data to be received properly.

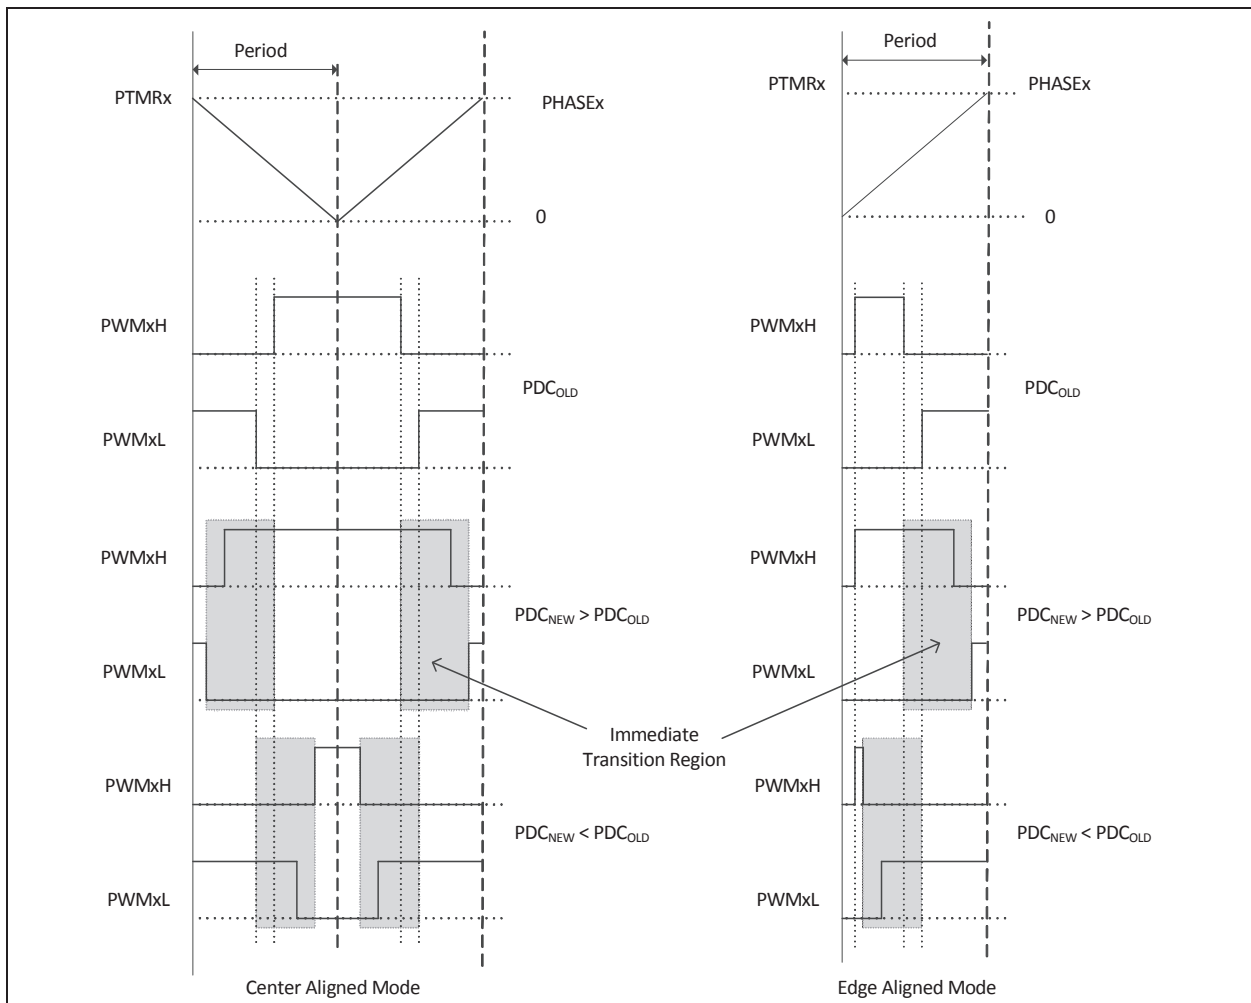
**FIGURE 2: TIMING DIAGRAMS FOR CENTER-ALIGNED AND EDGE-ALIGNED MODES**

The PWM generator may not assert dead time on the edges of transitions. This has been observed when all of the following conditions are present:

In Figure 2, if the duty cycle write occurred in the shaded box, then PWMxH and PWMxL will make an immediate transition without dead time.

However, in most applications, the duty cycle update timing can be controlled using the TRIGx trigger or Special Event Trigger, such that the above mentioned conditions are avoided altogether.

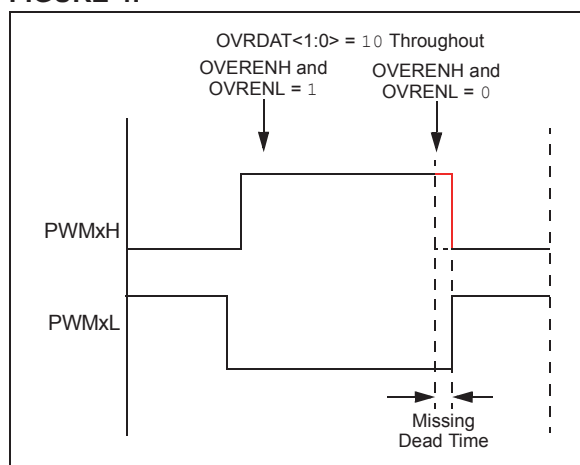
FIGURE 4:

- Output override synchronization is configured to occur on the CPU clock boundary (IOCONx<0> = 0);
- Both PWMxH and PWMxL overrides are enabled prior to the event (OVRENH and OVRENL are both '1'), and
- Both overrides are disabled (OVRENH and OVRENL are both '0') at the instant the dead time should be asserted (Figure 4). This has been observed in both Center-Aligned and Edge-Aligned modes.

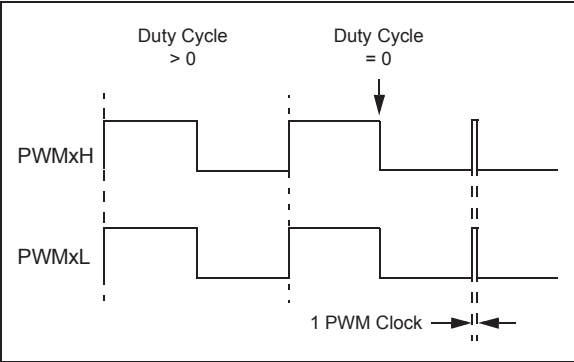
FIGURE 5:

In the Redundant Output mode (IOCONx<11:10> = 10) and Push-Pull Output mode (IOCONx<11:10> = 01) with Immediate Update disabled (PWMCONx<0> = 0), when the Duty Cycle register is updated from a non-zero value to zero, a glitch pulse of a width equal to one PWM clock will appear at the next PWM period boundary, as shown in Figure 5, for the Redundant Output mode. Here, the Duty Cycle register refers to the PDCx register if PWMCONx<8> = 0 or the MDC register if PWMCONx<8> = 1.

If the application requires a zero duty cycle output, there are two possible work around methods:

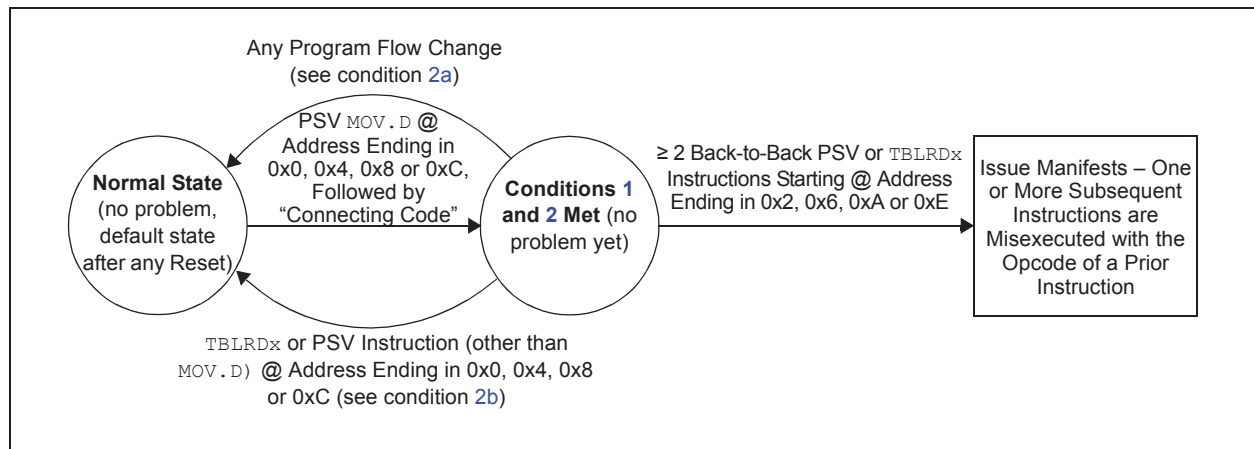
**FIGURE 7: SIMPLIFIED BEHAVIOR**

When two or more data Flash read instructions (via Program Space Visibility (PSV) read or table read) are executed back-to-back, one or more subsequent instructions can be misexecuted when all of the conditions in [Table 6](#) occur.

[Figure 7](#) provides an example of the effective behavior.

1. All instances of PSV `MOV.D` can be replaced with two PSV `MOV` instructions instead. Non-PSV `MOV.D` instructions acting on RAM/SFRs do not need to be modified; or
2. If not already present, a program flow change instruction (such as `BRA $+2`) can be inserted above back-to-back data Flash read sequences; or
3. Back-to-back data Flash read instruction sequences can be broken up by inserting a non-Flash read instruction (such as a `NOP`), in between the Flash read instructions; or
4. The alignment of the code can be shifted to avoid the required opcode location addresses.
