Product Change Notification - SYST-04GTSX528

ERRATA - PIC32MK Motor Control and General Purpose Errata and Data Sheet Clarification

PIC32MK General Purpose and Motor Control (GP/MC) Silicon Errata and Data Sheet Clarification

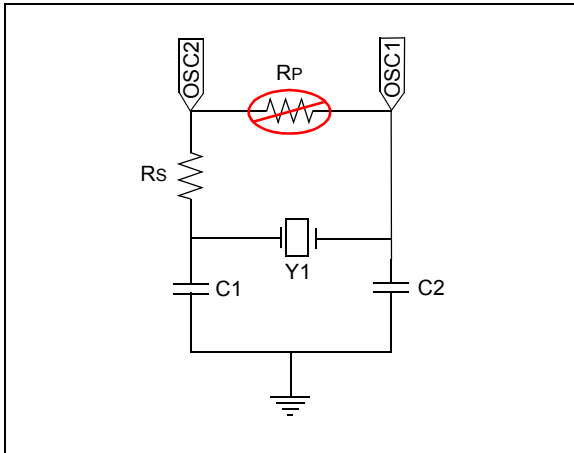
FIGURE 1: POSC CRYSTAL CIRCUIT

1. Module: Primary Oscillator

The POSC supports only specific crystal operation as provided in [Table 1](#).

The Primary Oscillator (POSC) has been characterized to operate at 8 MHz and 12 MHz when the circuit shown in [Figure 1](#) is implemented and the operating conditions provided in [Table 1](#) are met.

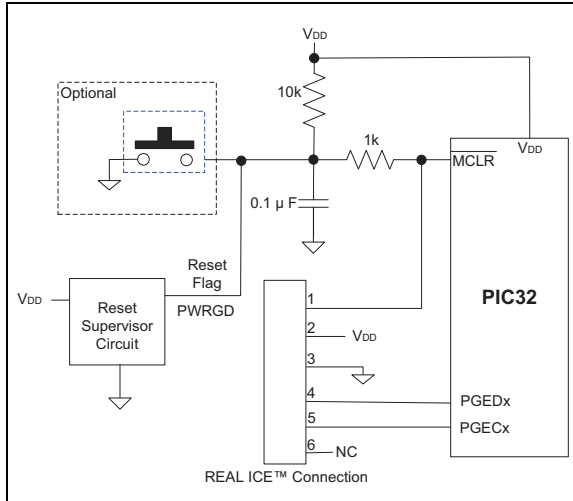
FIGURE 2: RESET SUPERVISOR CIRCUIT

On a BOR event, $V_{POR} < V_{DD} < V_{BOR}$, a Reset is not generated when the BOR threshold is reached. System clocks will stop with all I/O pins functions frozen in their present state until either VDD falls to V_{POR} or VDD returns to above V_{BOR} . The user must assess if this VDD brown-out condition and the resulting frozen I/O pin state has an adverse effect on their application (UART, PWM, I/O, OC, etc.).

If the application can sustain frozen I/O states for ~2.1 ms (UART, CAN, I/O, etc.), the application must enable the Deep Sleep Watchdog Timer and Clock Fail Monitor, based on the details provided in Table 3 and Table 4. If implemented correctly, after ~2.1 ms, a valid internal reset state is entered and the I/O pins are set to the device default Reset state.
