Product Change Notification - SYST-14YTT0745

ERRATA - dsPIC33EVXXXGM00X/10X Family Silicon Errata and Data Sheet Clarification

dsPIC33EVXXXGM00X/10X Family Silicon Errata and Data Sheet Clarification

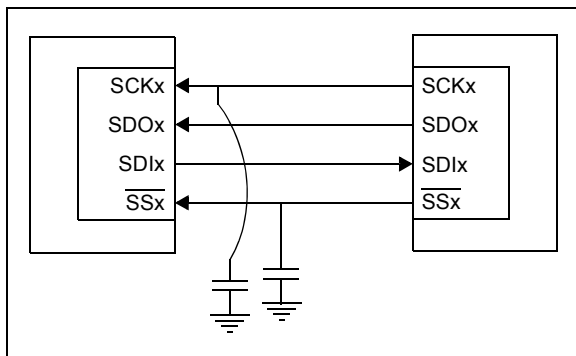
FIGURE 1:

When the SPIx module is configured in SPIx Slave mode (MSTEN bit (SPIxCON1[5]) = 0), the frame slave (FRMEN bit (SPIxCON2[15]) = 1) and the SPIFSD bit (SPIxCON2[14] = 1), in Standard Buffer mode with the Clock Polarity Select bit, CKP = 0, the data is not transmitted in both 8-bit and 16-bit mode, but the data is being received correctly.

Adding a capacitance on the signal, as shown in Figure 1, will help the data to be received properly.

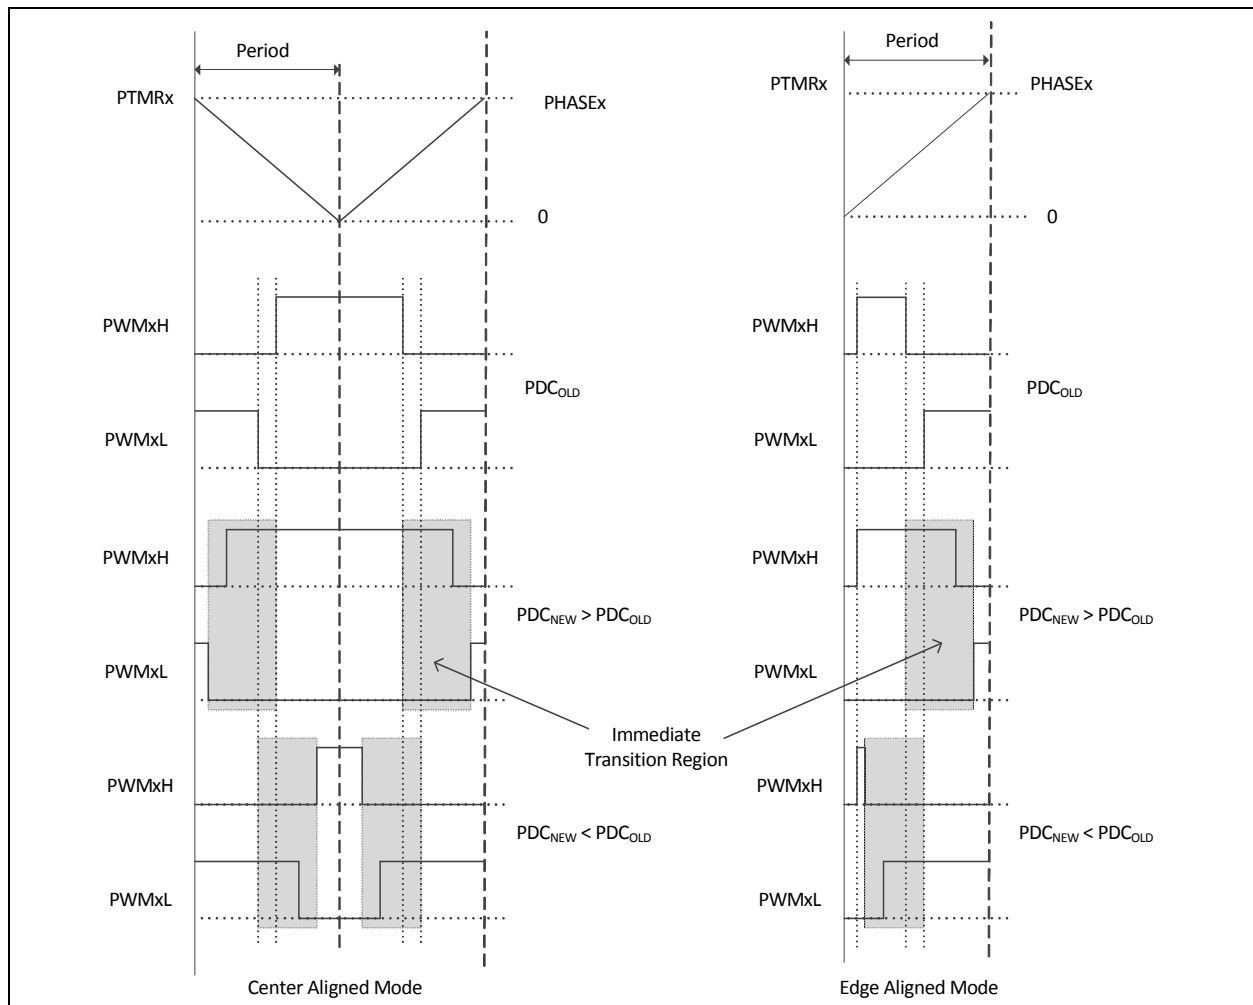
FIGURE 2: TIMING DIAGRAMS FOR CENTER-ALIGNED AND EDGE-ALIGNED MODES

The PWM generator may not assert dead time on the edges of transitions. This has been observed when all of the following conditions are present:

In [Figure 2](#), if the duty cycle write occurred in the shaded box, then PWMxH and PWMxL will make an immediate transition without dead time.

However, in most applications, the duty cycle update timing can be controlled using the TRIGx trigger or Special Event Trigger, such that the above mentioned conditions are avoided altogether.

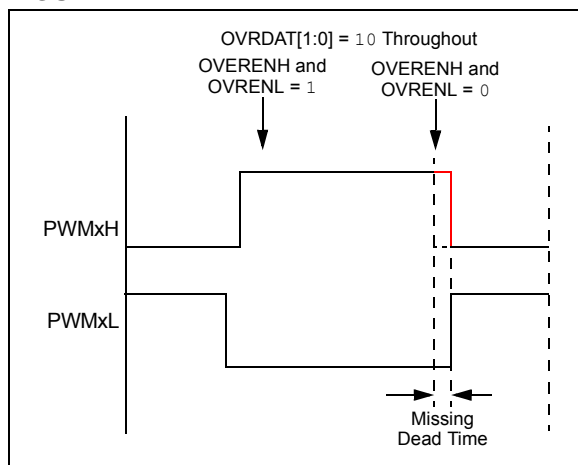
FIGURE 4:

- Output override synchronization is configured to occur on the CPU clock boundary (IOCONx[0] = 0);
- Both PWMxH and PWMxL overrides are enabled prior to the event (OVRENH and OVRENL are both '1'), and
- Both overrides are disabled (OVRENH and OVRENL are both '0') at the instant the dead time should be asserted (Figure 4). This has been observed in both Center-Aligned and Edge-Aligned modes.

None.

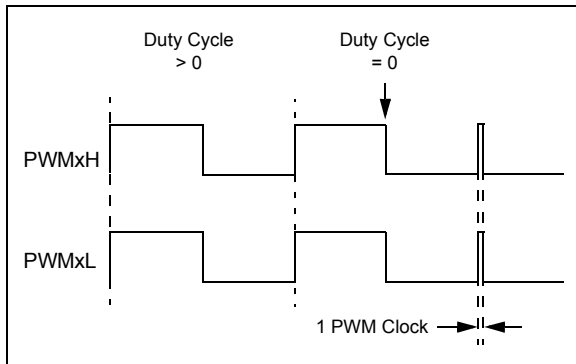
FIGURE 5:

In the Redundant Output mode (IOCONx[11:10] = 10) and Push-Pull Output mode (IOCONx[11:10] = 01) with Immediate Update disabled (PWMCONx[0] = 0), when the Duty Cycle register is updated from a non-zero value to zero, a glitch pulse of a width equal to one PWM clock will appear at the next PWM period boundary, as shown in Figure 5, for the Redundant Output mode. Here, the Duty Cycle register refers to the PDCx register if PWMCONx[8] = 0 or the MDC register if PWMCONx[8] = 1.

If the application requires a zero duty cycle output, there are two possible work around methods:

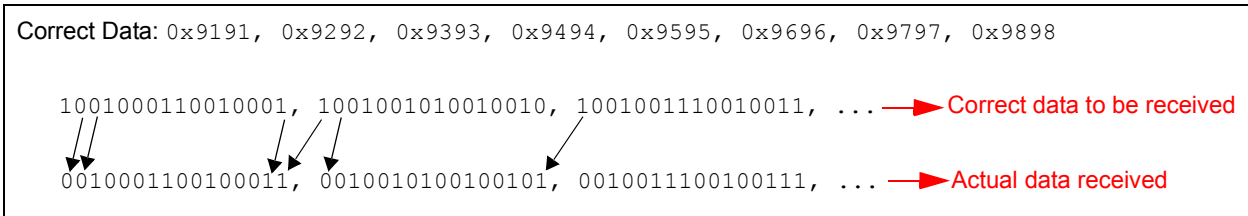
FIGURE 6:

Received data of the SPI is sampled one clock cycle late for the following conditions:

For example, the correct data that should be received is 0x9191, 0x9292, 0x9393, 0x9494, 0x9595, 0x9696, 0x9797, 0x9898, but the actual data received is 0x2323, 0x2525, 0x2727, 0x2929, 0x2B2B, 0x2D2D, 0x2F2F, 0x3130 (Figure 6).

None.

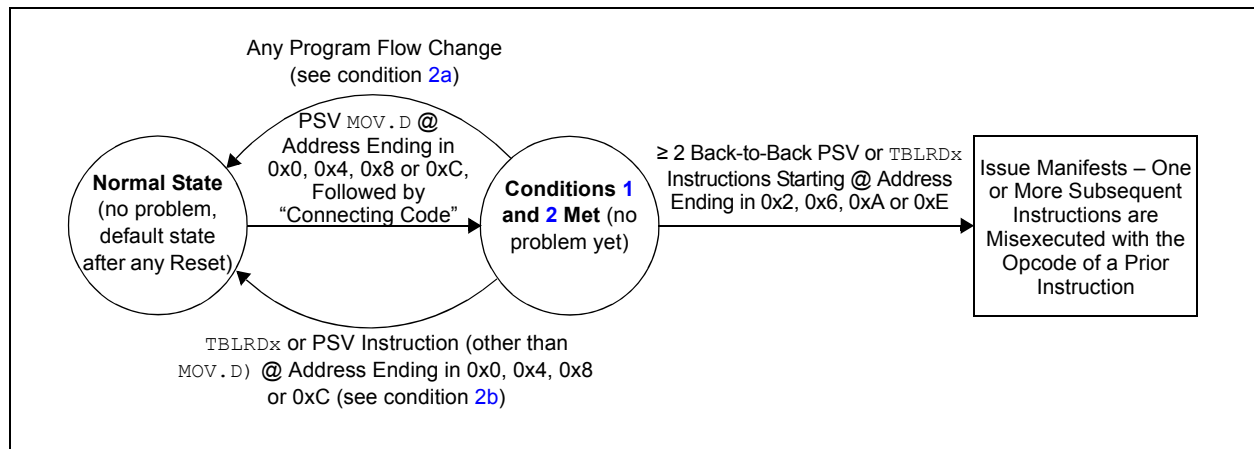
FIGURE 7: SIMPLIFIED BEHAVIOR

When two or more data Flash read instructions (via Program Space Visibility (PSV) read or table read) are executed back-to-back, one or more subsequent instructions can be misexecuted when all of the conditions in [Table 6](#) occur.

[Figure 7](#) provides an example of the effective behavior.

1. All instances of PSV `MOV.D` can be replaced with two PSV `MOV` instructions instead. Non-PSV `MOV.D` instructions acting on RAM/SFRs do not need to be modified; or
2. If not already present, a program flow change instruction (such as `BRA $+2`) can be inserted above back-to-back data Flash read sequences; or
3. Back-to-back data Flash read instruction sequences can be broken up by inserting a non-Flash read instruction (such as a `NOP`), in between the Flash read instructions; or
4. The alignment of the code can be shifted to avoid the required opcode location addresses.
