Product Change Notification - SYST-21GKUR444

ERRATA - dsPIC33EPXXXGS70X/80X Family Silicon Errata and Data Sheet Clarification

dsPIC33EPXXXGS70X/80X Family Silicon Errata and Data Sheet Clarification

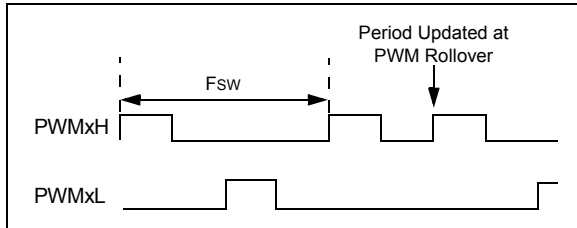
FIGURE 1:

When the PWM module is configured for Push-Pull mode (IOCONx[11:10] = 0b10) with the Enable Immediate Period Update bit enabled (PTCON [10] = 1), a write to the Period register that coincides with the period rollover event may cause the push-pull output logic to produce back-to-back pulses on the PWMx pins (see Figure 1).

Ensure that the update to the PWM Period register occurs away from the PWM rollover event by setting the EIPU bit (PTCON[10] = 1). Use either the PWM Special Event Trigger (SEVTCMP) or the PWM Primary Trigger (TRIGx) to generate a PWM Interrupt Service Routine (ISR) near the start of the PWM cycle. This ISR will ensure that period writes do not occur near the PWM period rollover event.

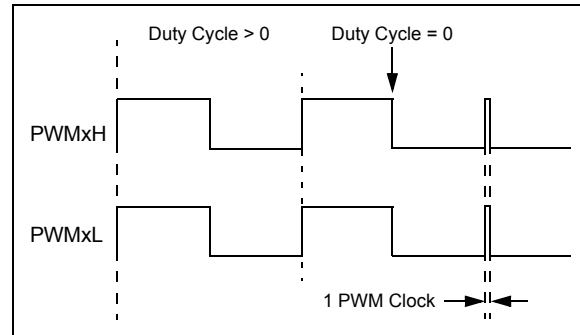
FIGURE 2: EXAMPLE FOR REDUNDANT OUTPUT MODE

In the Redundant Output mode (IOCONx[11:10] = 0b01) and Push-Pull Output mode (IOCONx[11:10] = 0b10), with the Immediate Update Enable bit disabled (PWMCONx[0] = 0), when the Duty Cycle register is updated from a non-zero value to zero, a glitch pulse of a width equal to 1 PWM clock will appear at the next PWM period boundary, as shown in Figure 2 (for the Redundant Output mode). The Duty Cycle register refers to the PDCx register if PWMCONx[8] = 0 or the MDC register if PWMCONx[8] = 1.

If the application requires a zero duty cycle output, there are two possible work around methods:

1. Use the PWM override feature to override the PWM output to a low state instead of writing to the Duty Cycle register. In order to switch back to a non-zero duty cycle output, turn off the PWM override. The override-on and override-off events must be timed close to the PWM period boundary if the IOCONx register has been configured with IOCONx[0] = 0 (i.e., output overrides through the OVRDAT[1:0] bits occur on the next CPU clock boundary).
2. Enable the Immediate Update Enable bit (PWMCONx[0] = 1) while configuring the PWMx module (i.e., before enabling the PWMx module, PTCON[15] = 1). With the Immediate Update enabled, writes to the Duty Cycle register can have an immediate effect on the PWM output. Therefore, the duty cycle write operations must be timed close to the PWM period boundary in order to avoid distortions in the PWM output.

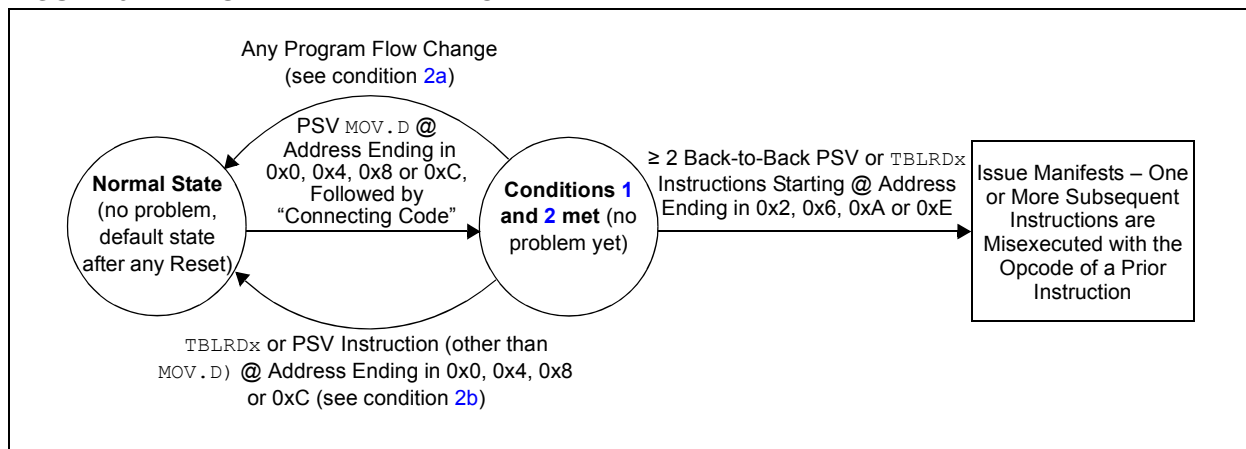
FIGURE 3: SIMPLIFIED BEHAVIOR

When two or more data Flash read instructions (via Program Space Visibility (PSV) read or Table Read) are executed back-to-back, one or more subsequent instructions can be misexecuted when all of the conditions in [Table 4](#) occur.

1. A PSV <code>MOV.D</code> instruction is executed, with opcode at address ending in 0x0, 0x4, 0x8 or 0xC; and
2. Some “connecting code” is executed (following the <code>MOV.D</code> of condition 1), with the properties: <ul style="list-style-type: none">a) The connecting code does not include any program flow changes, including: taken branch instructions (including all versions of <code>BRA</code>, <code>CPBEQ</code>, <code>CPBGT</code>, <code>CPBLT</code>, <code>CPBNE</code>), <code>CALL</code>, <code>CALL.L</code>, <code>GOTO</code>, <code>GOTO.L</code>, <code>RCALL</code>, <code>RETLW</code>, <code>RETURN</code>, vectoring to an ISR, returning from an interrupt (<code>RETFIE</code>) and certain debug operations, such as break and one-step; andb) The connecting code does not include a <code>TBLRDx</code> or non-<code>MOV.D</code> PSV instruction, located at a Flash memory address ending in 0x0, 0x4, 0x8 or 0xC; andc) The connecting code is at least two instruction words in length; andd) The connecting code does not end with a <code>REPEAT</code> instruction, with count > 0; and

3. ≥ 2 back-to-back PSV or <code>TBLRDx</code> instructions are executed (following the code of condition 2), where the first of the back-to-back instructions is located at an address ending in 0x2, 0x6, 0xA or 0xE.

The issue can be avoided by ensuring any one or more of the requirements are not met. For example:

1. All instances of PSV `MOV.D` can be replaced with two PSV `MOV` instructions instead. Non-PSV `MOV.D` instructions acting on RAM/SFRs do not need to be modified; or
2. If not already present, a program flow change instruction (such as `BRA $+2`) can be inserted above back-to-back data Flash read sequences; or
3. Back-to-back data Flash read instruction sequences can be broken up by inserting a non-Flash read instruction (such as a `NOP`), in between the Flash read instructions; or
4. The alignment of the code can be shifted to avoid the required opcode location addresses.
