Product Change Notification - SYST-19TBKO462

ERRATA - dsPIC33FJ06GS101/X02 and dsPIC33FJ16GSX02/X04 Family Silicon Errata and Data Sheet Clarification

dsPIC33FJ06GS101/X02 and dsPIC33FJ16GSX02/X04 Family Silicon Errata and Data Sheet Clarification

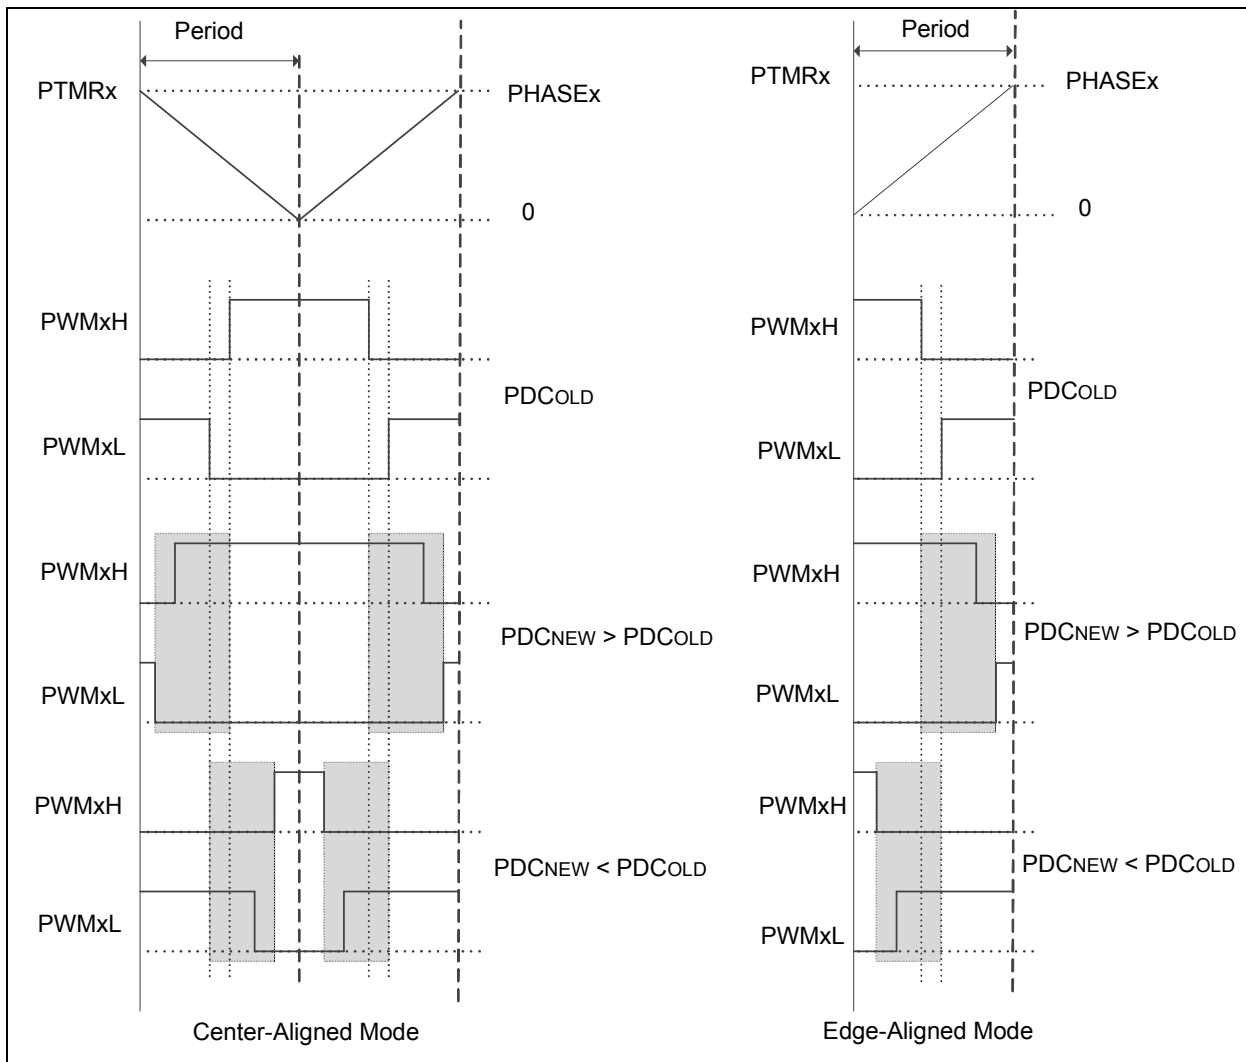
FIGURE 1: TIMING DIAGRAMS FOR CENTER-ALIGNED AND EDGE-ALIGNED MODES

The PWMx generator may not assert dead time on the edges of transitions. This has been observed when all of the following conditions are present:

None. However, in most applications, the duty cycle update timing can be controlled using the TRIGx trigger or Special Event Trigger, such that the above mentioned conditions are avoided altogether.

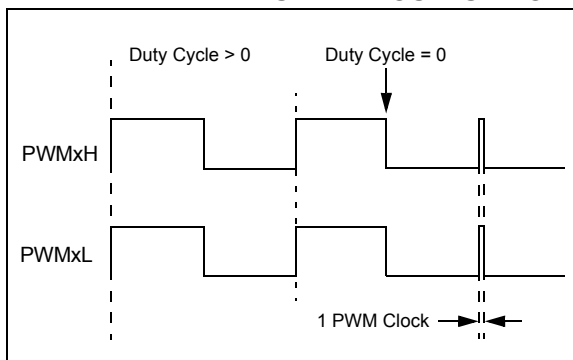
FIGURE 2: ISSUE EXAMPLE FOR REDUNDANT OUTPUT MODE

In Redundant Output mode (IOCONx[11:10] = 01) and Push-Pull Output mode (IOCONx[11:10] = 10), with the Immediate Update disabled (PWMCONx[0] = 0), when the Duty Cycle register is updated from a non-zero value to zero, a glitch pulse of a width equal to 1 PWM clock will appear at the next PWM period boundary, as shown in Figure 2 (for the Redundant Output mode). The Duty Cycle register refers to the PDCx register if PWMCONx[8] = 0 or the MDC register if PWMCONx[8] = 1.

If the application requires a zero duty cycle output, there are two possible work around methods:

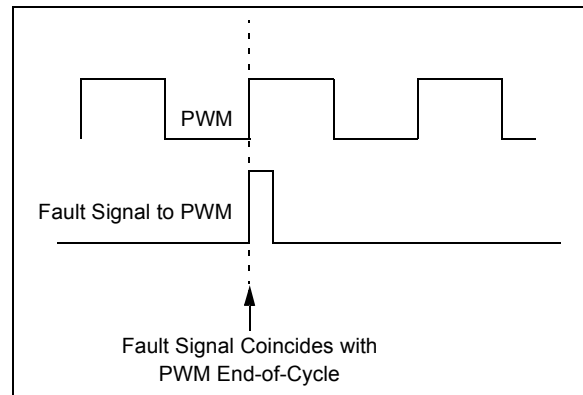
52. Module: PWM

When the PWM module is operated in Complementary, Redundant, Push-Pull or True Independent Output modes and the PWM Fault/Current-Limit Fault are configured to provide a Fault event to the PWM, under certain conditions where the Fault event active edge happens to coincide with the PWM End-of-Cycle (EOC) event, the PWM fails to recognize the Fault event.

Configure the PWM module to include Leading-Edge Blanking bits, LEB[6:0] (LEBCONx [9:3]), with a count always greater than eight, with the appropriate PWMxH/PWMxL Leading-Edge Blanking triggers.
