## Product Change Notification - SYST-01DHOH680

ERRATA - SAM D21 Family Silicon Errata and Data Sheet Clarification

## SAM D21 Family Silicon Errata and Data Sheet Clarification

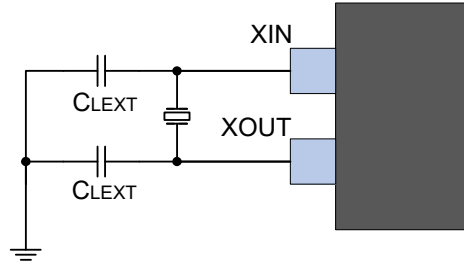
The load capacitor values shown in figure 42-6 and table 42-5 should not be used.  $C_{LEXT}$  should be calculated from the Load Capacitance Equation listed below. The corrected information is shown in **BOLD** type.
