Product Change Notification - SYST-10GTDD251

ERRATA - dsPIC33EVXXXGM00X/10X Family Silicon Errata and Data Sheet Clarification

dsPIC33EVXXXGM00X/10X Family Silicon Errata and Data Sheet Clarification

The dsPIC33EVXXXGM00X/10X family devices that you have received conform functionally to the current Device Data Sheet (DS70005144H), except for the anomalies described in this document.

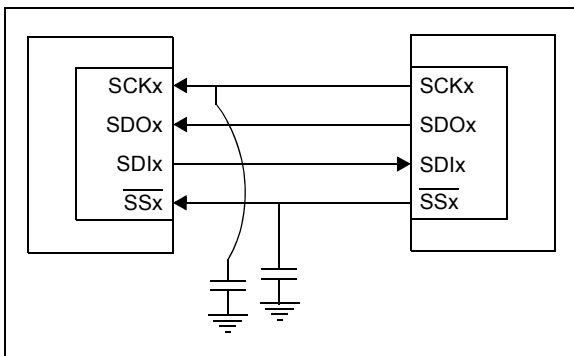
FIGURE 1:

| Module | Feature | Item Number | Issue Summary | Affected Revisions ⁽¹⁾ | | | | | | |
|---|---|---|--|---|---|---|---|---|---|---|
| SPI | Frame Sync Pulse | 5. | When the SPIx module is configured as the SPI slave, the frame slave standard buffer with CKP = 0, the data are not transmitted in both 8-bit and 16-bit modes, but the data are being received correctly. | X | X | X | X | X | X | X |

Adding a capacitance on the signal, as shown in Figure 1, will help the data to be received properly.

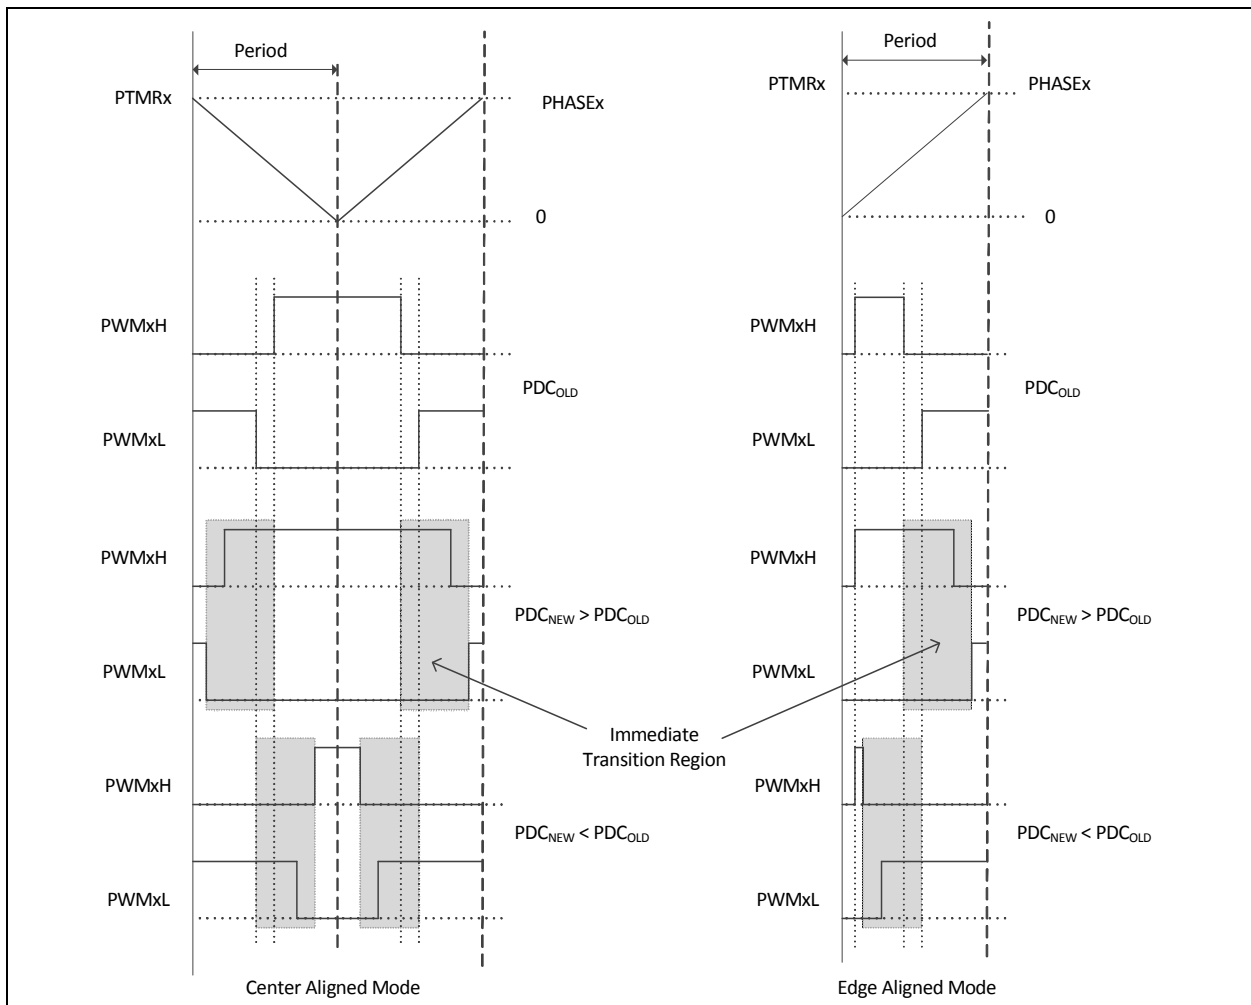
FIGURE 2: TIMING DIAGRAMS FOR CENTER-ALIGNED AND EDGE-ALIGNED MODES

The PWM generator may not assert dead time on the edges of transitions. This has been observed when all of the following conditions are present:

In [Figure 2](#), if the duty cycle write occurred in the shaded box, then PWMxH and PWMxL will make an immediate transition without dead time.

Work around

None.

However, in most applications, the duty cycle update timing can be controlled using the TRIGx trigger or Special Event Trigger, such that the above mentioned conditions are avoided altogether.

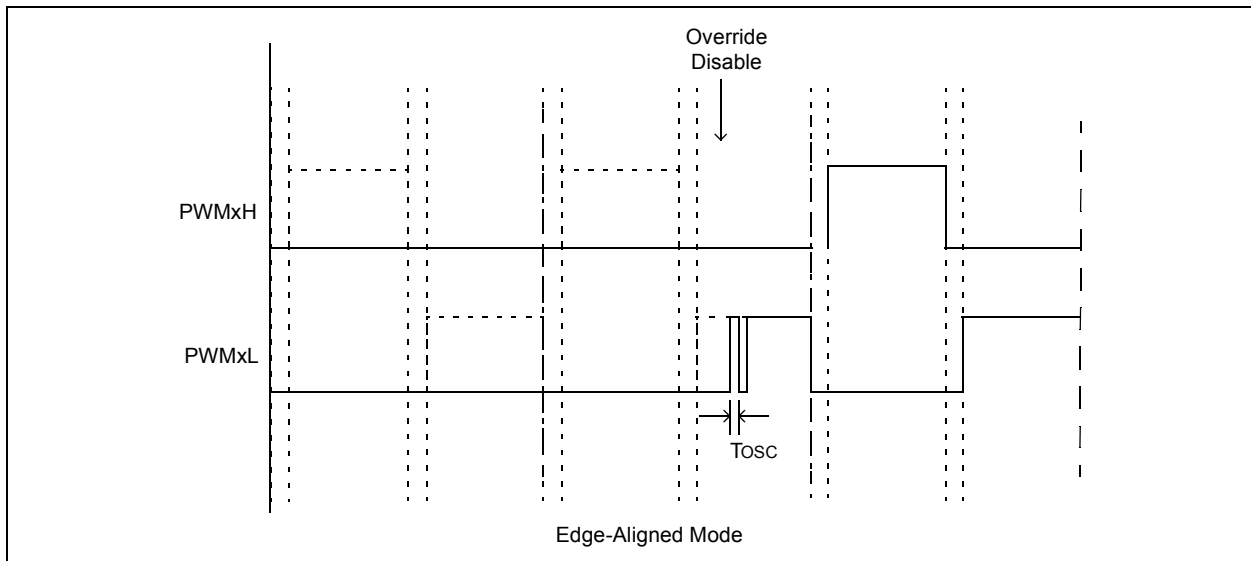
FIGURE 3: ILLUSTRATION OF 1 T_{osc} GLITCH WHEN PWM OVERRIDE IS TURNED OFF

| Module | Feature | Item Number | Issue Summary | Affected Revisions ⁽¹⁾ | | | | | | |
|---|---|---|--|---|---|---|---|---|---|---|
| PWM | PWM Override | 12. | Glitch on PWMxH and PWMxL pins when the override is turned off. | X | X | X | X | X | X | X |

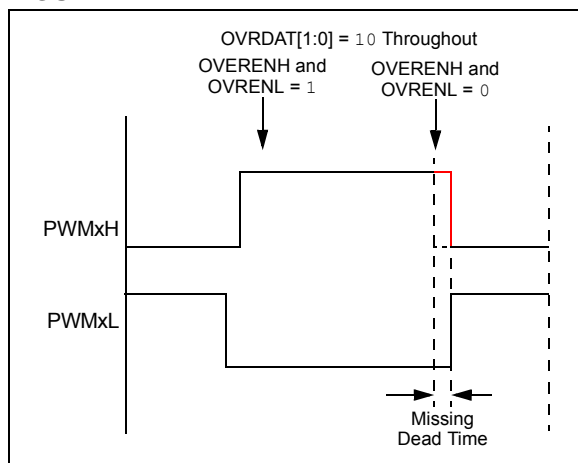
FIGURE 4:

- Output override synchronization is configured to occur on the CPU clock boundary (IOCONx[0] = 0);
- Both PWMxH and PWMxL overrides are enabled prior to the event (OVRENH and OVRENL are both '1'), and
- Both overrides are disabled (OVRENH and OVRENL are both '0') at the instant the dead time should be asserted (Figure 4). This has been observed in both Center-Aligned and Edge-Aligned modes.

Work around

None.

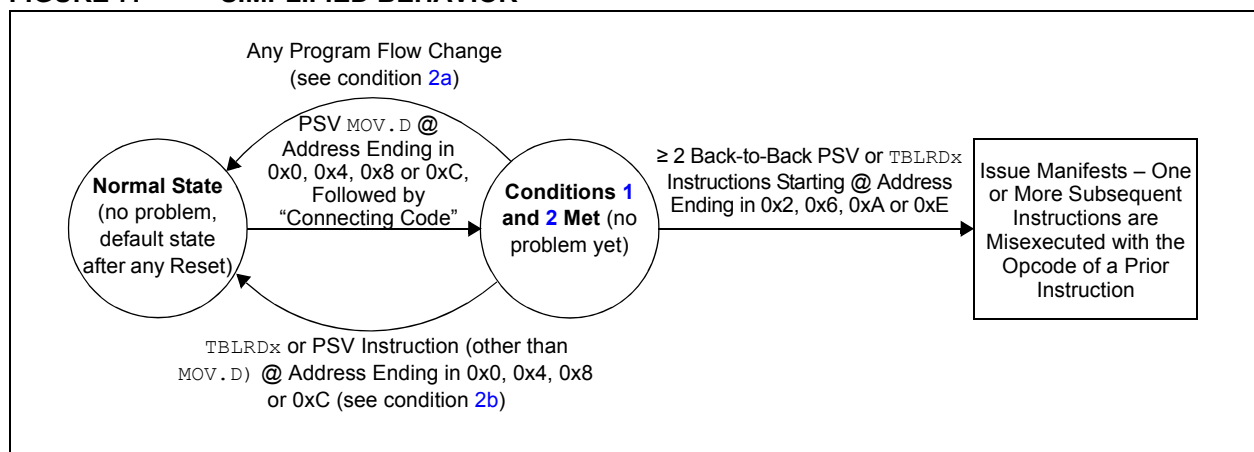
FIGURE 7: SIMPLIFIED BEHAVIOR

When two or more data Flash read instructions (via Program Space Visibility (PSV) read or table read) are executed back-to-back, one or more subsequent instructions can be misexecuted when all of the conditions in [Table 6](#) occur.

[Figure 7](#) provides an example of the effective behavior.

Work around

1. All instances of PSV `MOV.D` can be replaced with two PSV `MOV` instructions instead. Non-PSV `MOV.D` instructions acting on RAM/SFRs do not need to be modified; or
2. If not already present, a program flow change instruction (such as `BRA $+2`) can be inserted above back-to-back data Flash read sequences; or
3. Back-to-back data Flash read instruction sequences can be broken up by inserting a non-Flash read instruction (such as a `NOP`), in between the Flash read instructions; or
4. The alignment of the code can be shifted to avoid the required opcode location addresses.
