Product Change Notification - SYST-14DMFW468

ERRATA - dsPIC33EPXXGS50X Family Silicon Errata and Data Sheet Clarification

**dsPIC33EPXXGS50X Family
Silicon Errata and Data Sheet Clarification**

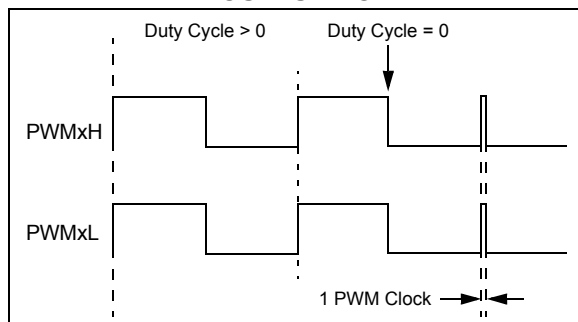
FIGURE 1: EXAMPLE FOR REDUNDANT OUTPUT MODE

In the Redundant Output mode (IOCONx[11:10] = 0b01) and Push-Pull Output mode (IOCONx[11:10] = 0b10), with the Immediate Update Enable bit disabled (PWMCONx[0] = 0), when the Duty Cycle register is updated from a non-zero value to zero, a glitch pulse of a width equal to one PWM clock will appear at the next PWM period boundary, as shown in Figure 1 (for the Redundant Output mode). The Duty Cycle register refers to the PDCx register if PWMCONx[8] = 0 or the MDC register if PWMCONx[8] = 1.

If the application requires a zero duty cycle output, there are two possible work around methods:

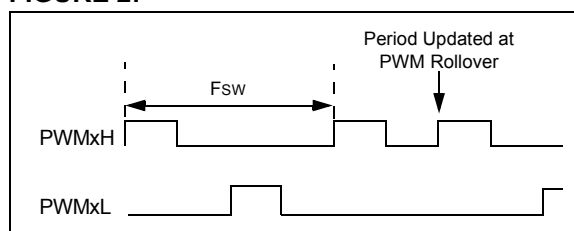
FIGURE 2:

When the PWM module is configured for Push-Pull mode (IOCONx[11:10] = 0b10) with the Enable Immediate Period Update bit enabled (PTCON [10] = 1), a write to the Period register that coincides with the period rollover event may cause the push-pull output logic to produce back-to-back pulses on the PWMx pins (Figure 2).

Ensure that the update to the PWM Period register occurs away from the PWM rollover event by setting the EIPU bit (PTCON[10] = 1). Use either the PWM Special Event Trigger (SEVTCMP) or the PWM Primary Trigger (TRIGx) to generate a PWM Interrupt Service Routine (ISR) near the start of the PWM cycle. This ISR will ensure that period writes do not occur near the PWM period rollover event.

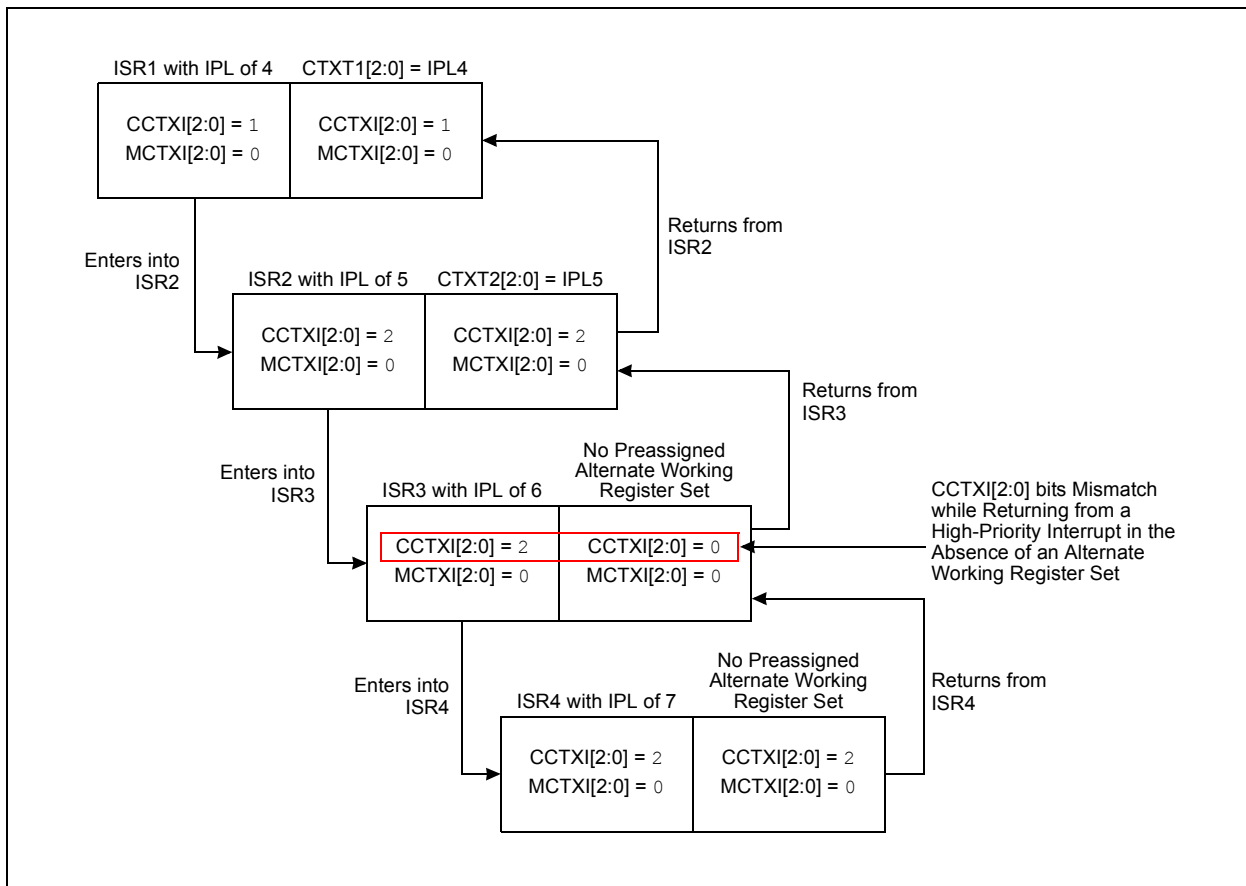
FIGURE 3: MISMATCH OF WORKING REGISTER SET WHEN NESTING MORE THAN ONE INTERRUPT WITHIN INTERRUPTS THAT USE ALTERNATE WORKING REGISTER SETS

Issue and work around are illustrated in [Figure 3](#) and [Figure 4](#), respectively. The figures show the status bits, `CCTXI[2:0]` and `MCTXI[2:0]`, after entering into an ISR from a lower priority ISR (left pane), and after returning to the same ISR from a higher priority ISR (right pane).

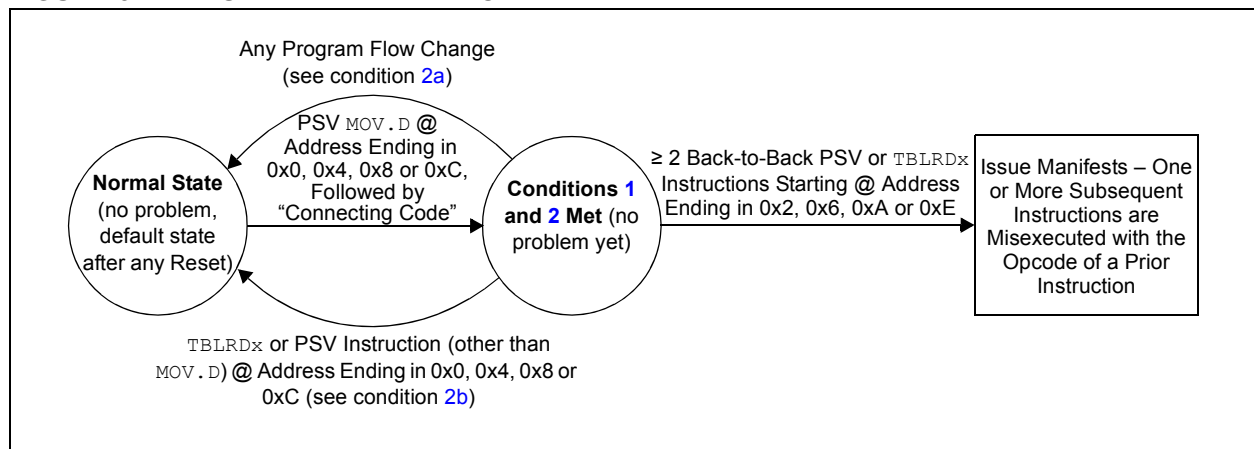
FIGURE 5: SIMPLIFIED BEHAVIOR

When two or more data Flash read instructions (via Program Space Visibility (PSV) read or table read) are executed back-to-back, one or more subsequent instructions can be misexecuted when all of the conditions in [Table 5](#) occur.

[Figure 5](#) provides an example of the effective behavior.

1. All instances of PSV `MOV.D` can be replaced with two PSV `MOV` instructions instead. Non-PSV `MOV.D` instructions acting on RAM/SFRs do not need to be modified; or
2. If not already present, a program flow change instruction (such as `BRA $+2`) can be inserted above back-to-back data Flash read sequences; or
3. Back-to-back data Flash read instruction sequences can be broken up by inserting a non-Flash read instruction (such as a `NOP`), in between the Flash read instructions; or
4. The alignment of the code can be shifted to avoid the required opcode location addresses.

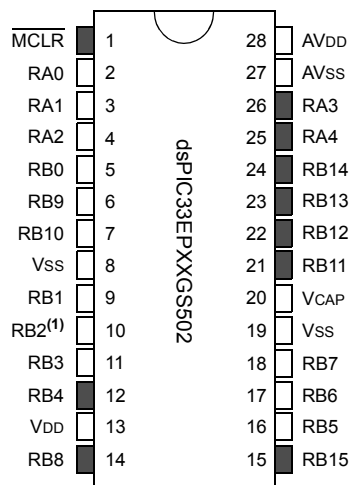
28-Pin SOIC

A note has been added to the RB2 port pin, as shown below in **bold**. This note applies to RB2 on all available packages.

Note 1: At device power-up (POR), a pulse with an amplitude around 2V and a duration greater than 500 μs, may be observed on this device pin independent of pull-down resistors. It is recommended not to use this pin as an output driver unless the circuit being driven can endure this active duration.
