Product Change Notification - SYST-13IXOV452

ERRATA - PIC32MK Motor Control and General Purpose Errata and Data Sheet Clarification

PIC32MK General Purpose and Motor Control (GP/MC) Silicon Errata and Data Sheet Clarification

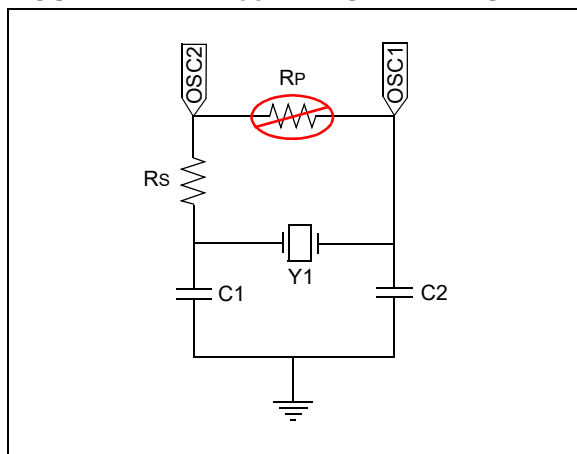
FIGURE 1: POSC CRYSTAL CIRCUIT

The POSC supports only specific crystal operation, as provided in [Table 1](#).

The Primary Oscillator (POSC) has been characterized to operate at 8 MHz and 12 MHz when the circuit shown in [Figure 1](#) is implemented and the operating conditions provided in [Table 1](#) are met.

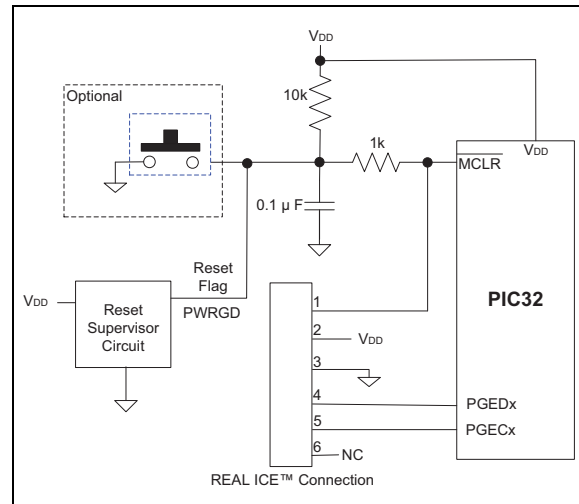
FIGURE 2: RESET SUPERVISOR CIRCUIT

On a BOR event, $V_{POR} < V_{DD} < V_{BOR}$, a Reset is not generated when the BOR threshold is reached. System clocks will stop with all I/O pins functions frozen in their present state until either V_{DD} falls to V_{POR} or V_{DD} returns to above V_{BOR} . The user must assess if this V_{DD} brown-out condition and the resulting frozen I/O pin state has an adverse effect on their application (UART, PWM, I/O, OC, etc.).

If the application can sustain frozen I/O states for ~2.1 ms (UART, CAN, I/O, etc.), the application must enable the Deep Sleep Watchdog Timer and Clock Fail Monitor, based on the details provided in Table 3 and Table 4. If implemented correctly, after ~2.1 ms, a valid internal reset state is entered and the I/O pins are set to the device default Reset state.
