Product Change Notification - SYST-11ODFZ833

ERRATA - dsPIC33CH128MP508 Family Silicon Errata and Datasheet Clarification

dsPIC33CH128MP508 Family Silicon Errata and Data Sheet Clarification

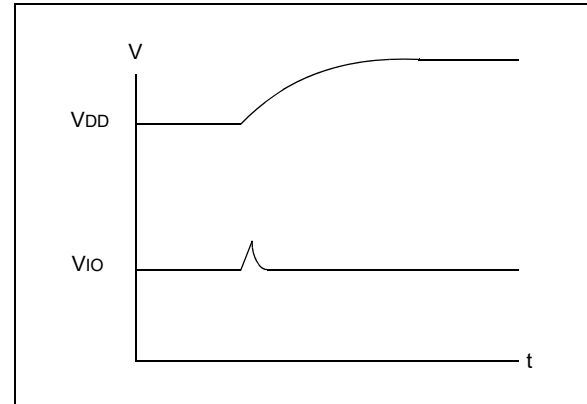
FIGURE 1: I/O RAMP

During a fast device power-up, when the V_{DD} ramp is less than 4 mS, the I/O pins may drive up to 100 μ A current for a duration of up to 10 μ S (Figure 1).

1. Slow down the V_{DD} ramp time (greater than 4 mS for V_{DD} to ramp 0V to 3.3V).
2. Ensure the circuitry that is connected to the pins can endure this pulse.
