## Product Change Notification - SYST-11ALNE662

ERRATA - dsPIC33CH512MP508 Family Silicon Errata and Data Sheet Clarification

## dsPIC33CH512MP508 Family Silicon Errata and Data Sheet Clarification

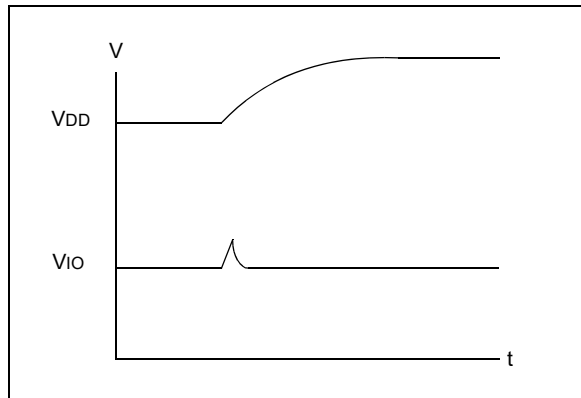
**FIGURE 1-1: I/O RAMP**

During a fast device power-up, when the VDD ramp is less than 4 mS, the I/O pins may drive up to 100  $\mu$ A current for a duration of up to 10  $\mu$ S (Figure 1-1).

Example applications affected may include complementary power switches, where a transient current shoot-through might occur. High-voltage applications with complementary switches should power the high-voltage 200  $\mu$ Sec later than powering the dsPIC<sup>®</sup> device to avoid the current shoot-through. This behavior is specific to each device and not affected by aging.

1. Slow down the VDD ramp time (greater than 4 mS for VDD to ramp 0V to 3.3V).
2. Ensure the circuitry that is connected to the pins can endure this pulse.
