## Product Change Notification - SYST-21EDWO528

ERRATA - PIC32MX1XX/2XX/5XX 64/100-pin Family Silicon Errata and Data Sheet Clarification

## PIC32MX1XX/2XX/5XX 64/100-pin Family Silicon Errata and Data Sheet Clarification

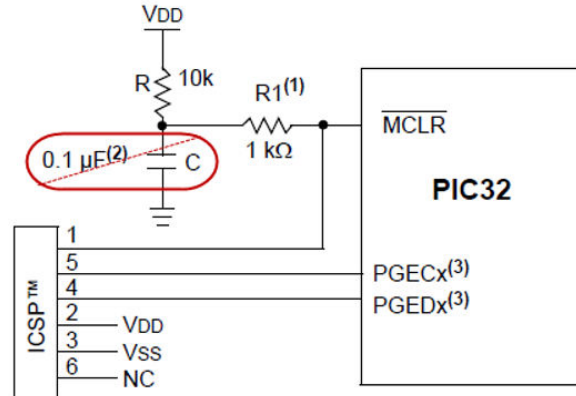
## 17. Module: I/O Port - Initial Pin State

On power-up depending on the VDD ramp rate, the I/O pins can be in an active random output driving state if  $\overline{\text{MCLR}}$  is active until a BOR event.

If, not using an external reset supervisor IC or equivalent, remove the  $\overline{\text{MCLR}}$  capacitor as shown below, and retain the  $\overline{\text{MCLR}}$  Pull-up resistor.
