Product Change Notification - SYST-21LMFR637

ERRATA - PIC32MX1XX/2XX/5XX 64/100-pin Family Silicon Errata and Data Sheet Clarification

PIC32MX1XX/2XX/5XX 64/100-pin Family Silicon Errata and Data Sheet Clarification

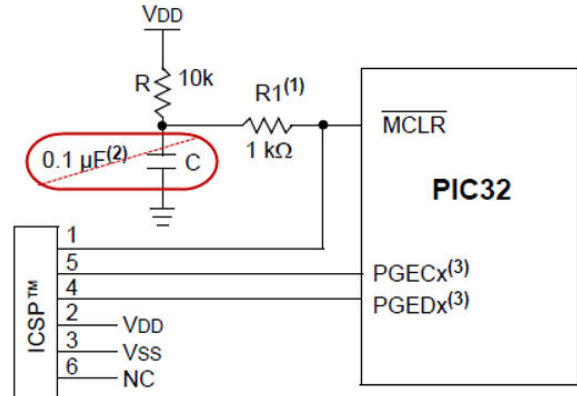
17. Module: I/O Port - Initial Pin State

On power-up depending on the VDD ramp rate, the I/O pins can be in an active random output driving state if MCLR is active until a BOR event.

Work around 1:

If, not using an external reset supervisor IC or equivalent, remove the MCLR capacitor as shown below, and retain the MCLR Pull-up resistor.

Work around 2:

If using an external reset supervisor IC or equivalent, increase the value of the VCAP capacitor to $\geq 47 \mu\text{f}$ ceramic or solid tantalum capacitor with an ESR $\leq 1 \text{ ohm}$.
