Product Change Notification - SYST-18PVLV994

ERRATA - dsPIC33CH128MP508 Family Silicon Errata and Datasheet Clarification

dsPIC33CH128MP508 Family Silicon Errata and Data Sheet Clarification

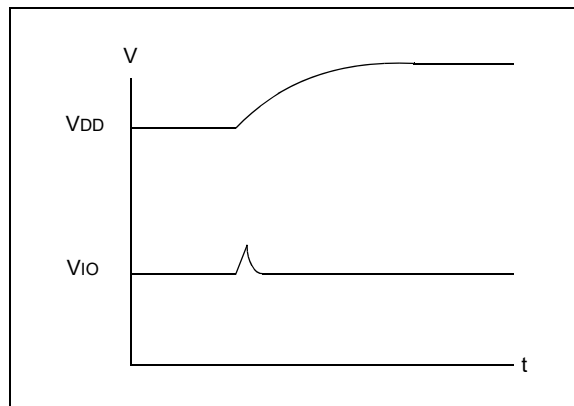
FIGURE 1: I/O RAMP

During a fast device power-up, when the V_{DD} ramp is less than 4 mS, the I/O pins may drive up to 100 μA current for a duration of up to 10 μS (Figure 1).

Example applications affected may include complementary power switches, where a transient current shoot-through might occur.

1. Slow down the V_{DD} ramp time (greater than 4 mS for V_{DD} to ramp 0V to 3.3V).
2. Ensure the circuitry that is connected to the pins can endure this pulse.

High-voltage applications with complementary switches should power the high-voltage 200 μSec later than powering the dsPIC[®] device to avoid the current shoot-through. This behavior is specific to each device and not affected by aging.
