Product Change Notification / SYST-08MPXV615

ERRATA - dsPIC33CH512MP508 Family Silicon Errata and Data Sheet Clarification

dsPIC33CH512MP508 Family Silicon Errata and Data Sheet Clarification

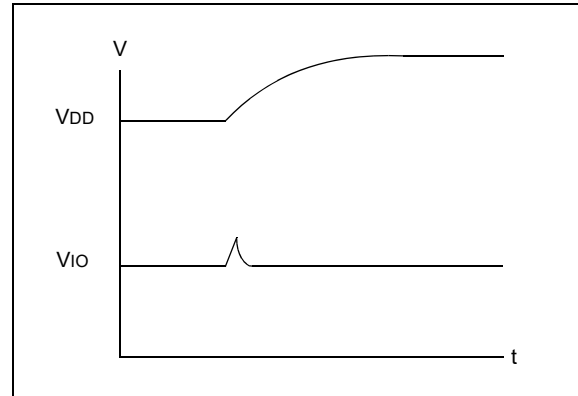
FIGURE 1-1: I/O RAMP

18. Module: I/O

During a fast device power-up, when the VDD ramp is less than 4 mS, the I/O pins may drive up to 100 μ A current for a duration of up to 10 μ S (Figure 1-1).

Example applications affected may include complementary power switches, where a transient current shoot-through might occur. High-voltage applications with complementary switches should power the high-voltage 200 μ Sec later than powering the dsPIC[®] device to avoid the current shoot-through. This behavior is specific to each device and not affected by aging.

1. Slow down the VDD ramp time (greater than 4 mS for VDD to ramp 0V to 3.3V).
2. Ensure the circuitry that is connected to the pins can endure this pulse.

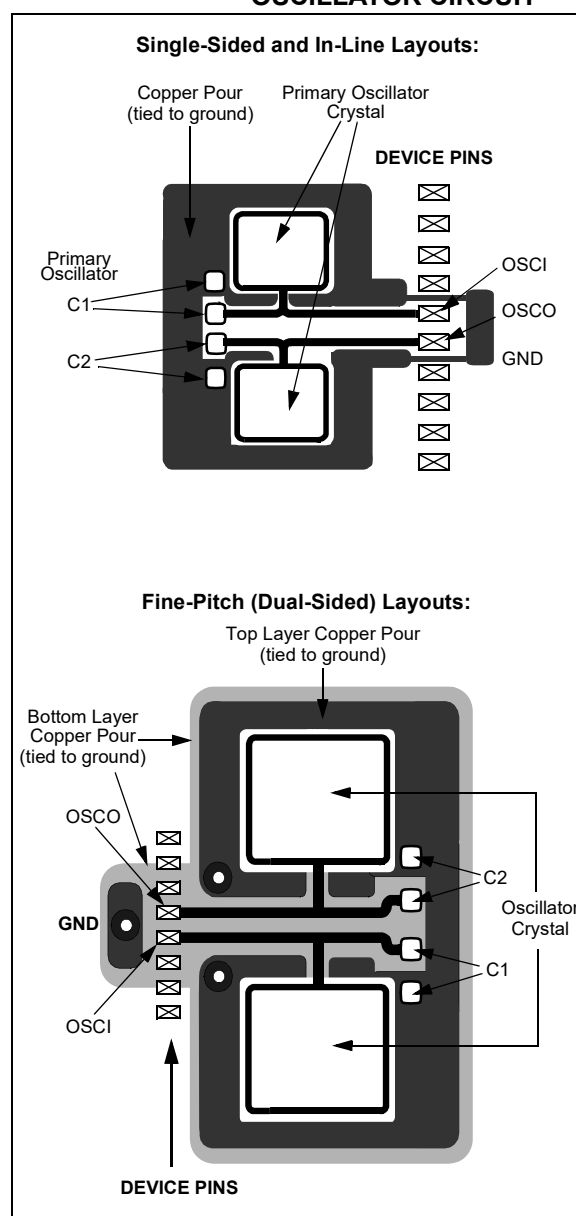
FIGURE 2-2: SUGGESTED PLACEMENT OF THE OSCILLATOR CIRCUIT

Use best practices during PCB layout to ensure robust start-up and operation. The oscillator circuit should be placed on the same side of the board as the device. Also, place the oscillator circuit close to the respective oscillator pins, not exceeding one-half inch (12 mm) distance between them. The load capacitors should be placed next to the oscillator itself, on the same side of the board. Use a grounded copper pour around the oscillator circuit to isolate it from surrounding circuits. The grounded copper pour should be routed directly to the MCU ground. Do not run any signal traces or power traces inside the ground pour. If using a two-sided board, avoid any traces on the other side of the board where the crystal is placed. Suggested layouts are shown in [Figure 2-2](#). With fine-pitch packages, it is not always possible to completely surround the pins and components. A suit-

able solution is to tie the broken guard sections to a mirrored ground layer. In all cases, the guard trace(s) must be returned to ground.
