## Product Change Notification / SYST-10NIVQ377

ERRATA - ATtiny202/402 Silicon Errata and Data Sheet Clarification

## ATtiny202/402 Silicon Errata and Data Sheet Clarification

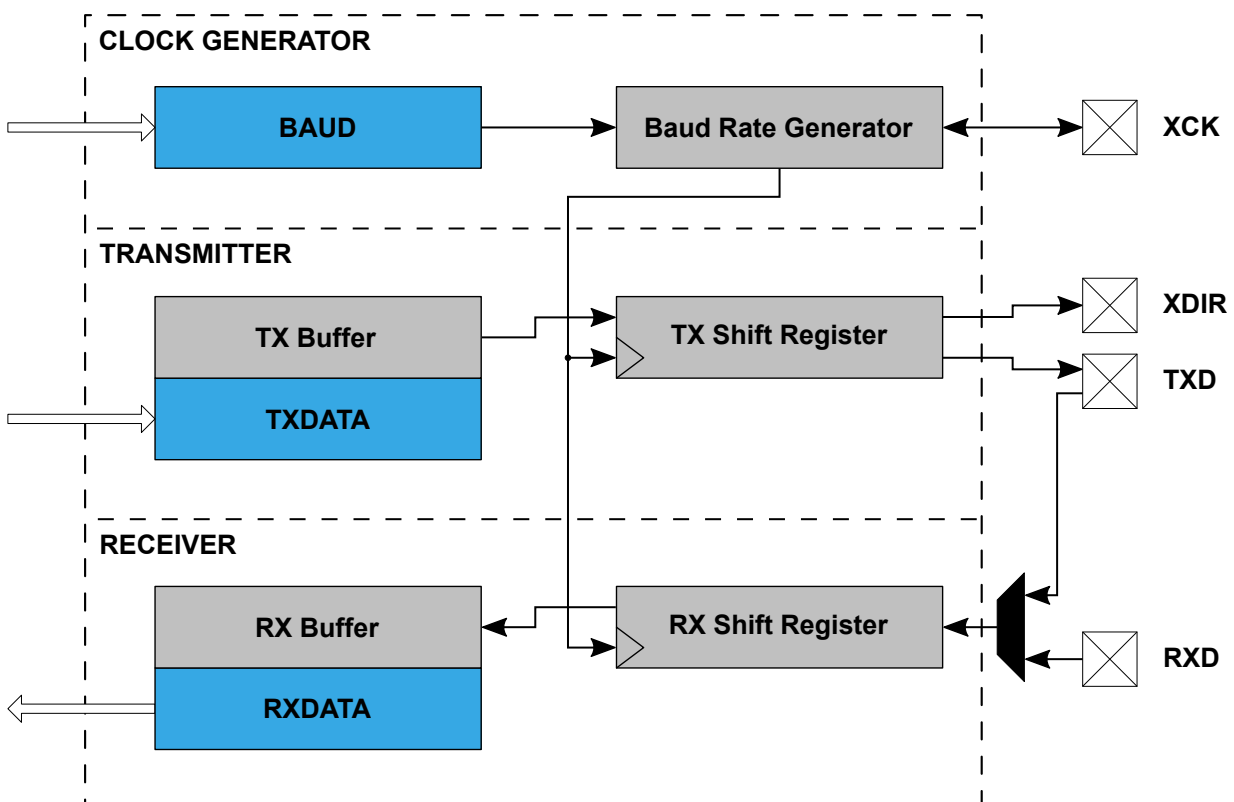
**Figure 3-1. Block Diagram**

The block diagram is missing that USART TX is double-buffered from figure 25-1 in the data sheet. Added **TX Buffer** is shown below.
