Product Change Notification / SYST-31HPWF472

ERRATA - dsPIC33CH128MP508 Family Silicon Errata and Datasheet Clarification

dsPIC33CH128MP508 Family Silicon Errata and Data Sheet Clarification

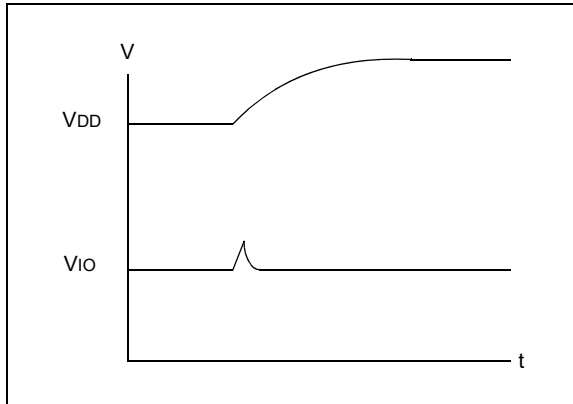
FIGURE 1: I/O RAMP

During a fast device power-up, when the VDD ramp is less than 4 mS, the I/O pins may drive up to 100 μ A current for a duration of up to 10 μ S (Figure 1).

Example applications affected may include complementary power switches, where a transient current shoot-through might occur.

1. Slow down the VDD ramp time (greater than 4 mS for VDD to ramp 0V to 3.3V).
2. Ensure the circuitry that is connected to the pins can endure this pulse.

High-voltage applications with complementary switches should power the high-voltage 200 μ Sec later than powering the dsPIC[®] device to avoid the current shoot-through. This behavior is specific to each device and not affected by aging.
