Product Change Notification / SYST-28PKOP667

ERRATA - MEC170x Silicon Errata and Data Sheet Clarification

MEC170x

Silicon Errata and Data Sheet Clarification

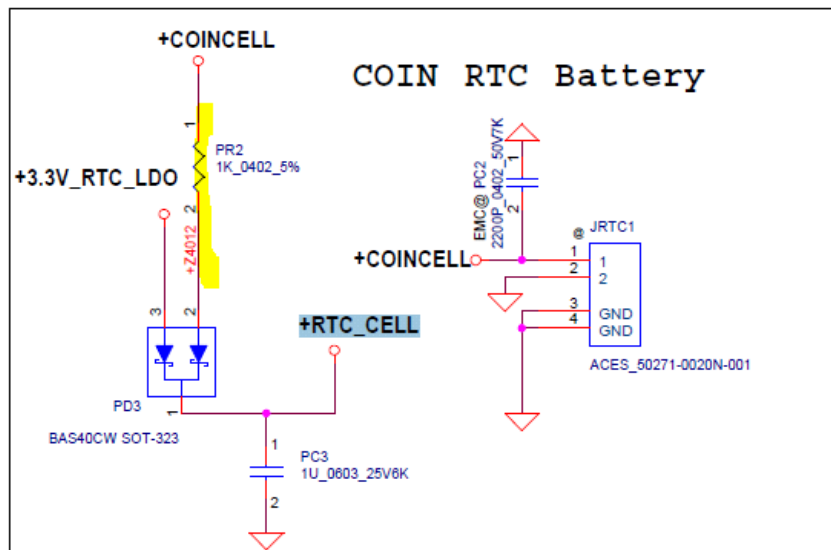
FIGURE 1: HIGH IBAT CURRENT DURING COIN CELL INSERTION

There could be a high I_{BAT} current on new coin cell insertion. During initial VBAT power rising, the VBAT circuit can enter a high current state causing a voltage drop across the 1K UL resistor. This affects all 128 and 144 pin packages. This issue is not present in the 169 pin packages.

- Under these conditions, the VBAT power on can stall in this high current state, with the VBAT on device pin between 0.7 and 1.2V.

Insert the coin cell and then apply VTR (i.e +3VALW). This enables VBAT low-power operation. A high I_{BAT} will not return on subsequent VTR power cycles.

Referring to the RTC Battery circuit shown in [Figure 1](#), applying VTR via the +3.3V_RTC_LDO signal, powers RTC_Cell (which is connected to VBAT of MEC170x) directly (without a series 1k resistor and hence no IR drop from the applied VTR), raising VBAT (RTC_Cell) to greater than 2.0 volts. This takes VBAT out of the “high current” region discussed above enabling normal VBAT low power operation.
