Product Change Notification / SYST-06AUDA206

ERRATA - ATtiny3216/3217 Silicon Errata and Data Sheet Clarification Document Revision

ATtiny3216/3217

Silicon Errata and Data Sheet Clarifications

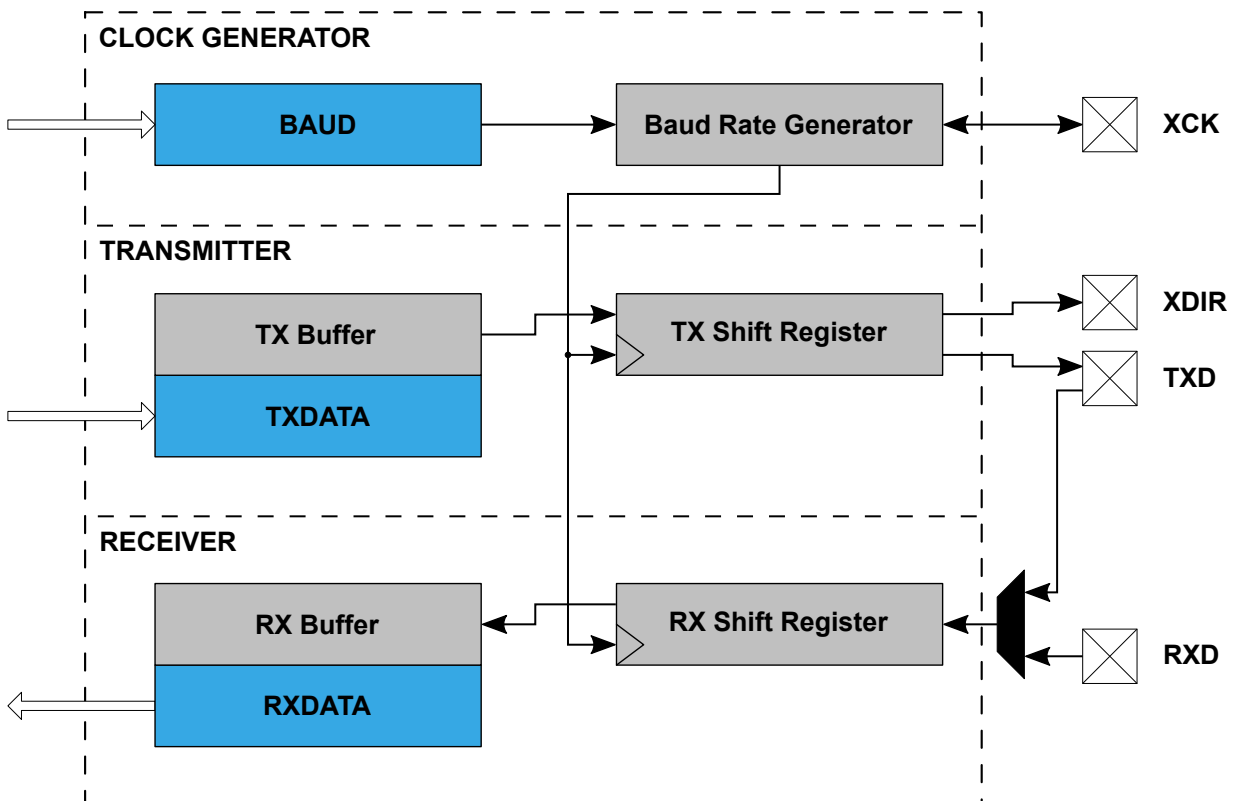
Figure 3-1. Block Diagram

The block diagram is missing that USART TX is double-buffered from Figure 25-1 in the data sheet. The figure below shows the added **TX Buffer**.

The transmitter consists of a **two-level** write buffer.

The data transmission is initiated by loading the **Transmit Data (USARTn.TXDATAL and USARTn.TXDATAH)** registers with the data to be sent. The data in the **Transmit Data registers** are moved to the **TX Buffer** once emptied and then to the Shift register once it is empty and ready to send a new frame.
