## Product Change Notification / SYST-07KIRV017

ERRATA - PIC32MK General Purpose and Motor Control (GP/MC) Family Silicon Errata and Data Sheet Clarification Errata Document Revision

## PIC32MK General Purpose and Motor Control (GP/MC) Silicon Errata and Data Sheet Clarification

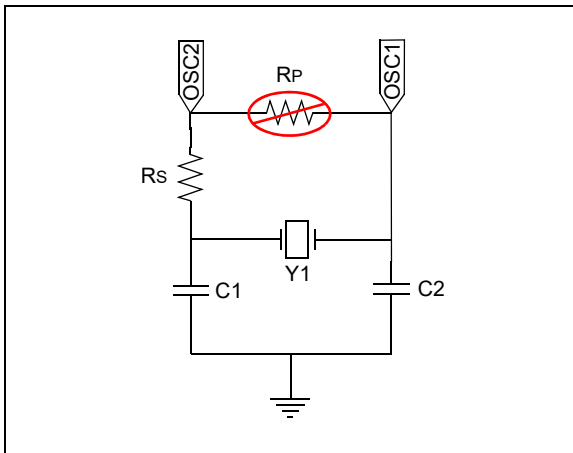
**FIGURE 1: Posc CRYSTAL CIRCUIT**

The Posc supports only specific crystal operation, as provided in [Table 1](#).

The Primary Oscillator (Posc) has been characterized to operate at 8 MHz and 12 MHz when the circuit shown in [Figure 1](#) is implemented and the operating conditions provided in [Table 1](#) are met.

**Note 1:** Using any other crystal frequency will require special component selection and characterization.

**2:** A parallel resistor (Rp) should not be used to increase the gain of the Posc.

**3:** Only 24 MHz crystals with a Mfg ESR ≤ 40Ω.

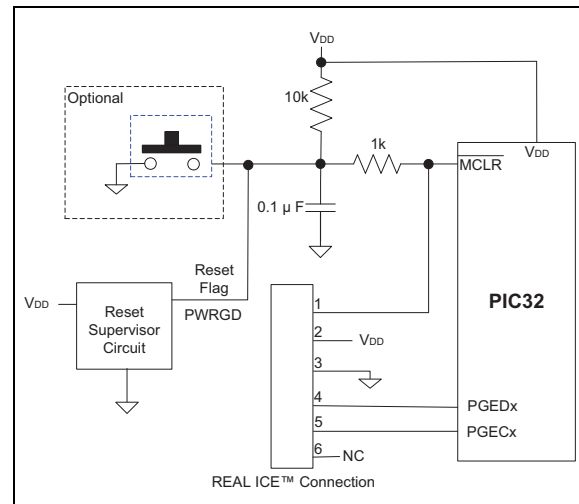
**FIGURE 2: RESET SUPERVISOR CIRCUIT**

On a BOR event,  $V_{POR} < V_{DD} < V_{BOR}$ , a Reset is not generated when the BOR threshold is reached. System clocks will stop with all I/O pins functions frozen in their present state until either  $V_{DD}$  falls to  $V_{POR}$  or  $V_{DD}$  returns to above  $V_{BOR}$ . The user must assess if this  $V_{DD}$  brown-out condition and the resulting frozen I/O pin state has an adverse effect on their application (UART, PWM, I/O, OC, etc.).

**Note:** For Motor Control applications utilizing the PWM module, **only Work around 1 is recommended.**

If the application can sustain frozen I/O states for ~2.1 ms (UART, CAN, I/O, etc.), the application must enable the Deep Sleep Watchdog Timer and Clock Fail Monitor, based on the details provided in Table 3 and Table 4. If implemented correctly, after ~2.1 ms, a valid internal reset state is entered and the I/O pins are set to the device default Reset state.
