# nRF21540

## Revision 2

### Errata

v1.2

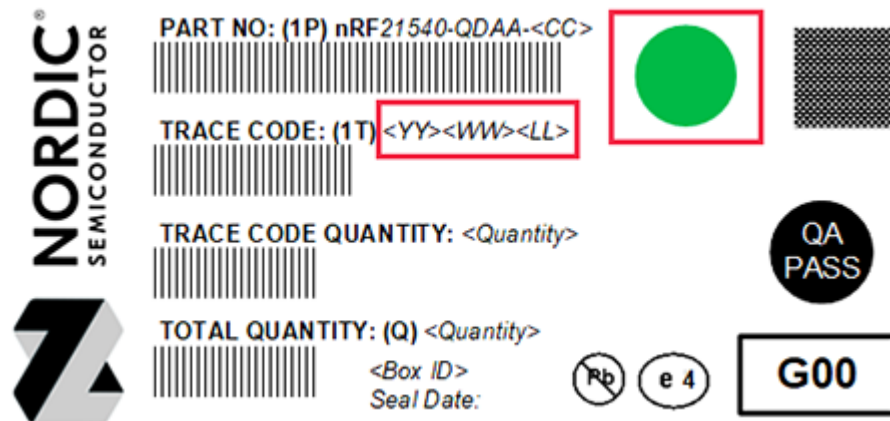
Figure 1: Trace code and green sticker on nRF21540 label

- For trace codes earlier than 2223xx (year 22, week 23), the supply current may be up to several hundred  $\mu$ A in typical conditions. The mean value is expected to be less than 1  $\mu$ A.
- For trace codes earlier than 2223xx (year 22, week 23) with a green sticker on the reel, vacuum bag, and inner box label, the supply current may be up to 1  $\mu$ A in typical conditions. The mean value is expected to be less than 100 nA.
- For trace codes later than 2223xx (year 22, week 23), the supply current may be up to 1  $\mu$ A in typical conditions. The mean value is expected to be less than 100 nA.

Use samples with trace code 2223xx (year 22, week 23) or later or retested samples marked with a green round sticker on the reel, vacuum bag, and inner box label to keep maximum supply current at less than 1  $\mu$ A in typical conditions.
