## Product Change Notification / SYST-08DHB472

ERRATA - PIC18F26/46/56Q84 Silicon Errata and Data Sheet Clarifications

# PIC18F26/46/56Q84 Silicon Errata and Data Sheet Clarifications

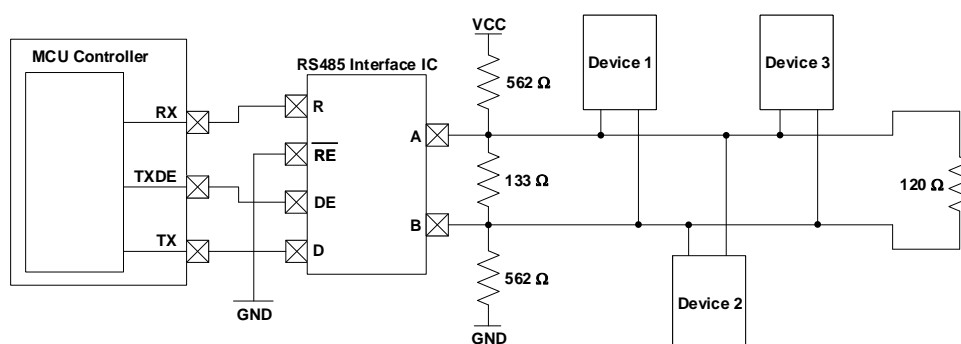
### 1.6.1 UART TXDE Signal May Go Low Before the STOP Bit Has Been Entirely Transmitted

The UART Transmit Drive Enable (TXDE) signal could potentially transition into a low state before the UART STOP bit has been entirely transmitted due to the effects of parasitic capacitance on the TX line. In some applications, this could result in communication being prematurely terminated due to the TXDE bit going low before the STOP bit has had enough time to settle.

To ensure that the STOP bit settles into its final logic state before the TXDE signal transitions low, a biasing circuit can be implemented. A biasing circuit allows the TX line to either be driven high or low, rather than being left in a floating tri-state mode where prolonged rise or fall times could lead to communication being disrupted. This bias circuit should only be implemented on one end of the serial bus, and a termination resistor should be used on the other end. The figure below shows an example of a bias circuit that can be used to achieve this.

Please note that the resistor values used in this circuit are recommendations, and that the actual resistor values required may vary based on the application.
