Product Change Notification / SYST-30GUOE517

ERRATA - PIC18F04/05/14/15Q41 Silicon Errata and Data Sheet Clarifications

Description of Change: Adding silicon revision E0. Adding silicon errata 1.4.3, 1.4.4, 1.4.5 and 1.9.1.

PIC18F04/05/14/15Q41 Silicon Errata and Data Sheet Clarifications

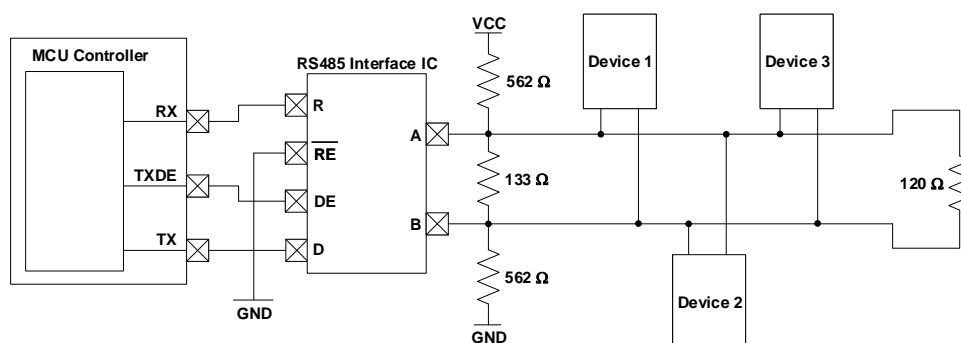
1.6 Module: Universal Asynchronous Receiver Transmitter (UART)**1.6.1 UART TXDE Signal May Go Low Before the STOP Bit Has Been Entirely Transmitted**

The UART Transmit Drive Enable (TXDE) signal could potentially transition into a low state before the UART STOP bit has been entirely transmitted due to the effects of parasitic capacitance on the TX line. In some applications, this could result in communication being prematurely terminated due to the TXDE bit going low before the STOP bit has had enough time to settle.

To ensure that the STOP bit settles into its final logic state before the TXDE signal transitions low, a biasing circuit can be implemented. A biasing circuit allows the TX line to either be driven high or low, rather than being left in a floating tri-state mode where prolonged rise or fall times could lead to communication being disrupted. This bias circuit should only be implemented on one end of the serial bus, and a termination resistor should be used on the other end. The figure below shows an example of a bias circuit that can be used to achieve this.

Please note that the resistor values used in this circuit are recommendations, and that the actual resistor values required may vary based on the application.
