Product Change Notification / SYST-30XUJC204

ERRATA - PIC18F04/05/14/15Q40 Silicon Errata and Data Sheet Clarifications

PIC18F04/05/14/15Q40 Silicon Errata and Data Sheet Clarifications

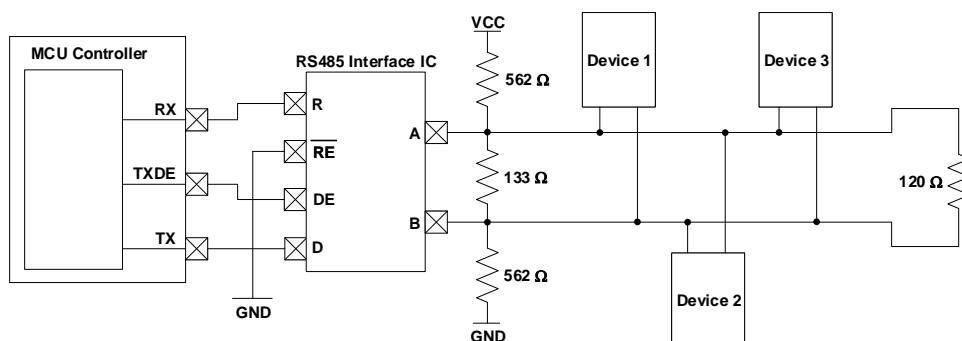
1.4.1 UART TXDE Signal May Go Low Before the STOP Bit Has Been Entirely Transmitted

The UART Transmit Drive Enable (TXDE) signal could potentially transition into a low state before the UART STOP bit has been entirely transmitted due to the effects of parasitic capacitance on the TX line. In some applications, this could result in communication being prematurely terminated due to the TXDE bit going low before the STOP bit has had enough time to settle.

To ensure that the STOP bit settles into its final logic state before the TXDE signal transitions low, a biasing circuit can be implemented. A biasing circuit allows the TX line to either be driven high or low, rather than being left in a floating tri-state mode where prolonged rise or fall times could lead to communication being disrupted. This bias circuit should only be implemented on one end of the serial bus, and a termination resistor should be used on the other end. The figure below show an example of a bias circuit that can be used to achieve this.

Please note that the resistor values used in this circuit are recommendations, and that the actual resistor values required may vary based on the application.
