## Product Change Notification / SYST-28PENM521

ERRATA - PIC32MZ Embedded Connectivity with Floating Point Unit (EF) Family Silicon Errata and Data Sheet Clarification

## PIC32MZ Embedded Connectivity with Floating Point Unit (EF) Family Silicon Errata and Data Sheet Clarification

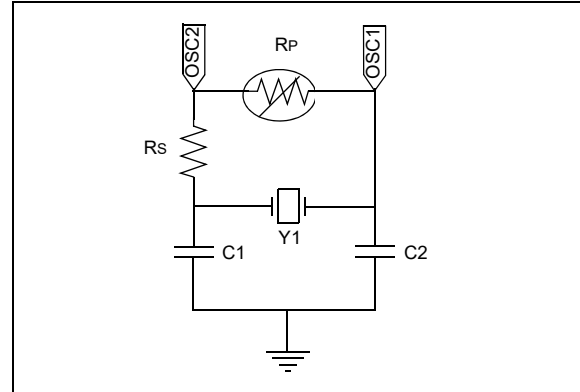
**FIGURE 1: Posc CRYSTAL CIRCUIT**

The Primary Oscillator (Posc) has been characterized to operate at 8 MHz, 12 MHz, and 24 MHz when the circuit in [Figure 1](#) is implemented, and the operating conditions listed in [Table 3](#) are met.

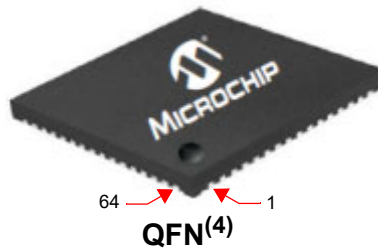
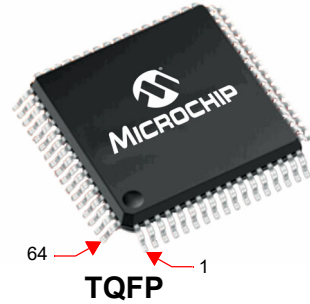
### 64-PIN QFN<sup>(4)</sup> AND TQFP (TOP VIEW)

The following typographic corrections and clarifications are to be noted for the latest version of the device data sheet (DS60001320H):
