## Product Change Notification / SYST-09AZKK894

PIC18F27/47/57Q84 Silicon Errata and Data Sheet Clarifications

Removed data sheet clarifications, updated data sheet revision to current revision, added silicon revision C0.

# PIC18F27/47/57Q84 Silicon Errata and Data Sheet Clarifications

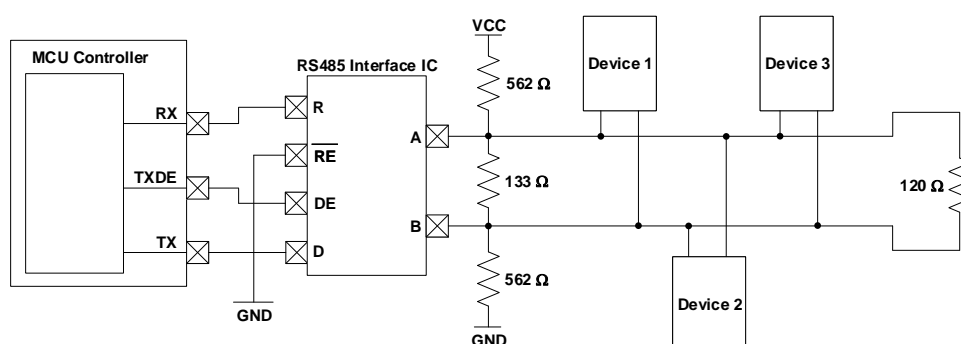
The UART Transmit Drive Enable (TXDE) signal could potentially transition into a low state before the UART STOP bit has been entirely transmitted due to the effects of parasitic capacitance on the TX line. In some applications, this could result in communication being prematurely terminated due to the TXDE bit going low before the STOP bit has had enough time to settle.

To ensure that the STOP bit settles into its final logic state before the TXDE signal transitions low, a biasing circuit can be implemented. A biasing circuit allows the TX line to either be driven high or low, rather than being left in a floating tri-state mode where prolonged rise or fall times could lead to communication being disrupted. This bias circuit should only be implemented on one end of the serial bus, and a termination resistor should be used on the other end. The figure below shows an example of a bias circuit that can be used to achieve this.

Please note that the resistor values used in this circuit are recommendations and that the actual resistor values required may vary based on the application.
