Product Change Notification: SYST-25VMMA872

PIC18F06/16Q40 Silicon Errata and Data Sheet Clarifications

Microchip has released a new Document for the PIC18F06/16Q40 Silicon Errata and Data Sheet Clarifications of devices. If you are using one of these devices please read the document located at [PIC18F06/16Q40 Silicon Errata and Data Sheet Clarifications](#).

Added silicon issue 1.8.1; updated DS revision letter.

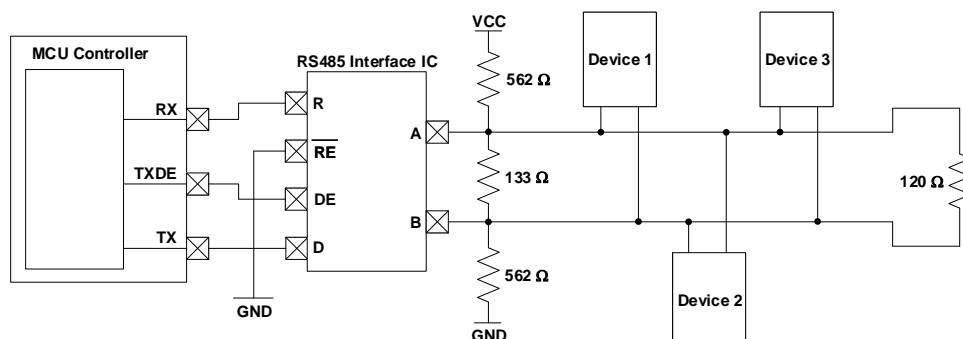
1.4.1 UART TXDE Signal May Go Low Before the STOP Bit Has Been Entirely Transmitted

The UART Transmit Drive Enable (TXDE) signal could potentially transition into a low state before the UART STOP bit has been entirely transmitted due to the effects of parasitic capacitance on the TX line. In some applications, this could result in communication being prematurely terminated due to the TXDE signal going low before the STOP bit has had enough time to settle.

To ensure that the STOP bit settles into its final logic state before the TXDE signal transitions low, a biasing circuit can be implemented. A biasing circuit allows the TX line to either be driven high or low, rather than being left in a floating tri-state mode where prolonged rise or fall times could lead

to communication being disrupted. This bias circuit should only be implemented on one end of the serial bus, and a termination resistor should be used on the other end. The figure below shows an example of a bias circuit that can be used to achieve this.

Please note that the resistor values used in this circuit are recommendations and that the actual resistor values required may vary based on the application.
