Product Change Notification: SYST-25GKII385

dsPIC33CDVL64MC106 Family Silicon Errata and Data Sheet Clarification

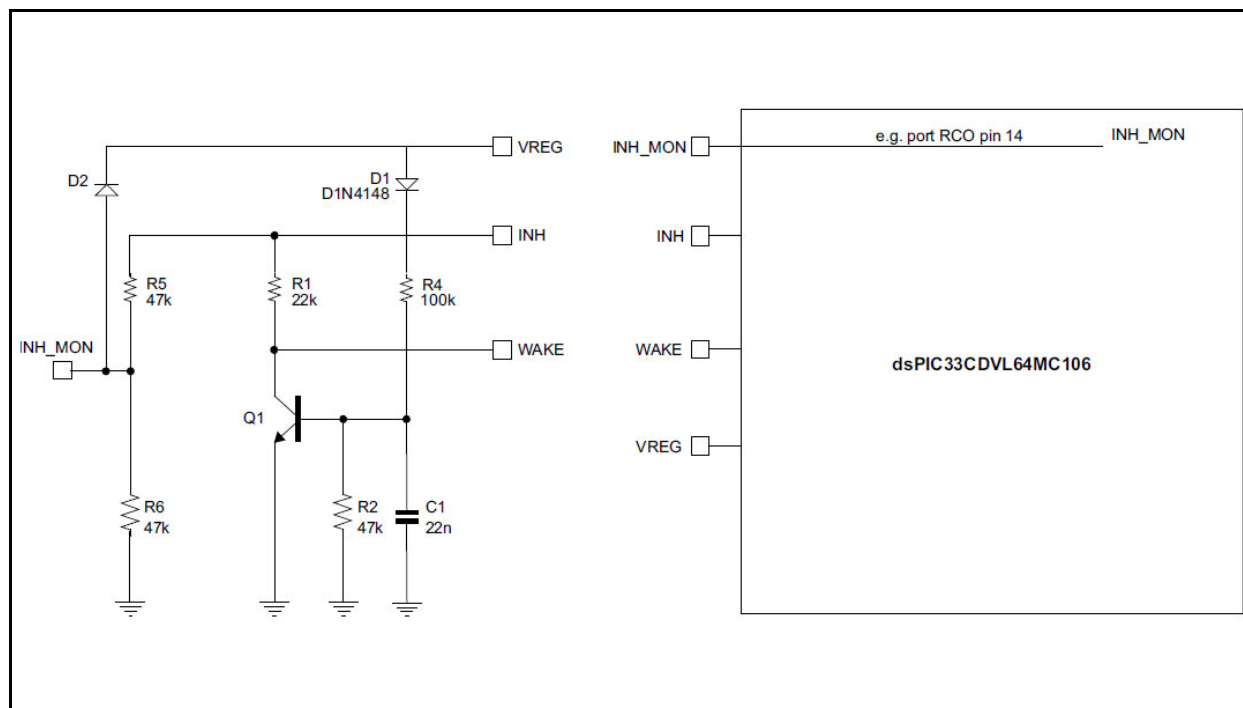
Figure 1: Wake Extender Circuit

10. Module: MOSFET Gate Driver

When utilizing the VREG output of the MOSFET Gate Driver module to power the host processor and relying on LIN Transceiver bus activity to generate a wake-up event, a timing conflict may occur. If the MOSFET Gate Driver is in Sleep mode, the edge from the LIN_INH output that triggers the wake event may fail to be detected by the MOSFET Gate Driver. This situation occurs if the incoming rising edge happens before the setup time required to put the MOSFET Gate Driver into Sleep mode has been satisfied. This could lead to the gate driver not waking up as expected.

Implement the external HW circuit and SW routine below to delay any incoming rising edge on the WAKE pin $\geq t_{\text{SLEEP}} + t_{\text{WAIT_SETUP}}$.

In conjunction with the additional hardware in Figure 1, the node labeled “INH_MON” should be utilized as an input to the dsPIC DSC to monitor the state of the LIN Transceiver module to ensure the LIN device is in Sleep mode prior to sending the Sleep command to the gate driver. Since INH_MON is a product of LIN_INH, it will be low when LIN_EN is set low. After INH_MON is confirmed to be in a Low state via software, the host dsPIC DSC can proceed with putting the gate driver to sleep after tSLEEP_MIN has elapsed. Figure 2 shows a block diagram of the recommended software flow. See sections Section 17.1.6, Enable Input Pin (LIN_EN) and Section 17.1.7, Inhibit Output Pin (LIN_INH) in the data sheet DS70005441E for details on the functionality of pins LIN_EN and LIN_INH for the LIN Transceiver.
