## Product Change Notification - SYST-20OUBT552

ERRATA - dsPIC33EPXXGS50X Family Silicon Errata and Data Sheet Clarification

## dsPIC33EPXXGS50X Family Silicon Errata and Data Sheet Clarification

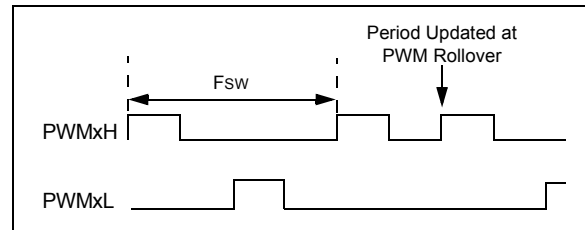
FIGURE 2:

When the PWM module is configured for Push-Pull mode (IOCONx[11:10] = 0b10) with the Enable Immediate Period Update bit enabled (PTCON[10] = 1), a write to the Period register that coincides with the period rollover event may cause the push-pull output logic to produce back-to-back pulses on the PWMx pins (Figure 2).

Ensure that the update to the PWM Period register occurs away from the PWM rollover event by setting the EIPU bit (PTCON[10] = 1). Use either the PWM Special Event Trigger (SEVTCMP) or the PWM Primary Trigger (TRIGx) to generate a PWM Interrupt Service Routine (ISR) near the start of the PWM cycle. This ISR will ensure that period writes do not occur near the PWM period rollover event.

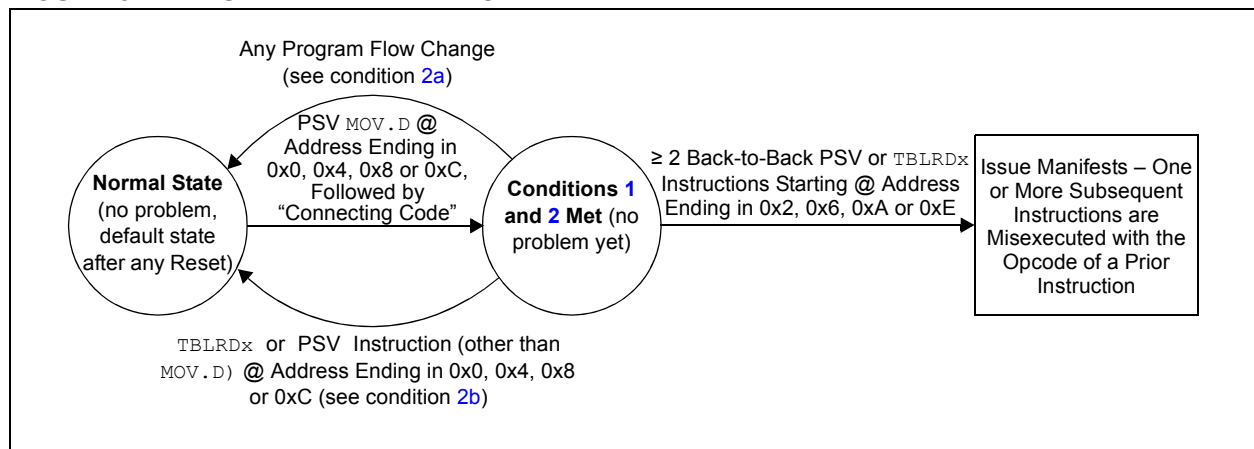
**FIGURE 5: SIMPLIFIED BEHAVIOR**

When two or more data Flash read instructions (via Program Space Visibility (PSV) read or table read) are executed back-to-back, one or more subsequent instructions can be misexecuted when all of the conditions in [Table 5](#) occur.

[Figure 5](#) provides an example of the effective behavior.

1. All instances of PSV `MOV.D` can be replaced with two PSV `MOV` instructions instead. Non-PSV `MOV.D` instructions acting on RAM/SFRs do not need to be modified; or
2. If not already present, a program flow change instruction (such as `BRA $+2`) can be inserted above back-to-back data Flash read sequences; or
3. Back-to-back data Flash read instruction sequences can be broken up by inserting a non-Flash read instruction (such as a `NOP`), in between the Flash read instructions; or
4. The alignment of the code can be shifted to avoid the required opcode location addresses.

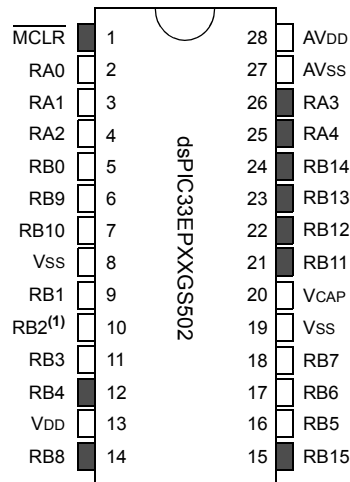
#### 28-Pin SOIC

A note has been added to the RB2 port pin, as shown below in **bold**. This note applies to RB2 on all available packages.

**Note 1:** At device power-up (POR), a pulse with an amplitude around 2V and a duration greater than 500  $\mu$ s, may be observed on this device pin independent of pull-down resistors. It is recommended not to use this pin as an output driver unless the circuit being driven can endure this active duration.
