Product Change Notification - SYST-03XNIB815

ERRATA - PIC32MZ Graphics (DA) Family Silicon Errata

PIC32MZ Graphics (DA) Family Silicon Errata and Data Sheet Clarification

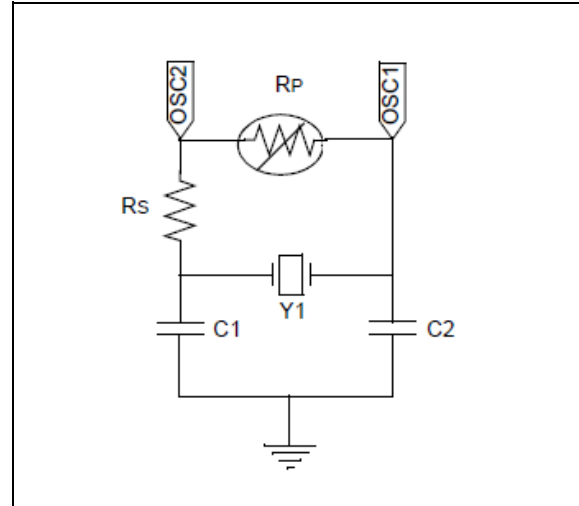
FIGURE 1: Posc CRYSTAL CIRCUIT

1. Module: Primary Oscillator

The POSC has been tested in a normal power-up sequence and supports specific crystal operation.

The Primary Oscillator (POsc) has been characterized to operate at 8 MHz and 12 MHz when the circuit shown in Figure 1 is implemented, and the operating conditions listed in Table 3 are met.

Alternatively, use an external clock or Internal FRC Oscillator. Note that communication interfaces (DDR2, USB, etc.,) with tighter clock accuracy requirements will not function with the FRC as clock source.

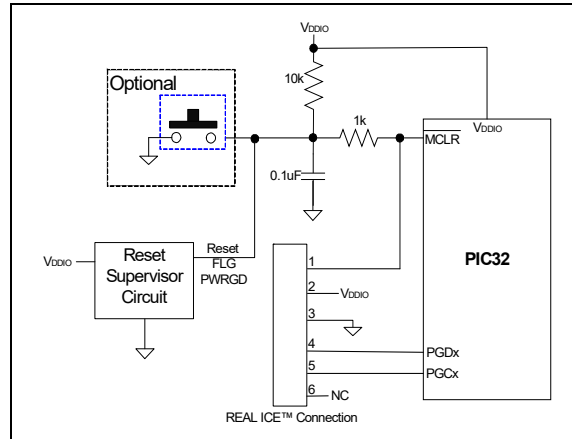
FIGURE 2: EXTERNAL RESET CIRCUIT

3. Module: Reset

A system Reset is not generated on a BOR event ($V_{PORIO} < V_{DDIO} < V_{BORIO}$). This will stop system clocks with all the I/O pin functions frozen in the present state until either V_{DDIO} falls to V_{PORIO} or $V_{DDIO} > V_{BORIO}$.

Reset device using a \overline{MCLR} pin through an external reset supervisor/monitor is shown in Figure 2. Set the SMCLR (DEVCFG2<15>) configuration bit to '0', which makes the \overline{MCLR} to act as a POR Reset instead of a normal system reset.

- Minimum Reset trip voltage of the external supervisor should be $V_{BORIO} (Max)+0.5V$.
- The external reset supervisor/LDO output going to \overline{MCLR} should have an open drain output to not interfere with the MPLAB programming/debug tools.

When this work around is implemented, the minimum V_{DDIO} operating voltage of the application needs to be above the reset supervisor maximum trip voltage + 0.2V, where 0.2V compensates for variation in the external reset supervisor voltage.
