Product Change Notification - SYST-16FCTK442

ERRATA - dsPIC33FJ32GS406/606/608/610 and dsPIC33FJ64GS406/606/608/610 Sil Err and DS Cla

dsPIC33FJ32GS406/606/608/610 and dsPIC33FJ64GS406/606/608/610 Family Silicon Errata and Data Sheet Clarification

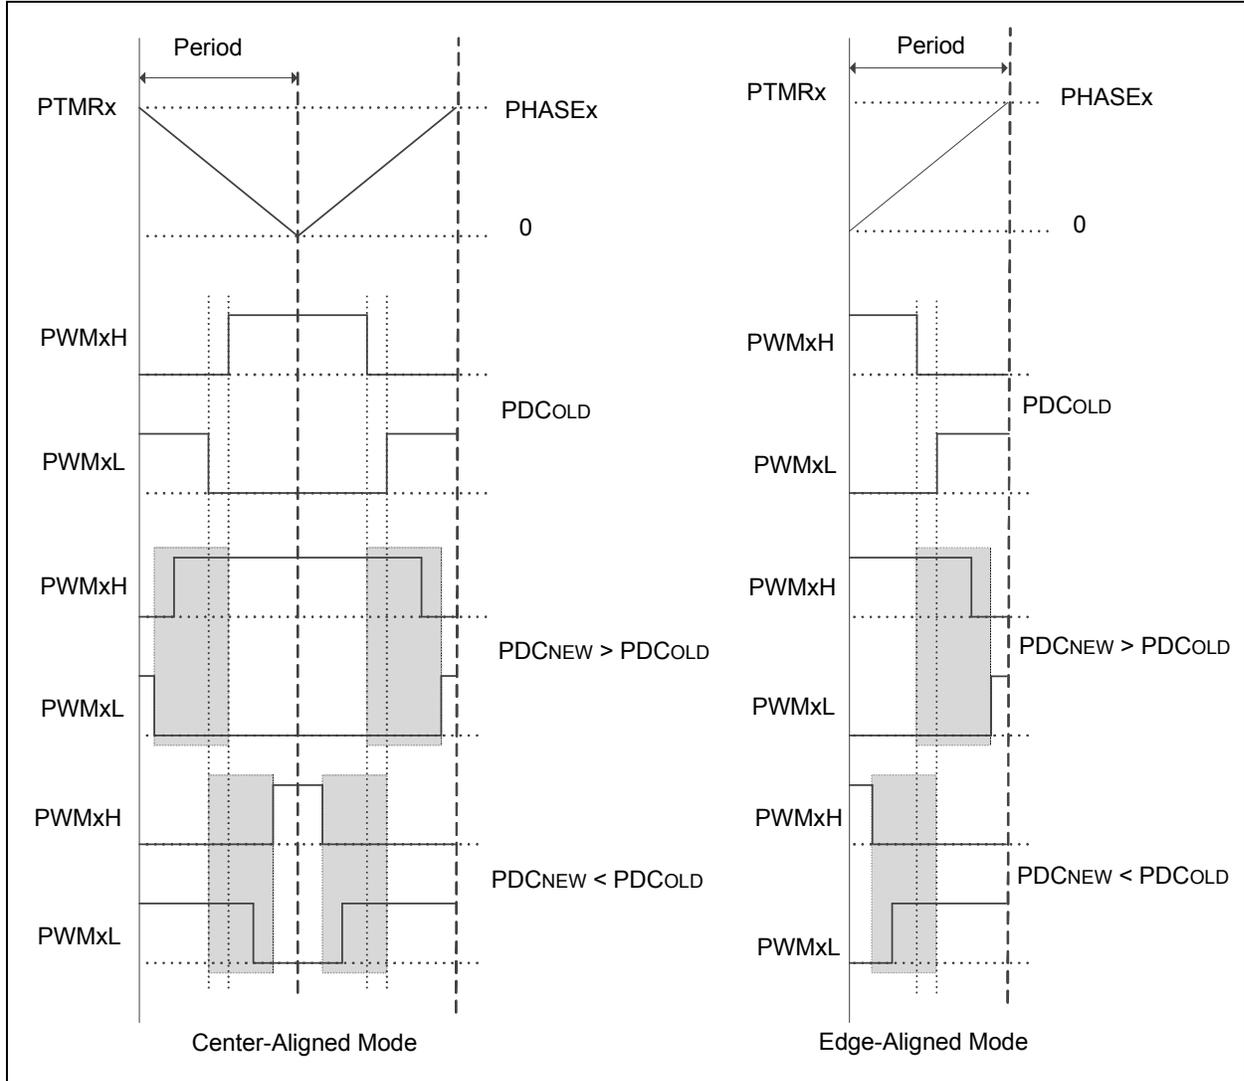
FIGURE 1: TIMING DIAGRAMS FOR CENTER-ALIGNED AND EDGE-ALIGNED MODES

The PWMx generator may not assert dead time on the edges of transitions. This has been observed when all of the following conditions are present:

In [Figure 1](#) (following page), if the duty cycle write occurred in the shaded box, then PWMxH and PWMxL will make an immediate transition without dead time.

None. However, in most applications the duty cycle update timing can be controlled using the TRIGx trigger or Special Event Trigger, such that the above mentioned conditions are avoided altogether.

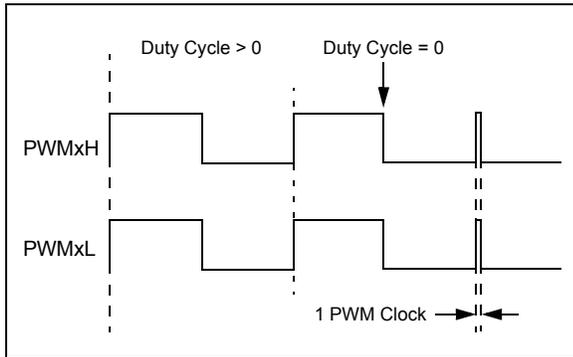
FIGURE 2: ISSUE EXAMPLE FOR REDUNDANT OUTPUT MODE

In Redundant Output mode (IOCONx[11:10] = 01) and Push-Pull Output mode (IOCONx[11:10] = 10), with the Immediate Update Enable bit disabled (PWMCONx[0] = 0), when the Duty Cycle register is updated from a non-zero value to zero, a glitch pulse of a width equal to one PWM clock will appear at the next PWM period boundary, as shown in Figure 2 (for the Redundant Output mode). The Duty Cycle register refers to the PDCx register if PWMCONx[8] = 0 or the MDC register if PWMCONx[8] = 1.

If the application requires a zero duty cycle output, there are two possible work around methods:

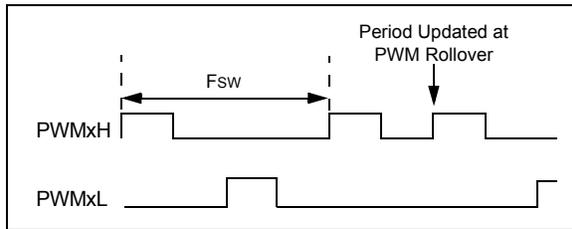
FIGURE 3:

When the PWM module is configured for Push-Pull mode (IOCONx[11:10] = 10) with the Enable Immediate Period Update bit enabled (PTCON [10] = 1), a write to the Period register that coincides with the period rollover event may cause the push-pull output logic to produce back-to-back pulses on the PWMx pins (Figure 3).

Ensure that the update to the PWM Period register occurs away from the PWM rollover event by setting the EIPU bit (PTCON[10] = 1). Use either the PWM Special Event Trigger (SEVTCMP) or the PWM Primary Trigger (TRIGx) to generate a PWM Interrupt Service Routine (ISR) near the start of the PWM cycle. This ISR will ensure that period writes do not occur near the PWM period rollover event.

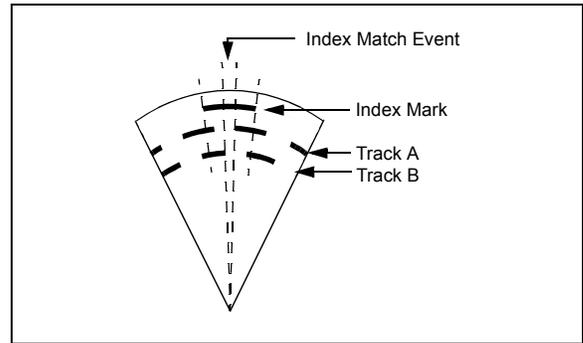
FIGURE 4: ENCODER IN THE SECTOR AROUND THE INDEX MARK

This issue is most likely to be seen in specific motor applications using a rotation encoder with an ungated index pulse, operating at near zero speed and/or in the presence of mechanical vibration. In these applications, the encoder may change direction and incrementally rock back and forth. If this happens with the encoder positioned in the vicinity of its index mark, the module will detect the first index match event as the encoder rotates into the index match event area, but not subsequent events if it drifts into and out of that position but stays within the index mark area (Figure 4). If the encoder count increments or decrements in only one direction, the index match will only occur once.

As a result of this, the value of POSxCNT may leave its expected range of 0 to maximum count (defined as the number of encoder pulses per revolution, minus 1), resulting in erroneous reporting of the rotor's position.

None.

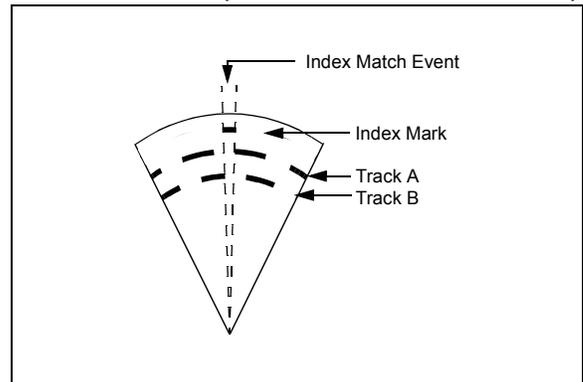
FIGURE 5: ENCODER IN THE SECTOR AROUND THE INDEX MARK (ONE COUNT WIDTH INDEX)

This issue is not seen when the encoder uses an index mark that is one encoder count in width (Figure 5).
