## Product Change Notification - SYST-23SBVG835

ERRATA - ATtiny417/817 Silicon Errata and Data Sheet Clarification

## ATtiny417/817 Silicon Errata and Data Sheet Clarification

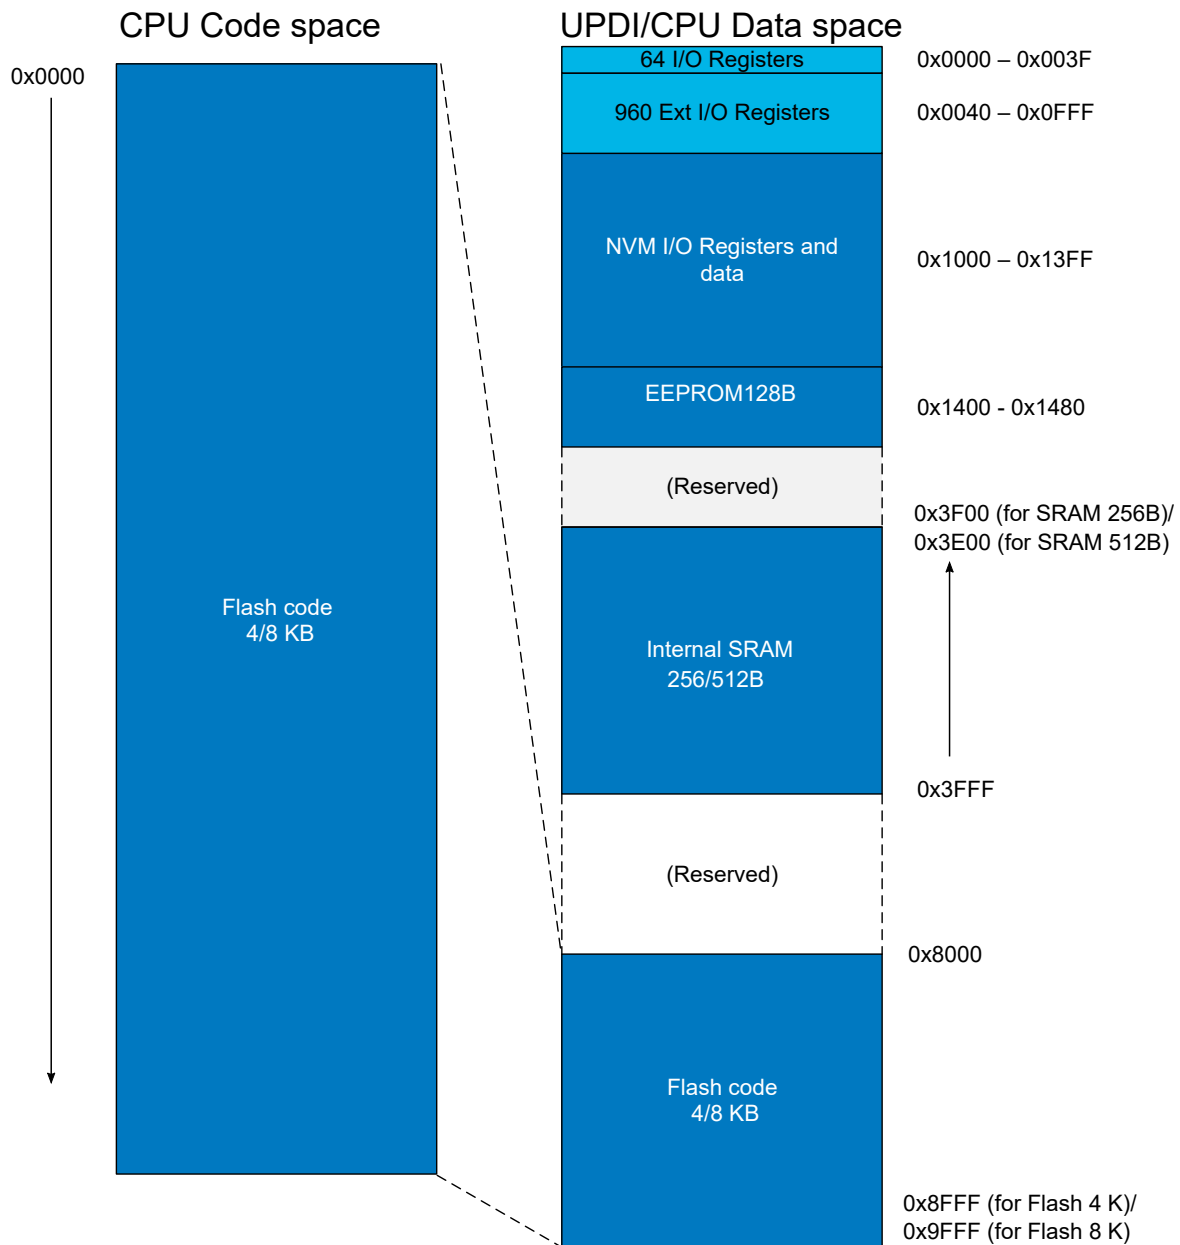
#### 3.1 Memories

Memory Map is missing from chapter 6.2 in the data sheet.

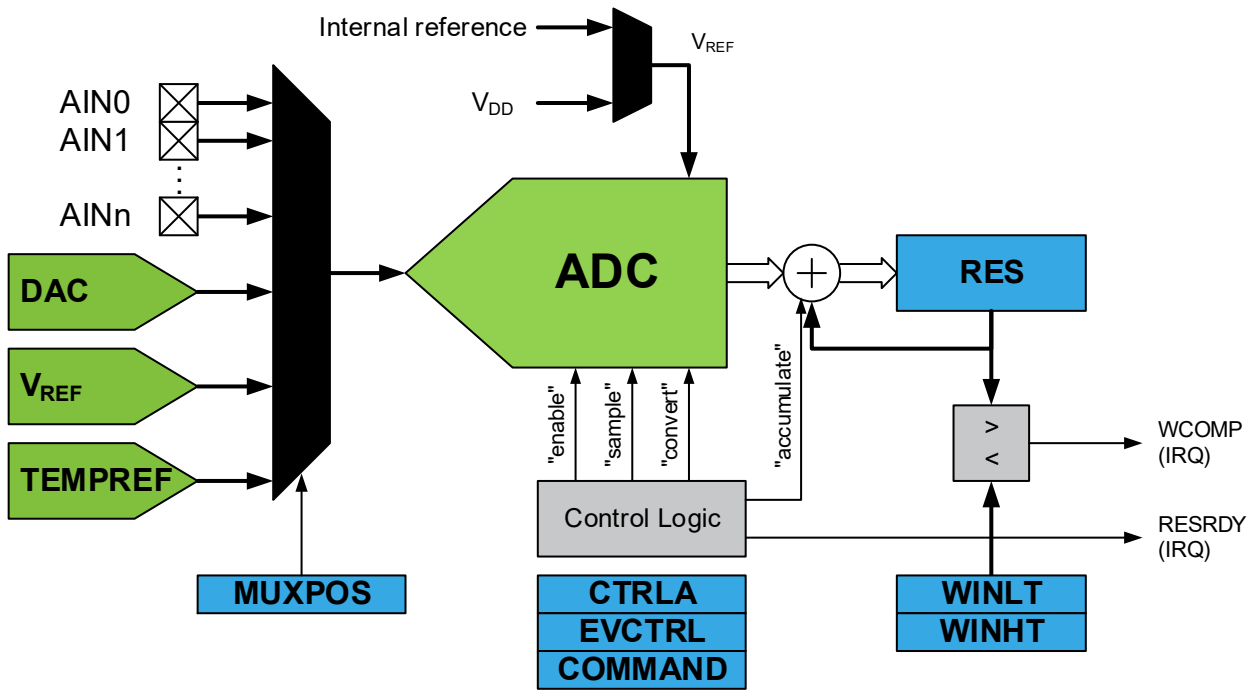
### 3.2 ADC

Block Diagram image is missing from figure 30-1 in the data sheet.
