## Product Change Notification - SYST-24WWIL685

ERRATA - dsPIC33EPXXX(GP/MC/MU)806/810/814 and PIC24EPXXX(GP/GU)810/814 Errata

## dsPIC33EPXXX(GP/MC/MU)806/810/814 and PIC24EPXXX(GP/GU)810/814 Family Silicon Errata and Data Sheet Clarification

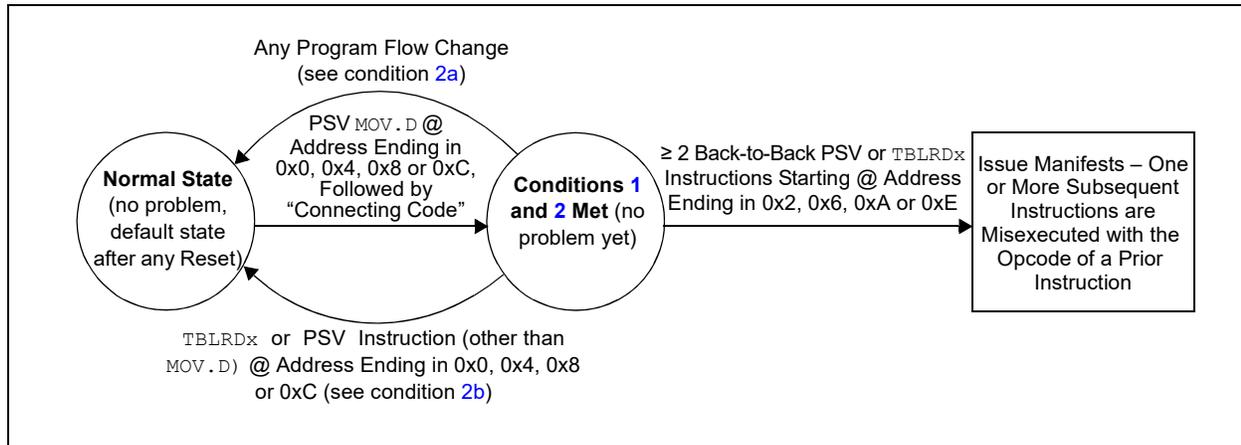
**FIGURE 1: SIMPLIFIED BEHAVIOR**

When two or more data Flash read instructions (via Program Space Visibility (PSV) read or table read) are executed back-to-back, one or more subsequent instructions can be misexecuted when all of the conditions in Table 3 occur.

1.	A PSV <code>MOV.D</code> instruction is executed, with opcode at address ending in 0x0, 0x4, 0x8 or 0xC; and
2.	Some “connecting code” is executed (following the <code>MOV.D</code> of condition 1), with the properties: <ul style="list-style-type: none"> <li>a) The connecting code does not include any program flow changes, including: taken branch instructions (including all versions of <code>BRA</code>, <code>CPBEQ</code>, <code>CPBGT</code>, <code>CPBLT</code>, <code>CPBNE</code>), <code>CALL</code>, <code>CALL.L</code>, <code>GOTO</code>, <code>GOTO.L</code>, <code>RCALL</code>, <code>RETLW</code>, <code>RETURN</code>, vectoring to an ISR, returning from an interrupt (<code>RETFIE</code>) and certain debug operations, such as <code>break</code> and <code>one-step</code>; and</li> <li>b) The connecting code does not include a <code>TBLRDx</code> or non-<code>MOV.D</code> PSV instruction, located at a Flash memory address ending in 0x0, 0x4, 0x8 or 0xC; and</li> <li>c) The connecting code is at least two instruction words in length; and</li> <li>d) The connecting code does not end with a <code>REPEAT</code> instruction, with count &gt; 0; and</li> </ul>

3.	≥ 2 back-to-back PSV or <code>TBLRDx</code> instructions are executed (following the code of condition 2), where the first of the back-to-back instructions is located at an address ending in 0x2, 0x6, 0xA or 0xE.

Figure 1 provides an example of the effective behavior.

The issue can be avoided by ensuring any one or more of the requirements are not met. For example:

1. All instances of PSV `MOV.D` can be replaced with two PSV `MOV` instructions instead. Non-PSV `MOV.D` instructions acting on RAM/SFRs do not need to be modified; or
2. If not already present, a program flow change instruction (such as `BRA $+2`) can be inserted above back-to-back data Flash read sequences; or
3. Back-to-back data Flash read instruction sequences can be broken up by inserting a non-Flash read instruction (such as a `NOB`) in between the Flash read instructions; or
4. The alignment of the code can be shifted to avoid the required opcode location addresses.

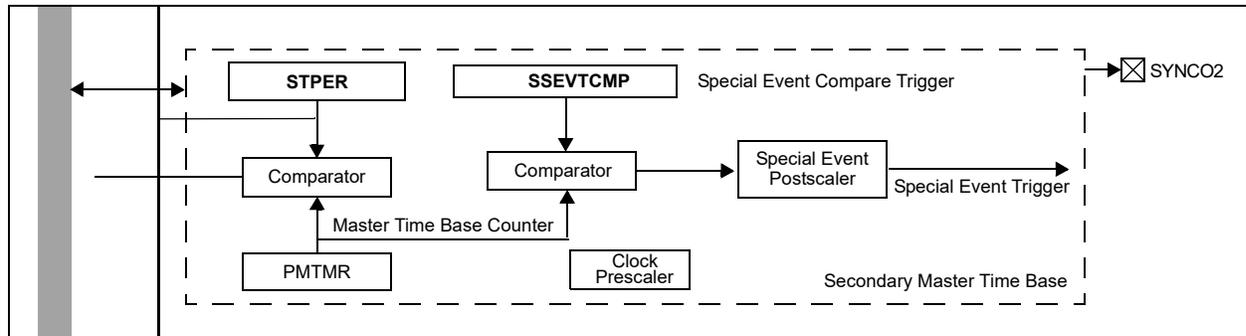
**FIGURE 16-2: HIGH-SPEED PWM MODULE REGISTER INTERCONNECTION DIAGRAM**

In **Figure 16-2: High-Speed PWM Module Register Interconnection Diagram**, the Secondary Master Time Base section has been updated. The updated text is shown in **bold** in [Figure 16-2](#) below.
