## Product Change Notification / SYST-24EVEA235

ERRATA - MCP2518FD Silicon Errata and Data Sheet Clarification Document Revision

## MCP2518FD Silicon Errata and Data Sheet Clarification

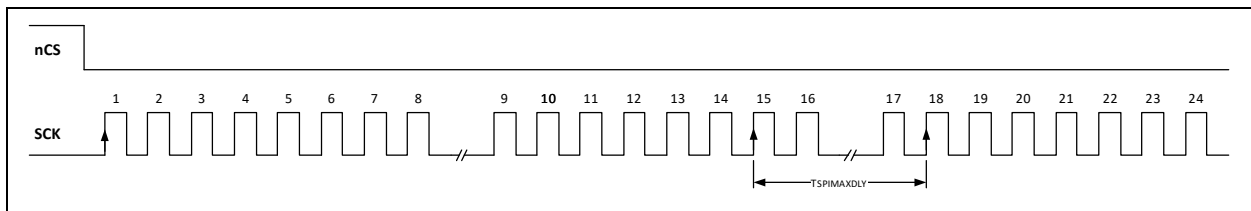
**FIGURE 1: MAXIMUM DELAY BETWEEN SPI BYTES**

The SPI interface blocks the CAN FD Controller module from accessing RAM between the 15th and 18th rising edge of SCK, during an SPI READ instruction, while accessing RAM.

If the CAN FD Controller module is blocked for more than TSPIMAXDLY, a TX MAB underflow can occur.

For example, TSPIMAXDLY is 8.5  $\mu$ s for a CAN FD frame at 500 kbps/2 Mbps. In comparison, an SPI byte takes 0.67  $\mu$ s at 12 MHz SCK. A delay of ten times the duration of one SPI byte could cause a TX MAB underflow. It is highly unlikely for an MCU application to introduce such a long delay, but this error could occur when running an operation system, such as Linux<sup>®</sup> on a slower MPU.

Keep the delay between two SPI bytes shorter than TSPIMAXDLY; see [Figure 1](#).

The maximum allowed delay between two bytes depends on which CAN Message Frame is transmitted, and on the selected Nominal Bit Time (NBT) and Data Bit Time (DBT). [Table 1](#) lists TSPIMAXDLY for the worst-case scenarios.
