Product Change Notification / SYST-23OUGH321

ERRATA - dsPIC33CH128MP508 Family Silicon Errata and Datasheet Clarification

dsPIC33CH128MP508 Family Silicon Errata and Data Sheet Clarification

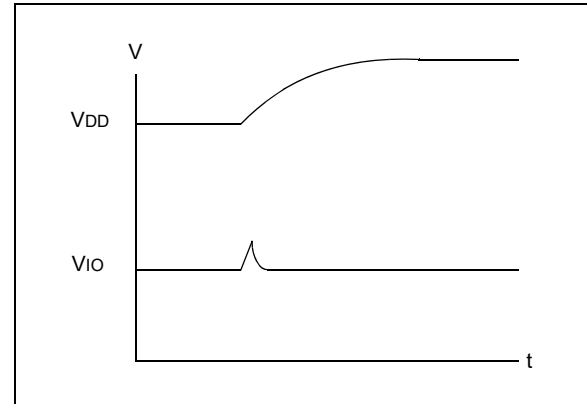
FIGURE 1: I/O RAMP

During a fast device power-up, when the V_{DD} ramp is less than 4 mS, the I/O pins may drive up to 100 μ A current for a duration of up to 10 μ S (Figure 1).

Example applications affected may include complementary power switches, where a transient current shoot-through might occur.

1. Slow down the V_{DD} ramp time (greater than 4 mS for V_{DD} to ramp 0V to 3.3V).
2. Ensure the circuitry that is connected to the pins can endure this pulse.

High-voltage applications with complementary switches should power the high-voltage 200 μ Sec later than powering the dsPIC[®] device to avoid the current shoot-through. This behavior is specific to each device and not affected by aging.
