Product Change Notification / SYST-29RHQU394

ERRATA - PIC18F24/25K40 Family Silicon Errata and Data Sheet Clarification

PIC18(L)F24/25K40 Family Silicon Errata and Data Sheet Clarification

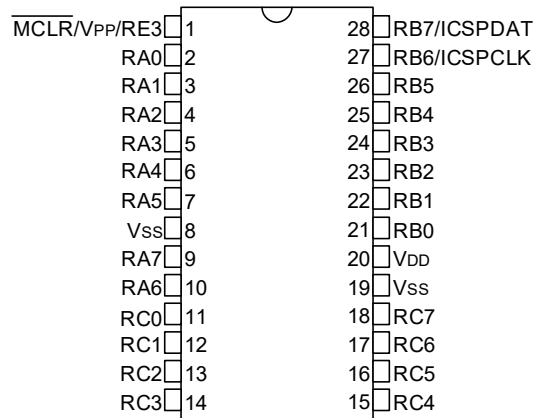
Figure 1. 28-pin SPDIP, SSOP, SOIC

The correct marking for pin 26 on the 28-pin SPDIP/SSOP/SOIC package is **RB5**.

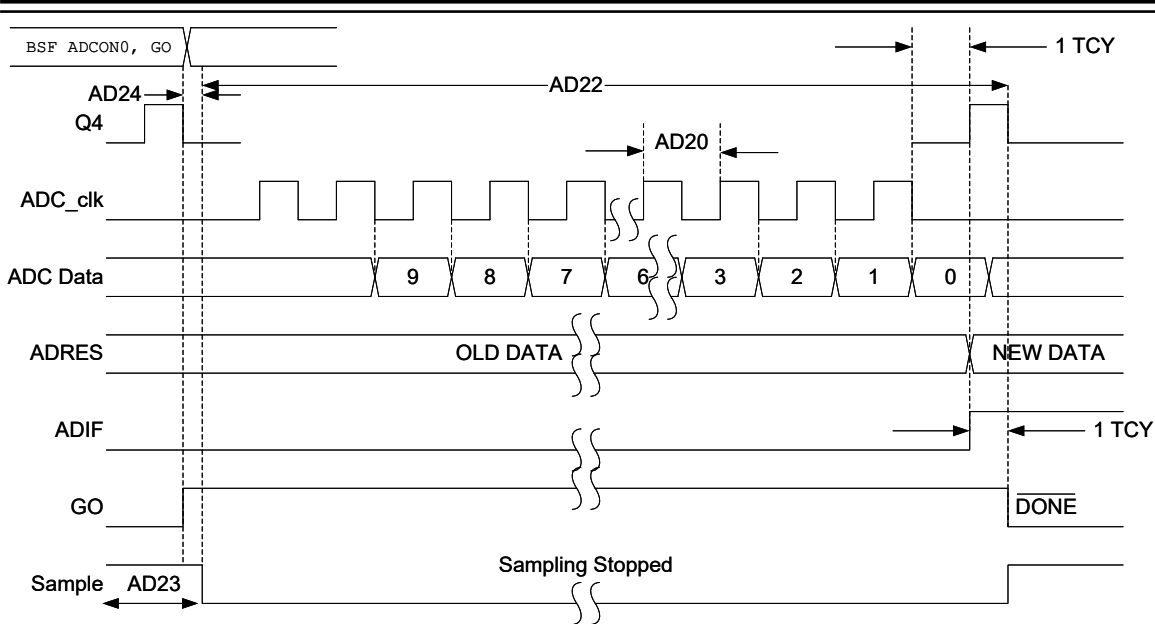
Figure 38-10: ADC Conversion Timing (ADC Clock F_{OSC}-Based)

Refer to the images below for corrections of Figure 38-10 and Figure 38-11. Previously, the parameter numbers were incorrect.
