## Product Change Notification / SYST-31TCNJ739

ERRATA - PIC18F27/47K40 Family Silicon Errata and Data Sheet Clarification

## PIC18(L)F27/47K40 Family Silicon Errata and Data Sheet Clarifications

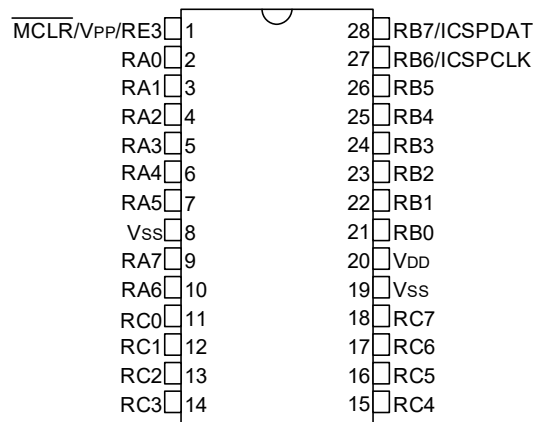
Figure 1. 28-pin SPDIP, SSOP, SOIC

The correct marking for pin 26 on the 28-pin SPDIP/SSOP/SOIC package is **RB5**.

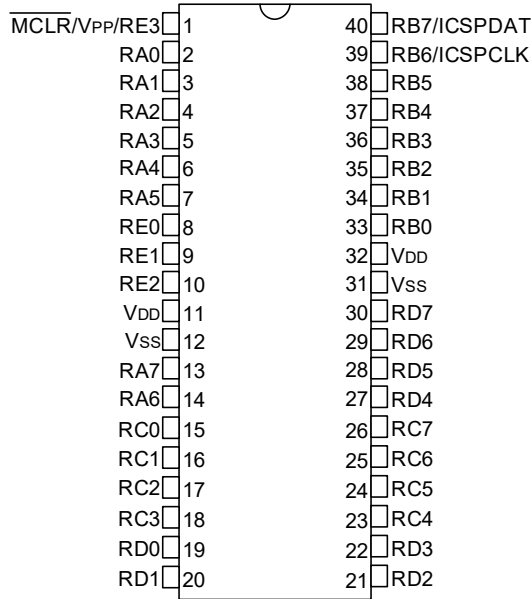
Figure 3. 40-pin PDIP

The correct marking for pin 38 on the 40-pin SPDIP package is **RB5**.

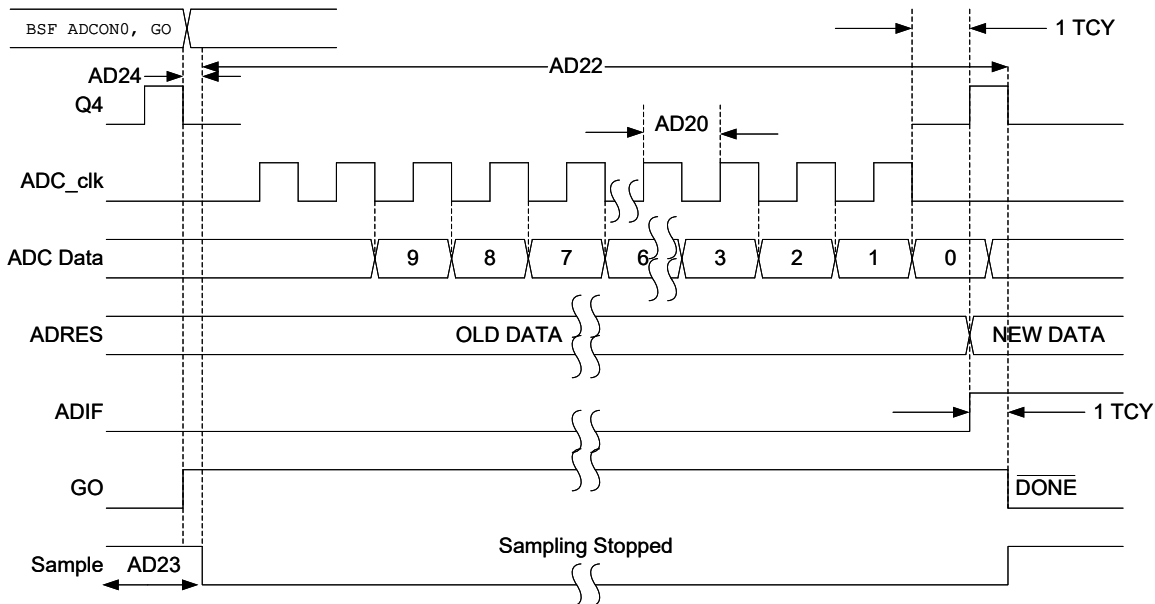
Figure 38-10: ADC Conversion Timing (ADC Clock  $F_{OSC}$ -Based)

Refer to the images below for corrections of Figure 38-10 and Figure 38-11. Previously, the parameter numbers were incorrect.
