## Product Change Notification / SYST-29WXAV969

ERRATA - dsPIC33FJ06GS101/X02 and dsPIC33FJ16GSX02/X04 Family Silicon Errata and Data Sheet Clarification Errata Document Revision

## dsPIC33FJ06GS101/X02 and dsPIC33FJ16GSX02/X04 Family Silicon Errata and Data Sheet Clarification

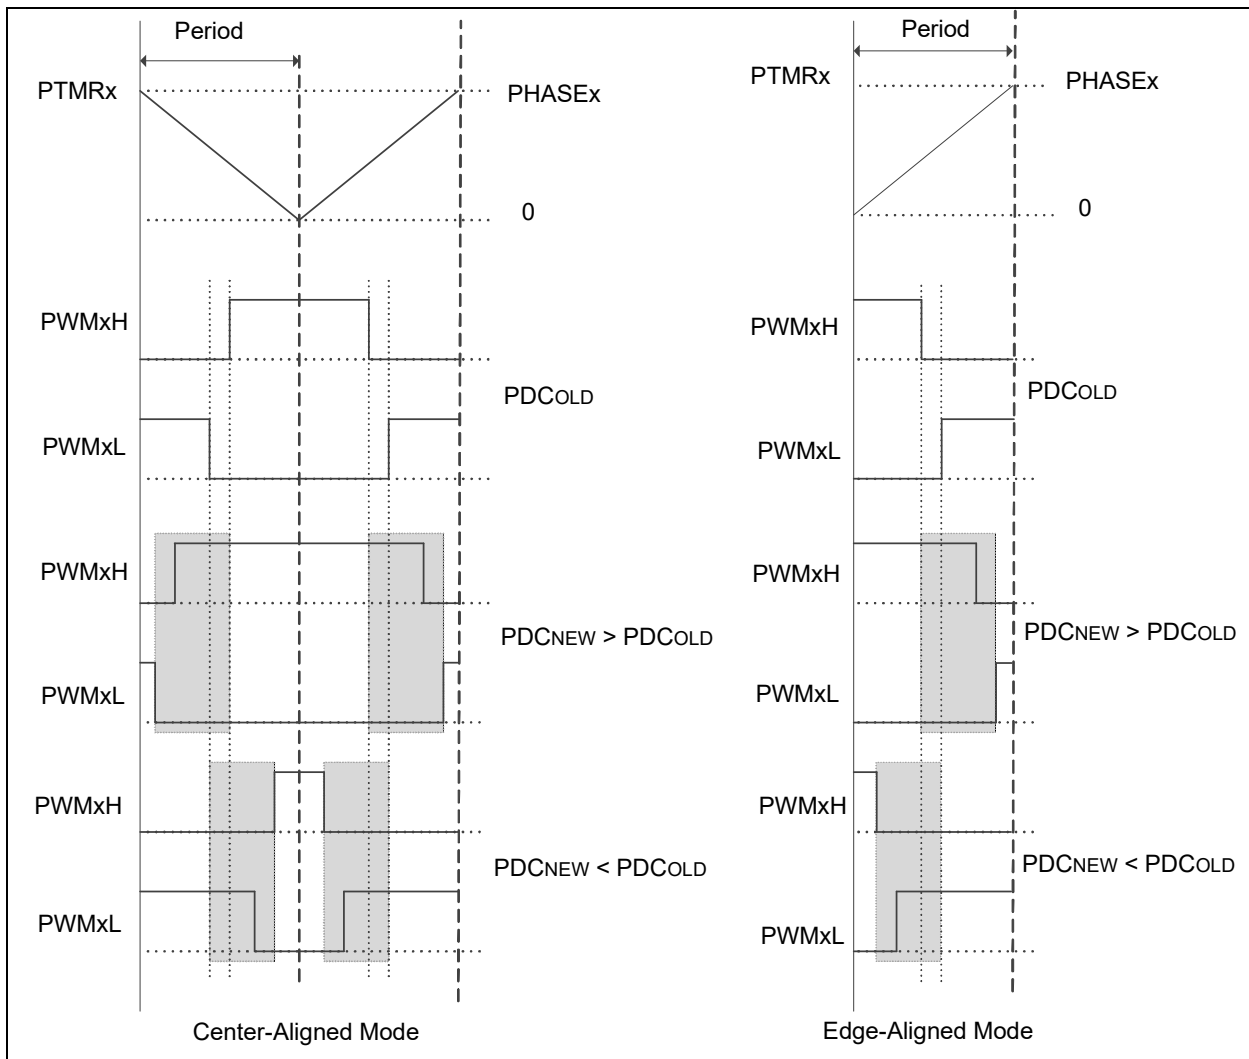
**FIGURE 1: TIMING DIAGRAMS FOR CENTER-ALIGNED AND EDGE-ALIGNED MODES**

The PWMx generator may not assert dead time on the edges of transitions. This has been observed when all of the following conditions are present:

None. However, in most applications, the duty cycle update timing can be controlled using the TRIGx trigger or Special Event Trigger, such that the above mentioned conditions are avoided altogether.

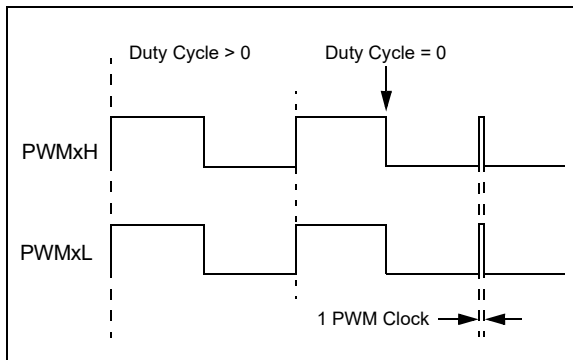
**FIGURE 2: ISSUE EXAMPLE FOR REDUNDANT OUTPUT MODE**

In Redundant Output mode (IOCONx[11:10] = 01) and Push-Pull Output mode (IOCONx[11:10] = 10), with the Immediate Update disabled (PWMCONx[0] = 0), when the Duty Cycle register is updated from a non-zero value to zero, a glitch pulse of a width equal to one PWM clock will appear at the next PWM period boundary, as shown in Figure 2 (for the Redundant Output mode). The Duty Cycle register refers to the PDCx register if PWMCONx[8] = 0 or the MDC register if PWMCONx[8] = 1.

If the application requires a zero duty cycle output, there are two possible work around methods:

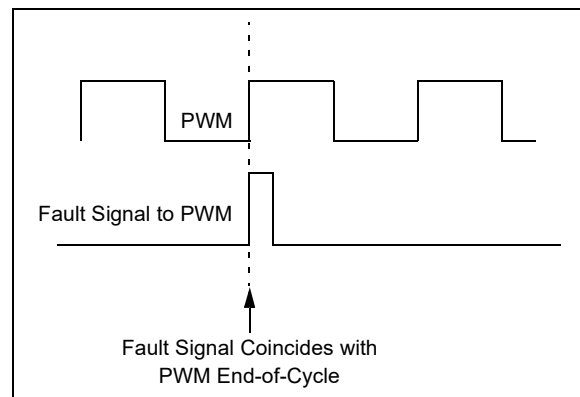
When the PWM module is operated in Complementary, Redundant, Push-Pull or True Independent Output modes and the PWM Fault/Current-Limit Fault are configured to provide a Fault event to the PWM, under certain conditions where the Fault event active edge happens to coincide with the PWM End-of-Cycle (EOC) event, the PWM fails to recognize the Fault event.

Configure the PWM module to include Leading-Edge Blanking bits, LEB[6:0] (LEBCONx [9:3]), with a count always greater than eight, with the appropriate PWMxH/PWMxL Leading-Edge Blanking triggers.
