## PART CHANGE NOTIFICATION

Part Number	CLB-JL73	Issue Date	27.05.2021
Original Design Image

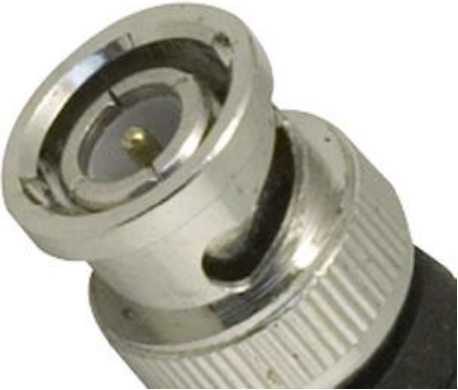
<p><b>COMMENTS</b> Original design features 4 incisions in centre ring</p>		
New Design Image

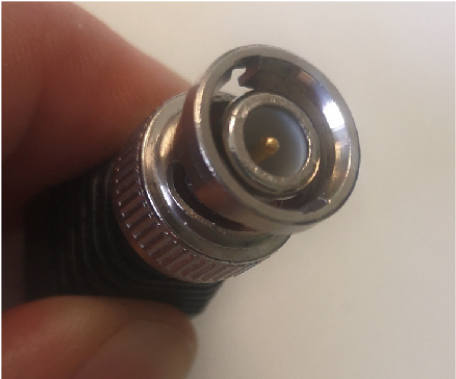
<p><b>COMMENTS</b> New design has solid centre ring</p>		
<p><b>REASONS FOR DESIGN CHANGE</b></p> <p>1) The centre ring with the 4 splits used to be made by hand which was difficult to put together, it can now be done by machine with the solid centre ring. This is an update of the production of the part, it does not affect the use.</p> <p>2) The centre ring with the 4 splits is formed by melting and moulding the metal, then the 4 incisions are made afterwards. Unfortunately this process can lead to residual metal slag inside the connector, which when electroplated can then become stuck inside and therefore cannot be removed. This introduces an obstruction which can cause a short circuit when the product is in use.</p>
