## Product Change Notification / SYST-07KOTG694

ERRATA - LAN8670/1/2 10BASE-T1S Ethernet PHY Transceiver Silicon Errata and Data Sheet Clarifications Revision

## 10BASE-T1S Ethernet PHY Transceiver Silicon Errata and Data Sheet Clarifications

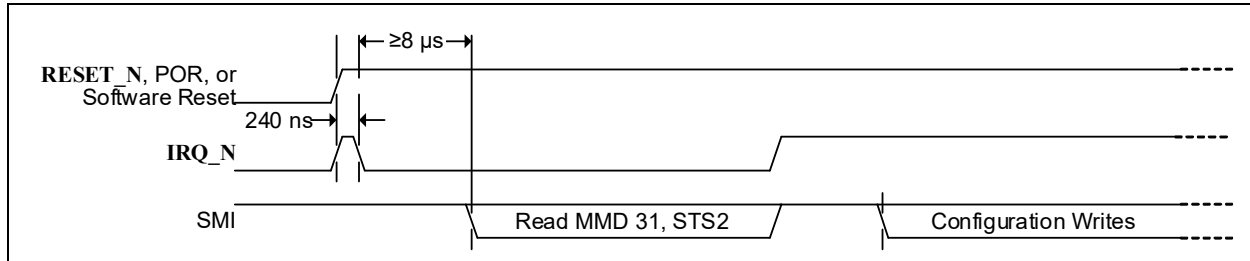
The device does not properly assert the IRQ\_N pin to interrupt the station management entity once it has been reset. The device should allow the IRQ\_N pin to be pulled high when it is in reset and only assert IRQ\_N low once it is ready for initialization by the station management entity. However, the device will assert IRQ\_N low during reset. Once the device reset is deasserted, the IRQ\_N pin will become deasserted for about 240 ns. The station management entity can only attempt communication with the device 8  $\mu$ s following reset.

When the device has been reset, the station management entity cannot immediately communicate with the device. The station management entity will receive a false interrupt indication on IRQ\_N when the device is reset. This may result in a failure to communicate with the device.

The station management entity must wait at least 8  $\mu$ s following reset to communicate with the device.
