Product Change Notification / SYST-04SBWB795

ERRATA - ATtiny1614/1616/1617 Silicon Errata and Data Sheet Clarification

ATtiny1614/1616/1617

Silicon Errata and Data Sheet Clarifications

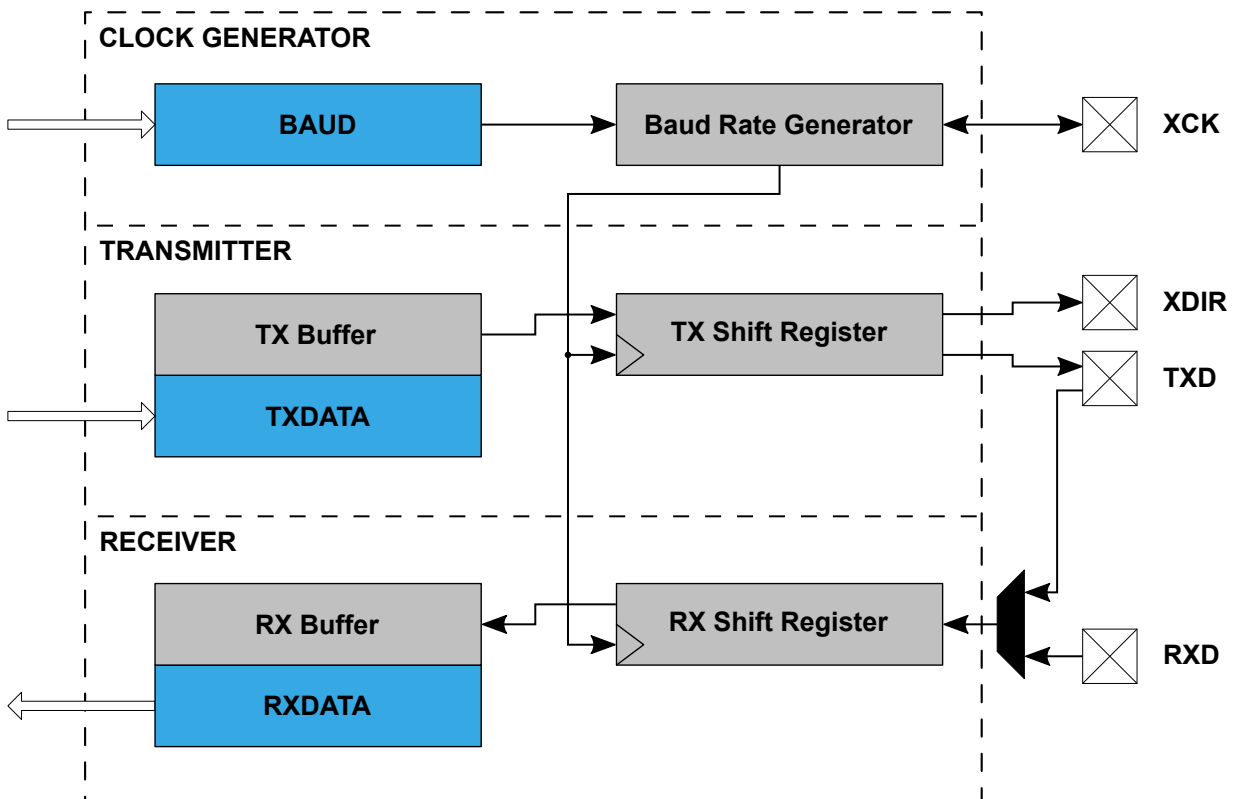
Figure 3-1. Block Diagram

The block diagram is missing that USART TX is double-buffered from Figure 25-1 in the data sheet. The figure below shows the added **TX Buffer**.

The following text is changed in the *Overview* section:

The transmitter consists of a **two-level** write buffer.
