Product Change Notification / SYST-10ZGXL795

ERRATA - AVR128DA28/32/48/64 Silicon Errata and Data Sheet Clarification

AVR128DA Silicon Errata and Data Sheet Clarification

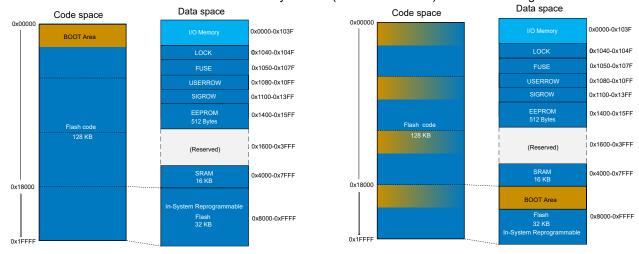
2.7.1 Flash Mapping Into Data Space not Working Properly

BOOT area for devices without issue

BOOT area for devices with issue

For read operations, the FLMAP bits work as documented when the Boot Read Protect (BOOTRP) bit is not enabled. For write operations, the inter-section Flash protection works properly only when FLMAP is set to '0x00'.

Use only store program memory (SPM) instructions to write and load program memory (LPM) instructions to read Flash memory.

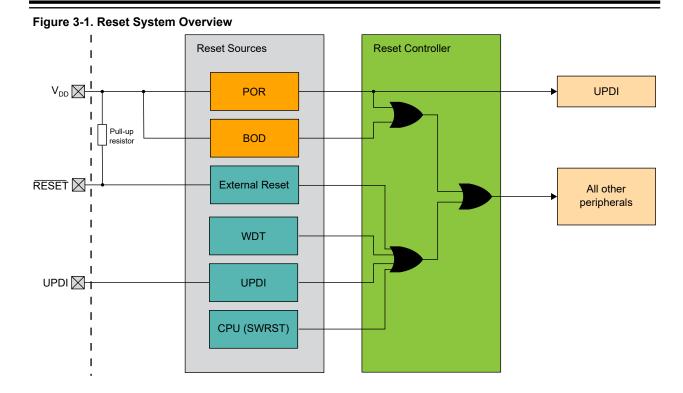
A clarification has been made to add the missing block diagram figure.
