## Product Change Notification / SYST-21QLVX434

ERRATA - dsPIC33EPXXXGM3XX/6XX/7XX Family Silicon Errata and Data Sheet Clarification Document Revision

## dsPIC33EPXXXGM3XX/6XX/7XX Family Silicon Errata and Data Sheet Clarification

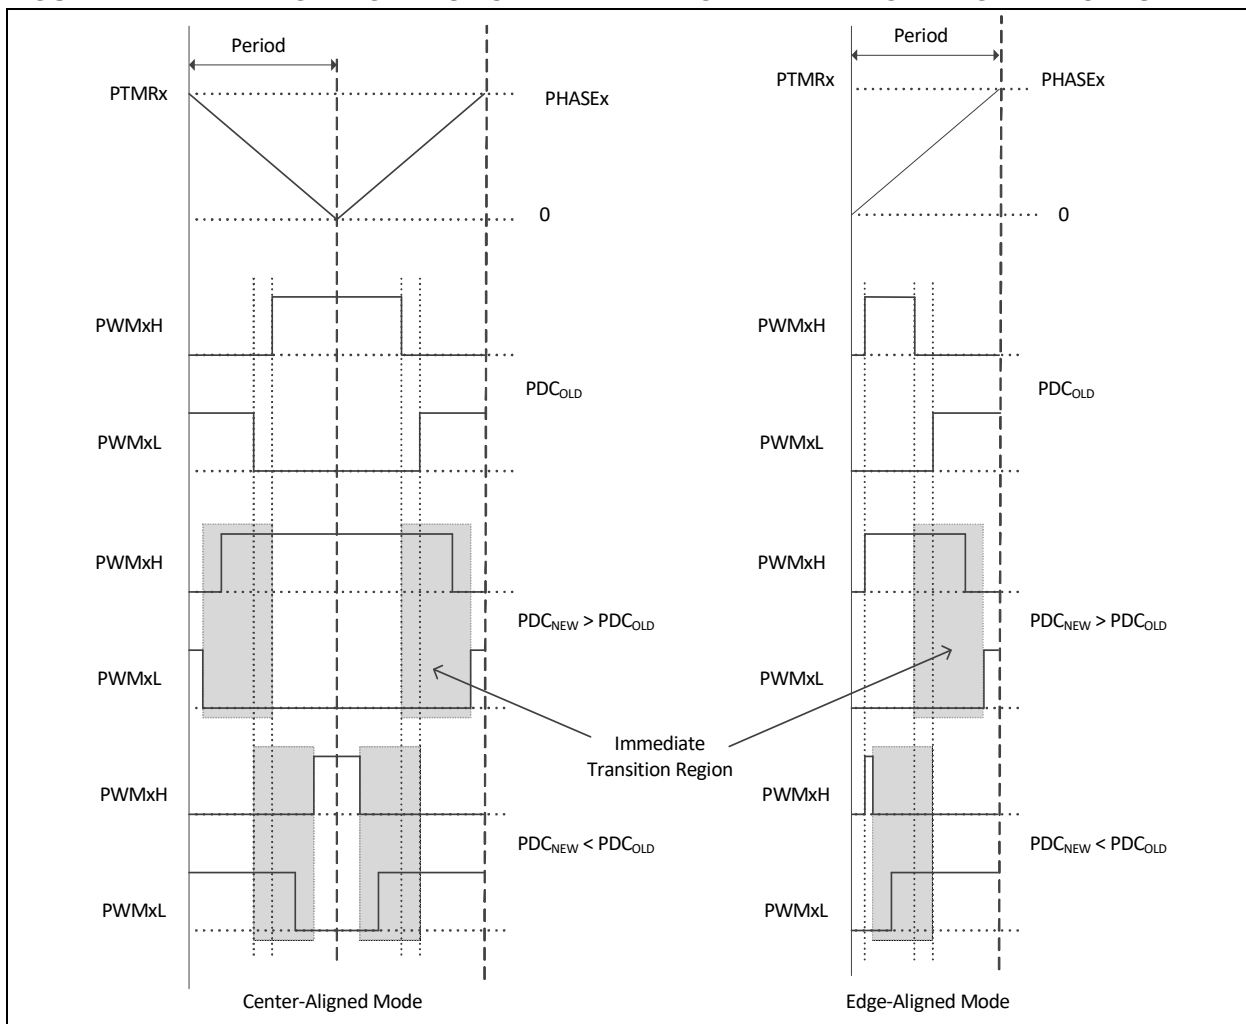
**FIGURE 1: TIMING DIAGRAMS FOR CENTER-ALIGNED AND EDGE-ALIGNED MODES**

The PWM generator may not assert dead time on the edges of transitions. This has been observed when all of the following conditions are present:

In Figure 1, if the duty cycle write occurred in the shaded box, then PWMxH and PWMxL will make an immediate transition without dead time.

### Work around

None.

In most applications, the duty cycle update timing can be controlled using the TRIGx trigger, or Special Event Trigger, such that the above mentioned conditions are avoided altogether.

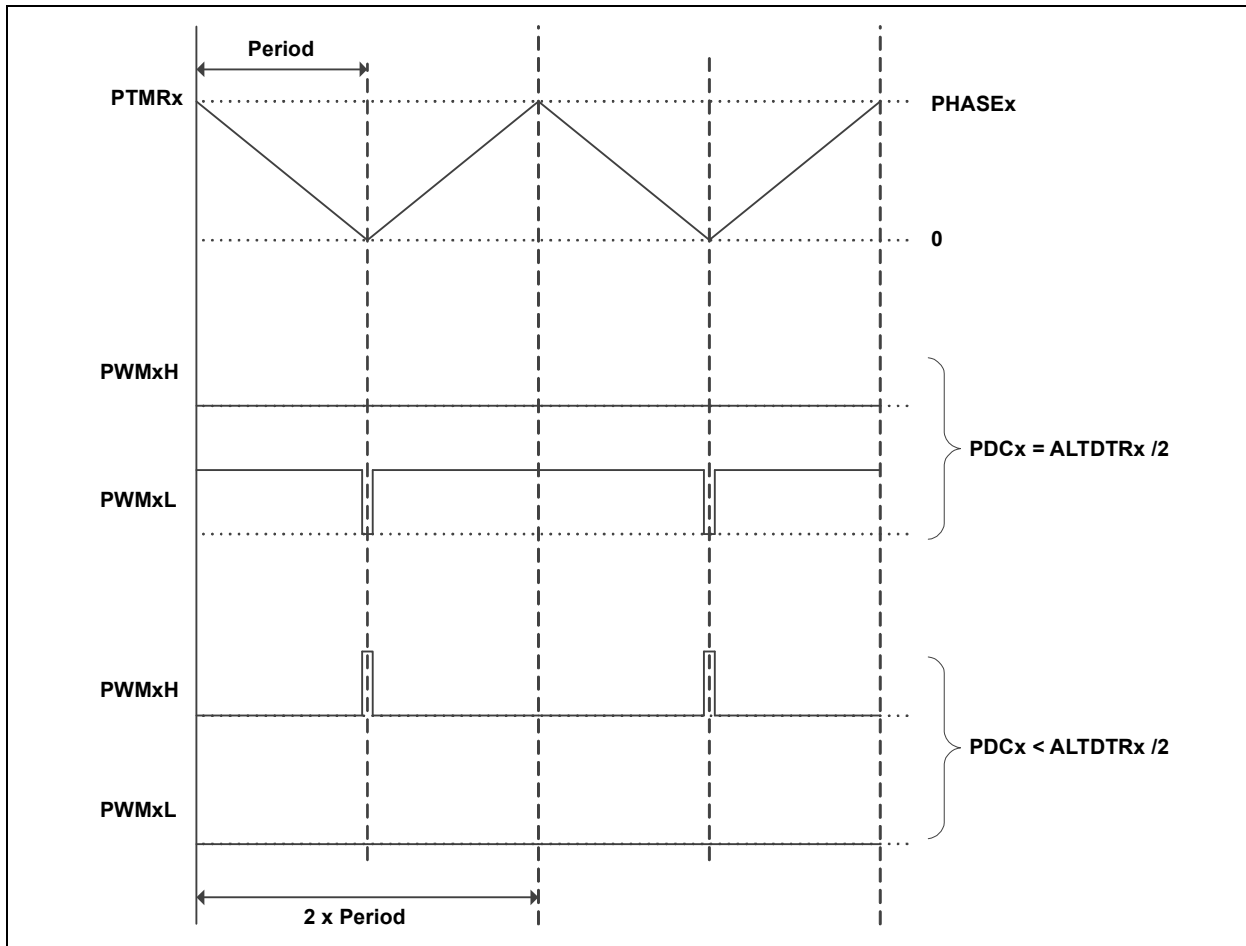
**FIGURE 2: PWM GENERATOR TIMING DIAGRAM**

In Center-Aligned Complementary mode with Independent Time Base, if the value in the PDCx register is less than one-half the value in the ALTDTRx register, the PWM generator will force the PWMxL to low, and on the PWMxH, generates pulses of a width less than twice the dead time, as shown in Figure 2.

### Work around

Include a software routine to ensure that the duty cycle value written to the PDCx register is at least one-half of the value in ALTDTRx. Example 1 shows one method, with PDCtemp representing the variable which has the value to be written to the PDCx register. Alternatively, for duty cycle values less than half the desired dead-time value, zero out the ALTDTRx register or dynamically reduce the value in the ALTDTRx register, such that ALTDTRx is always equal to  $2 * PDCx$ , as shown in Example 2.

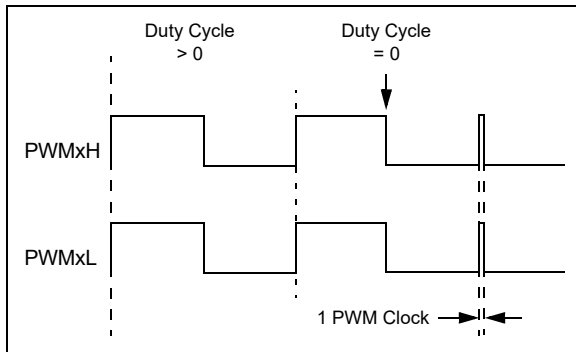
**FIGURE 3:**

In certain output modes, the PWMx module produces a pulse glitch of one PWM clock in width (Figure 3). This has been observed only when all of the following are true:

The pulse glitch has been observed to occur at the beginning of the following PWM boundary period.

### Work around

If the application requires a duty cycle of zero, two possible work arounds are available.

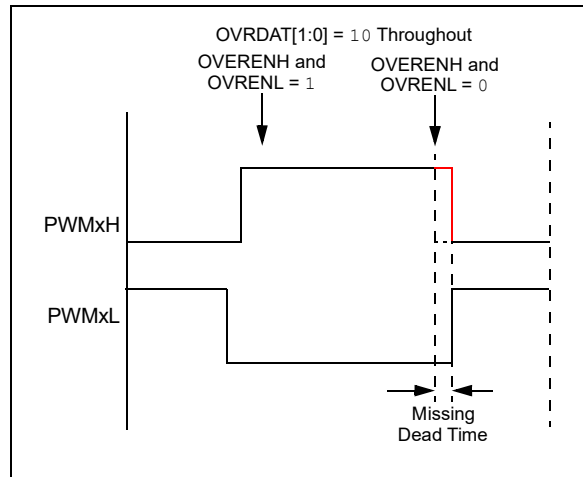
**FIGURE 4:**

This has been observed in both Center-Aligned and Edge-Aligned modes.

### Work around

None.

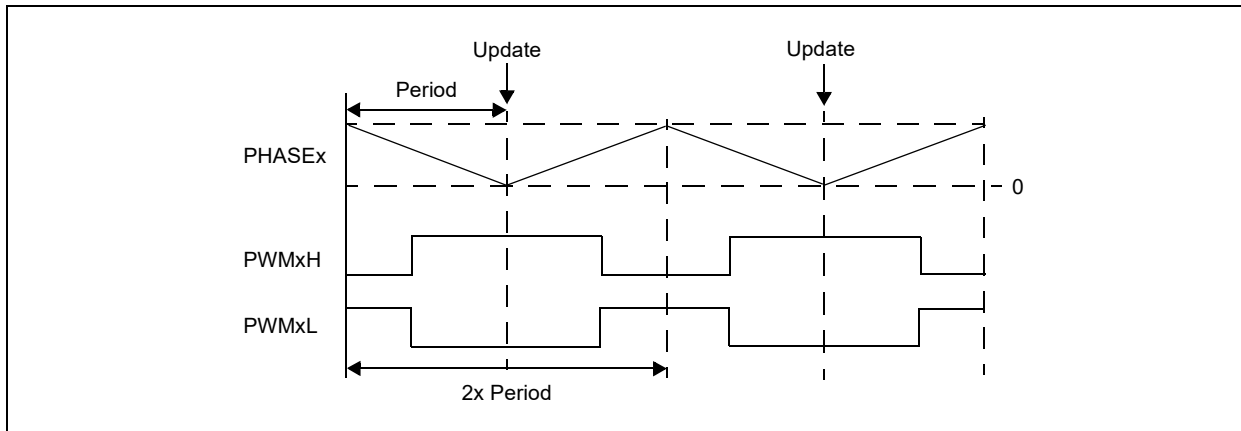
FIGURE 5:

In Center-Aligned Complementary mode with Independent Time Base, updates to the PHASEx register take effect in the middle of a Center-Aligned PWM cycle, as shown in Figure 5. This occurs only when the Immediate Update feature is disabled (IUE = 0). If Immediate Update is enabled (IUE = 1), the PHASEx register updates will take effect immediately.

### Work around

None.

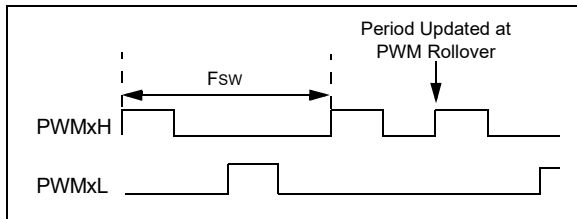
FIGURE 6:

When the PWM module is configured for Push-Pull mode (IOCONx[11:10] = 10) with the Enable Immediate Period Update bit enabled (PTCON[10] = 1), a write to the Period register that coincides with the period rollover event may cause the push-pull output logic to produce back-to-back pulses on the PWMx pins (Figure 6).

### Work around

Ensure that the update to the PWM Period register occurs away from the PWM rollover event by setting the EIPU bit (PTCON[10] = 1). Use either the PWM Special Event Trigger (SEVTCMP) or the PWM Primary Trigger (TRIGx) to generate a PWM Interrupt Service Routine (ISR) near the start of the PWM cycle. This ISR will ensure that period writes do not occur near the PWM period rollover event.

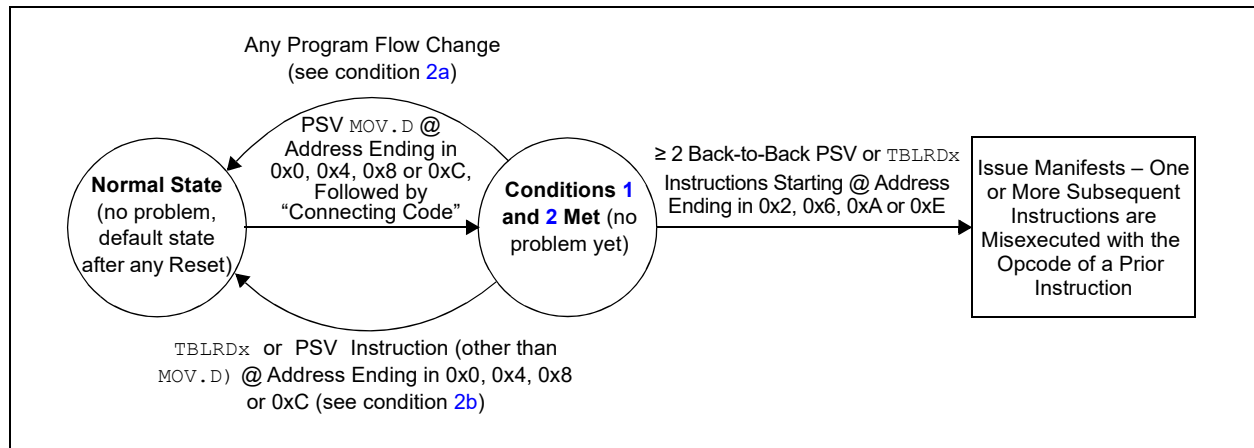
**FIGURE 7: SIMPLIFIED BEHAVIOR**

When two or more data Flash read instructions (via Program Space Visibility (PSV) read or table read) are executed back-to-back, one or more subsequent instructions can be misexecuted when all of the conditions in [Table 6](#) occur.

[Figure 7](#) provides an example of the effective behavior.

## Work around

1. All instances of PSV `MOV.D` can be replaced with two PSV `MOV` instructions instead. Non-PSV `MOV.D` instructions acting on RAM/SFRs do not need to be modified; or
2. If not already present, a program flow change instruction (such as `BRA $+2`) can be inserted above back-to-back data Flash read sequences; or
3. Back-to-back data Flash read instruction sequences can be broken up by inserting a non-Flash read instruction (such as a `NOP`), in between the Flash read instructions; or
4. The alignment of the code can be shifted to avoid the required opcode location addresses.
