## Product Change Notification / SYST-21MVID450

ERRATA - dsPIC33EVXXXGM00X/10X Family Silicon Errata and Data Sheet Clarification Document Revision

## dsPIC33EVXXXGM00X/10X Family Silicon Errata and Data Sheet Clarification

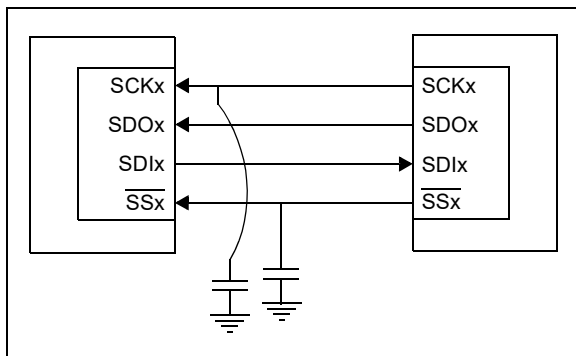
FIGURE 1:

Adding a capacitance on the signal, as shown in Figure 1, will help the data to be received properly.

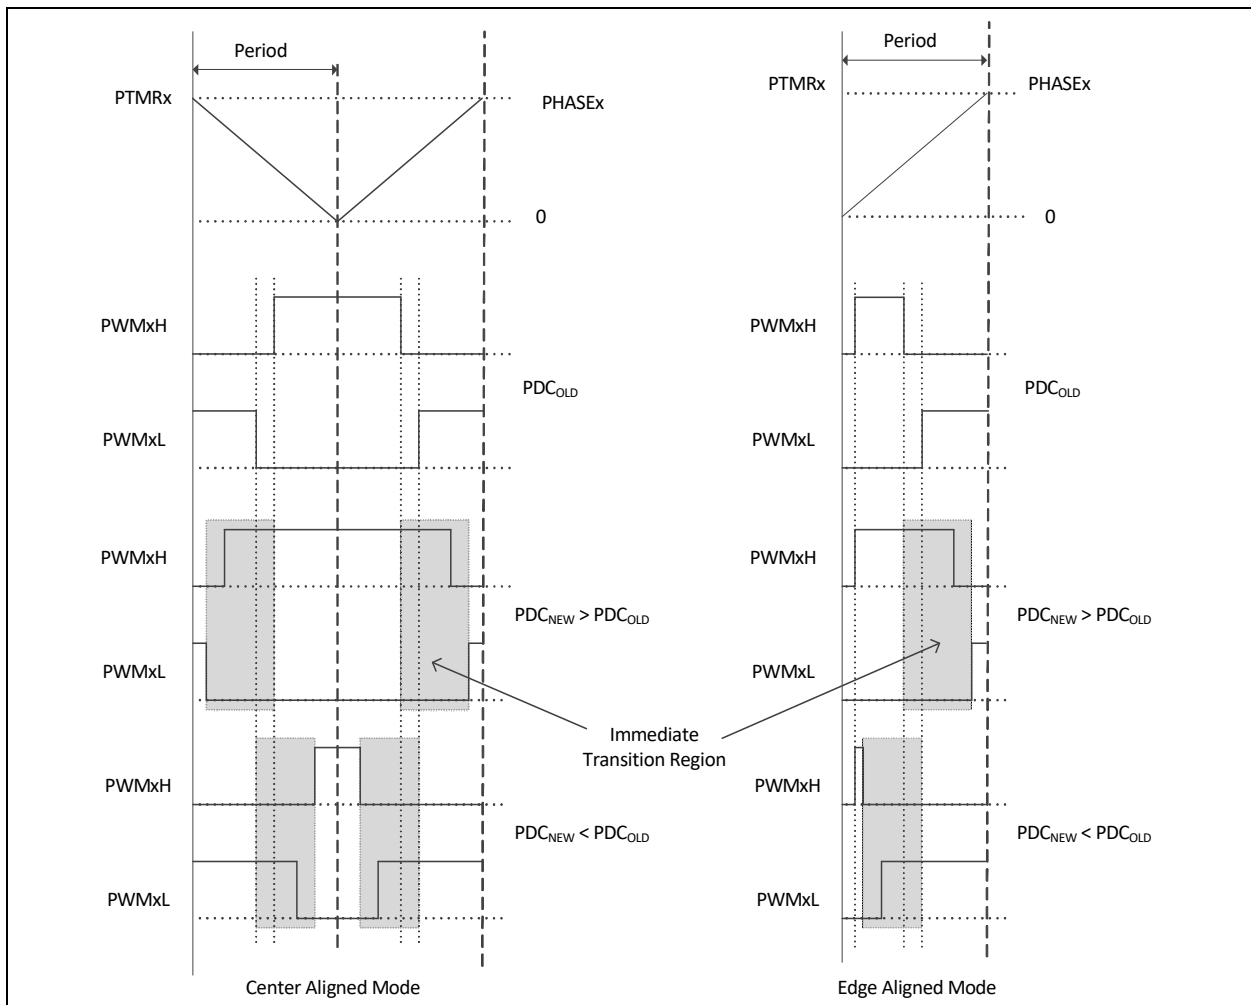
**FIGURE 2: TIMING DIAGRAMS FOR CENTER-ALIGNED AND EDGE-ALIGNED MODES**

The PWM generator may not assert dead time on the edges of transitions. This has been observed when all of the following conditions are present:

In [Figure 2](#), if the duty cycle write occurred in the shaded box, then PWMxH and PWMxL will make an immediate transition without dead time.

However, in most applications, the duty cycle update timing can be controlled using the TRIGx trigger or Special Event Trigger, such that the above mentioned conditions are avoided altogether.

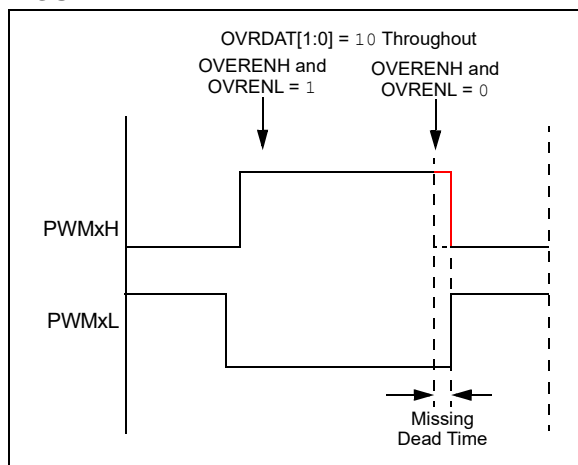
FIGURE 4:

- Output override synchronization is configured to occur on the CPU clock boundary (IOCONx[0] = 0);
- Both PWMxH and PWMxL overrides are enabled prior to the event (OVRENH and OVRENL are both '1'), and
- Both overrides are disabled (OVRENH and OVRENL are both '0') at the instant the dead time should be asserted (Figure 4). This has been observed in both Center-Aligned and Edge-Aligned modes.

None.

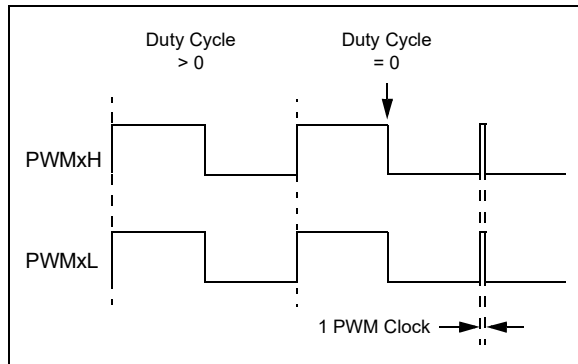
FIGURE 5:

In the Redundant Output mode (IOCONx[11:10] = 10) and Push-Pull Output mode (IOCONx[11:10] = 01) with Immediate Update disabled (PWMCONx[0] = 0), when the Duty Cycle register is updated from a non-zero value to zero, a glitch pulse of a width equal to one PWM clock will appear at the next PWM period boundary, as shown in Figure 5, for the Redundant Output mode. Here, the Duty Cycle register refers to the PDCx register if PWMCONx[8] = 0 or the MDC register if PWMCONx[8] = 1.

If the application requires a zero duty cycle output, there are two possible work around methods:

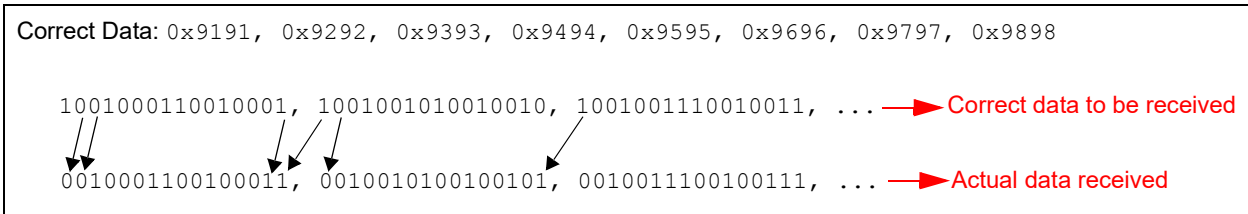
**FIGURE 6:**

Received data of the SPI are sampled one clock cycle late for the following conditions:

For example, the correct data that should be received are 0x9191, 0x9292, 0x9393, 0x9494, 0x9595, 0x9696, 0x9797, 0x9898, but the actual data received are 0x2323, 0x2525, 0x2727, 0x2929, 0x2B2B, 0x2D2D, 0x2F2F, 0x3130 (Figure 6).

None.

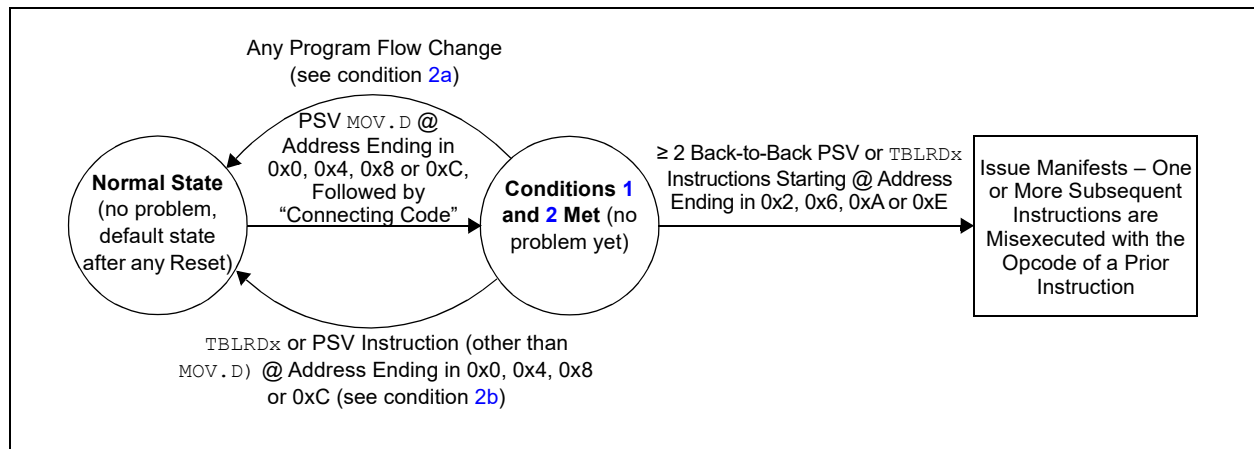
**FIGURE 7: SIMPLIFIED BEHAVIOR**

When two or more data Flash read instructions (via Program Space Visibility (PSV) read or table read) are executed back-to-back, one or more subsequent instructions can be misexecuted when all of the conditions in [Table 6](#) occur.

[Figure 7](#) provides an example of the effective behavior.

1. All instances of PSV MOV.D can be replaced with two PSV MOV instructions instead. Non-PSV MOV.D instructions acting on RAM/SFRs do not need to be modified; or
2. If not already present, a program flow change instruction (such as BRA \$+2) can be inserted above back-to-back data Flash read sequences; or
3. Back-to-back data Flash read instruction sequences can be broken up by inserting a non-Flash read instruction (such as a NOP), in between the Flash read instructions; or
4. The alignment of the code can be shifted to avoid the required opcode location addresses.

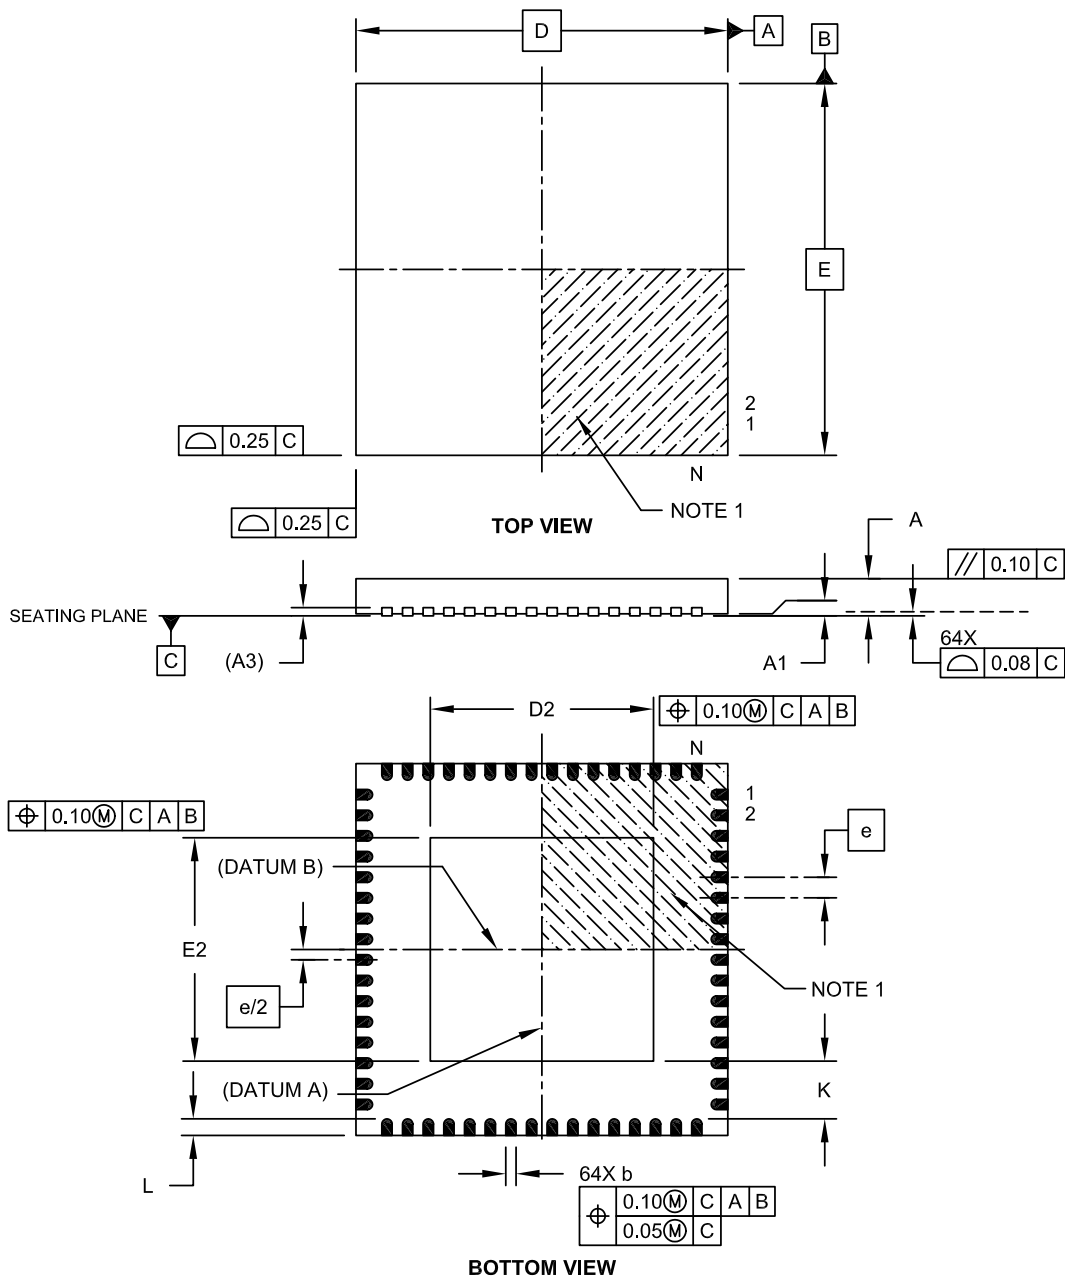
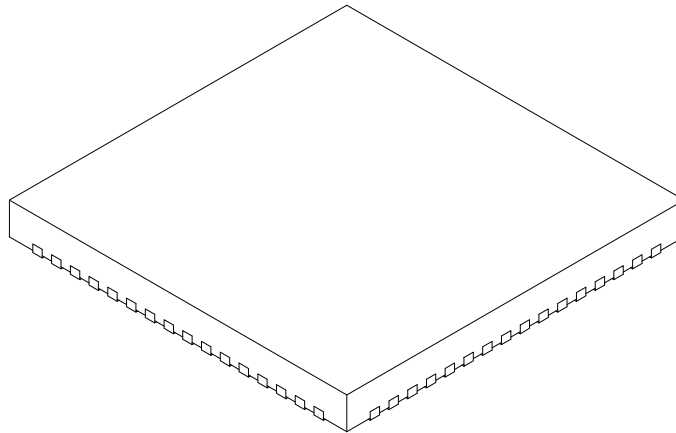
### 64-Lead Plastic Quad Flat, No Lead Package (MR) – 9x9x0.9 mm Body with 5.40 x 5.40 Exposed Pad [QFN]

The package drawing for the 64-pin QFN device has been updated with the 64-Lead Plastic Quad Flat, No Lead package (MR) – 9x9x0.9 mm Body with 5.40x5.40 Exposed Pad [QFN] package drawing as shown below.
