## Product Change Notification / SYST-08HQLN222

ERRATA - PIC32MZ Embedded Connectivity with Floating Point Unit (EF) Family Silicon Errata and Data Sheet Clarification

## PIC32MZ Embedded Connectivity with Floating Point Unit (EF) Family Silicon Errata and Data Sheet Clarification

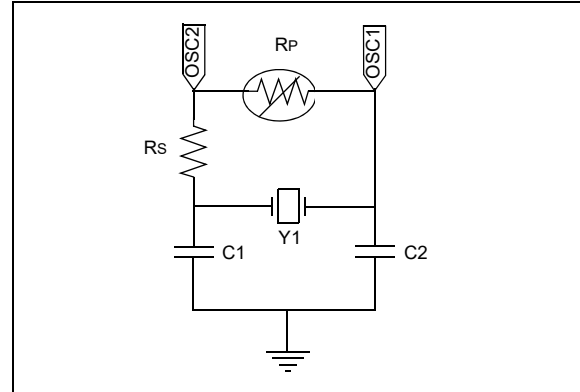
**FIGURE 1: Posc CRYSTAL CIRCUIT**

The Primary Oscillator (Posc) has been characterized to operate at 8 MHz, 12 MHz, and 24 MHz when the circuit in [Figure 1](#) is implemented, and the operating conditions listed in [Table 3](#) are met.

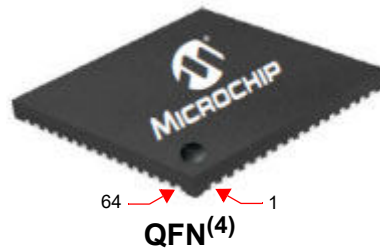
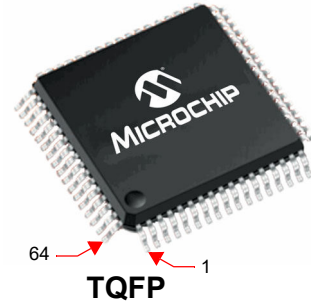
### 64-PIN QFN<sup>(4)</sup> AND TQFP (TOP VIEW)

The following typographic corrections and clarifications are to be noted for the latest version of the device data sheet (DS60001320G):
