Product Change Notification / SYST-22PIGS506

ERRATA - PIC32MK GPK/MCM Family Silicon Errata

PIC32MK General Purpose and Motor Control (GPK/MCM) with CAN FD Family Silicon Errata and Data Sheet Clarifications

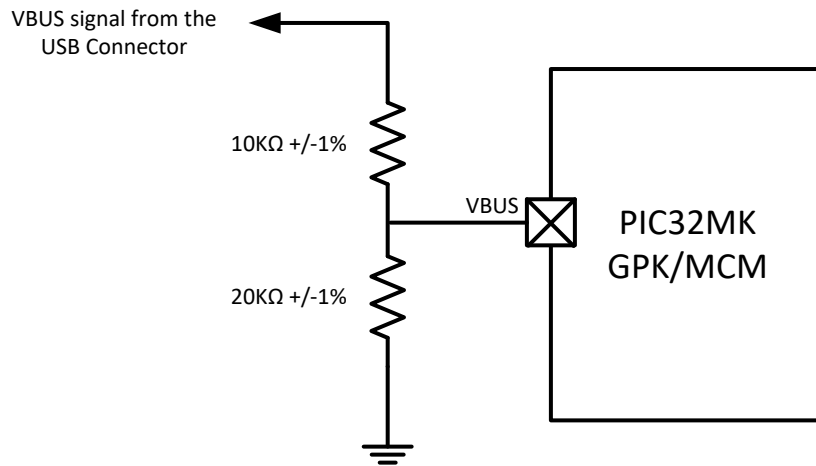
2.2.2 VBUS pin

The VBUS pin is not 5V tolerant.

Connect an external voltage divider as shown in the following figure:
