Product Advisory

Issue Date: September 15, 2022

Whitney+ power reduction configuration support in 2.25

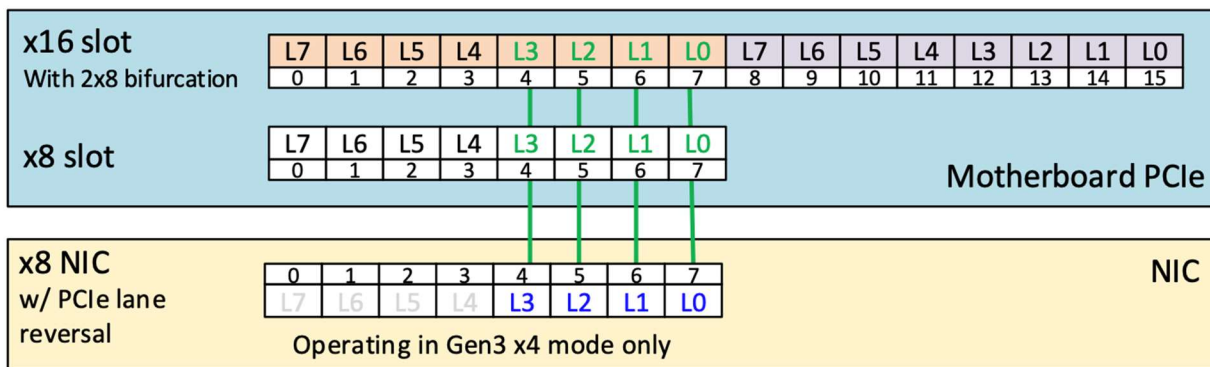
Example of **Compatible** Motherboard Configuration

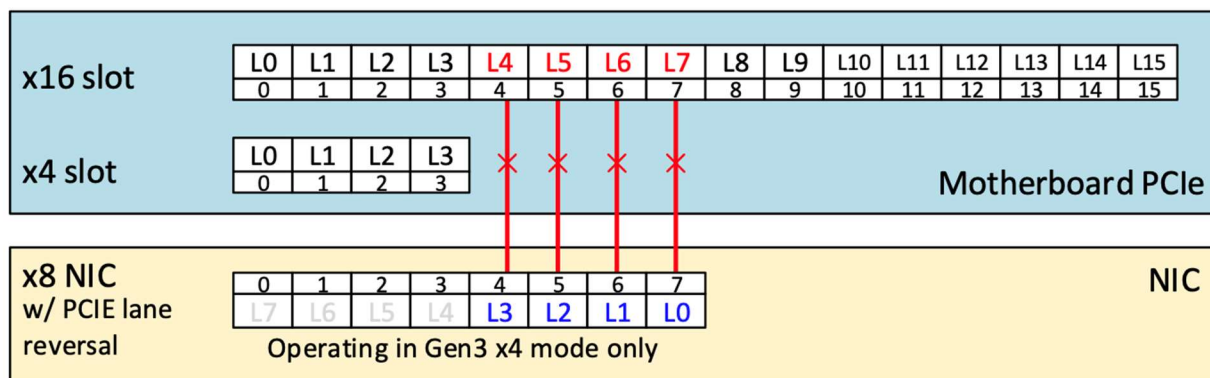
Above listed Broadcom NICs implement PCIe lane reversal (table 1) on the PCB, which may be incompatible with certain motherboards after enabling the power reduction feature. If the feature is enabled on an incompatible motherboard, **the card will not be detected by the host over the PCIe bus.**

The above sequence of events will result in the card not getting detected on incompatible motherboards. To recover the card, the customer will need to move the NIC card to a compatible system, disable the feature, and then move the card back to the original motherboard.

Example of **Incompatible** Motherboard Configuration

- Users must consult the FAE Advisory “Wh+ 10G Power Reduction Feature in 2.25 FW Release” to ensure system compatibility before enabling this feature.
- Customers should test the power reduction feature first before mass deploying the feature in the field for the NIC cards listed above.
- Follow the Firmware upgrade & downgrade considerations provided in the reference document.
